Oyster Point Marina

Updated Marina Facility Condition Survey Report

Prepared for:
San Mateo County
Harbor District

May 2021

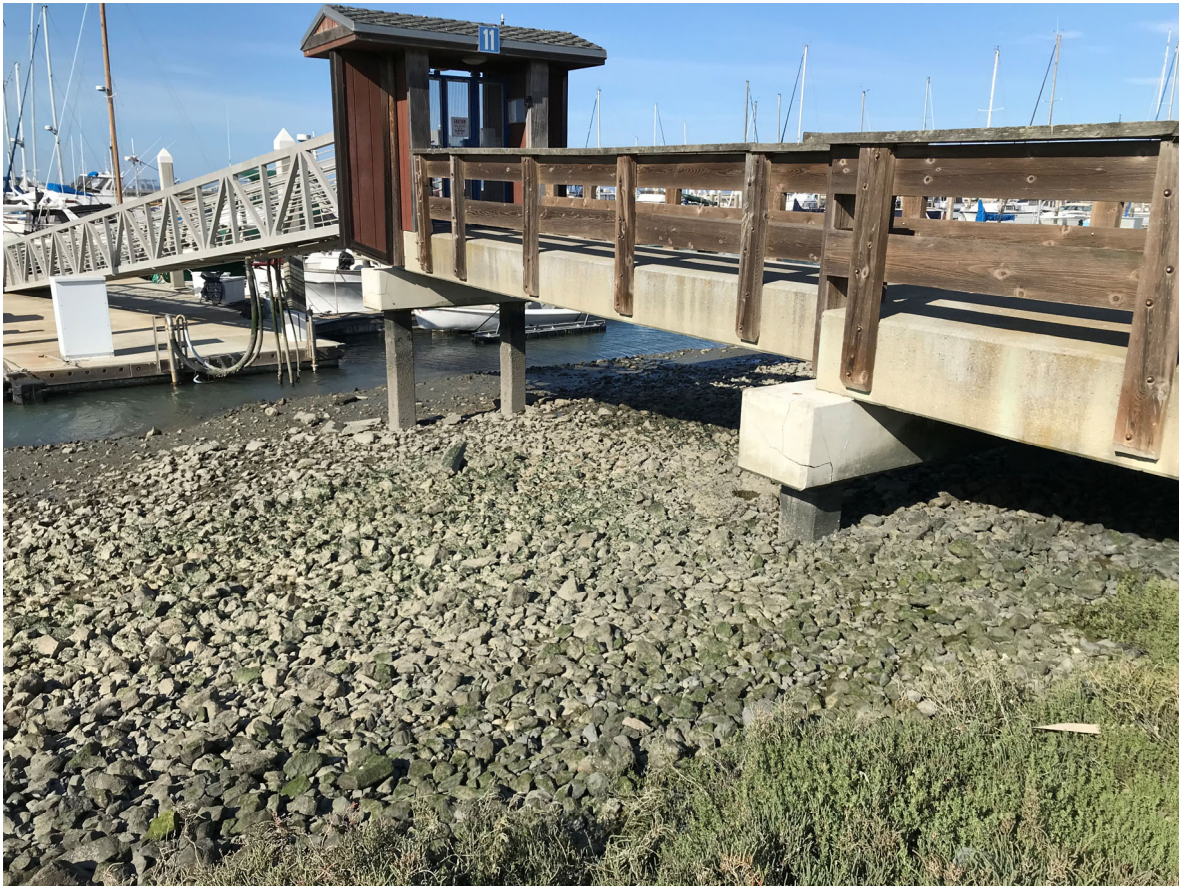
On the landside, the reinforced concrete gangway support platform serving Dock 11 is considered to be in “poor” condition due to the cracking and spalling observed in the concrete beams (or bents) atop the piling. Replacement of the platforms or repair of the concrete bents should be a priority within the next 10 years. The walking surface elevations of the existing gangway platforms are relatively low compared to the new walking surface of the Bay Trail currently being constructed as part of the adjacent Kilroy Oyster Point Redevelopment Project.

28 – View of Dock 11 gangway platform and ADA gangway

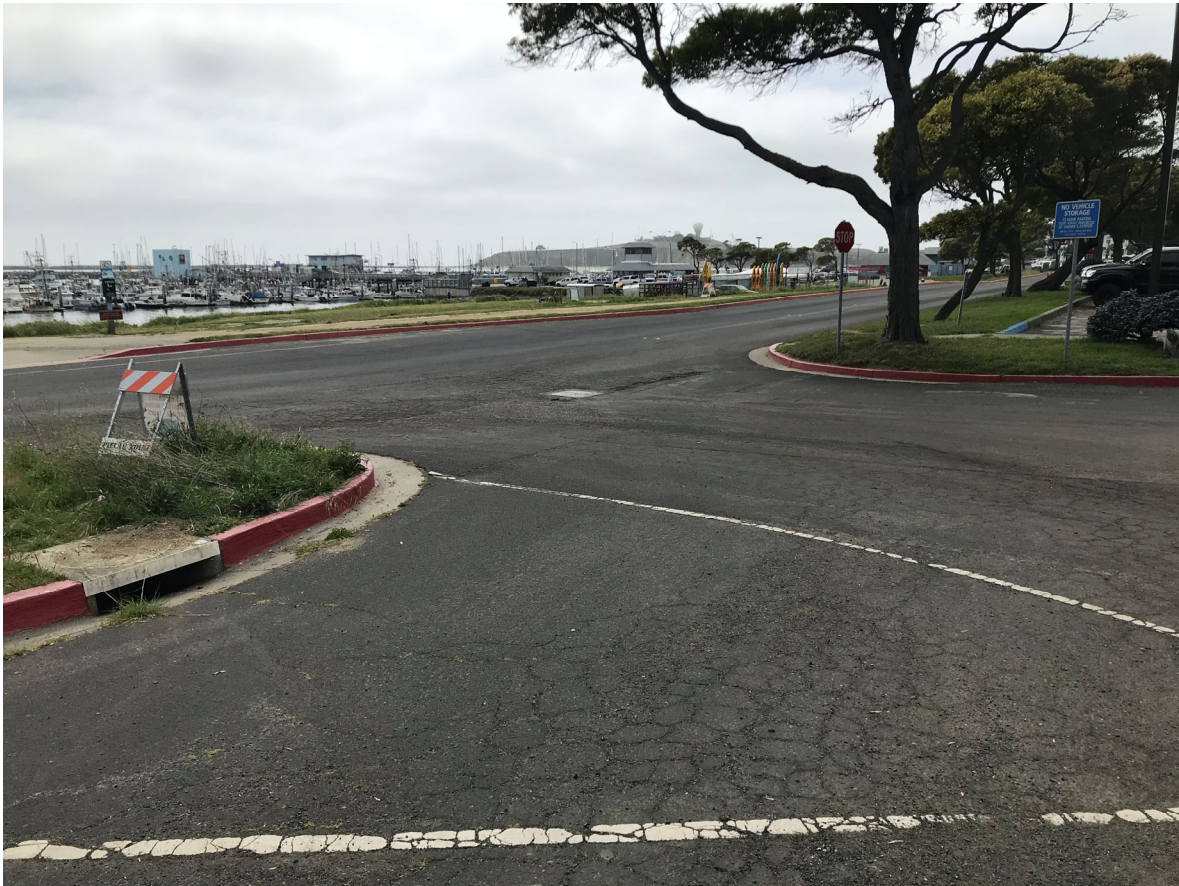
48 – View of worn and failing pavement to boat trailer parking area
