Appendix A
Site Photos

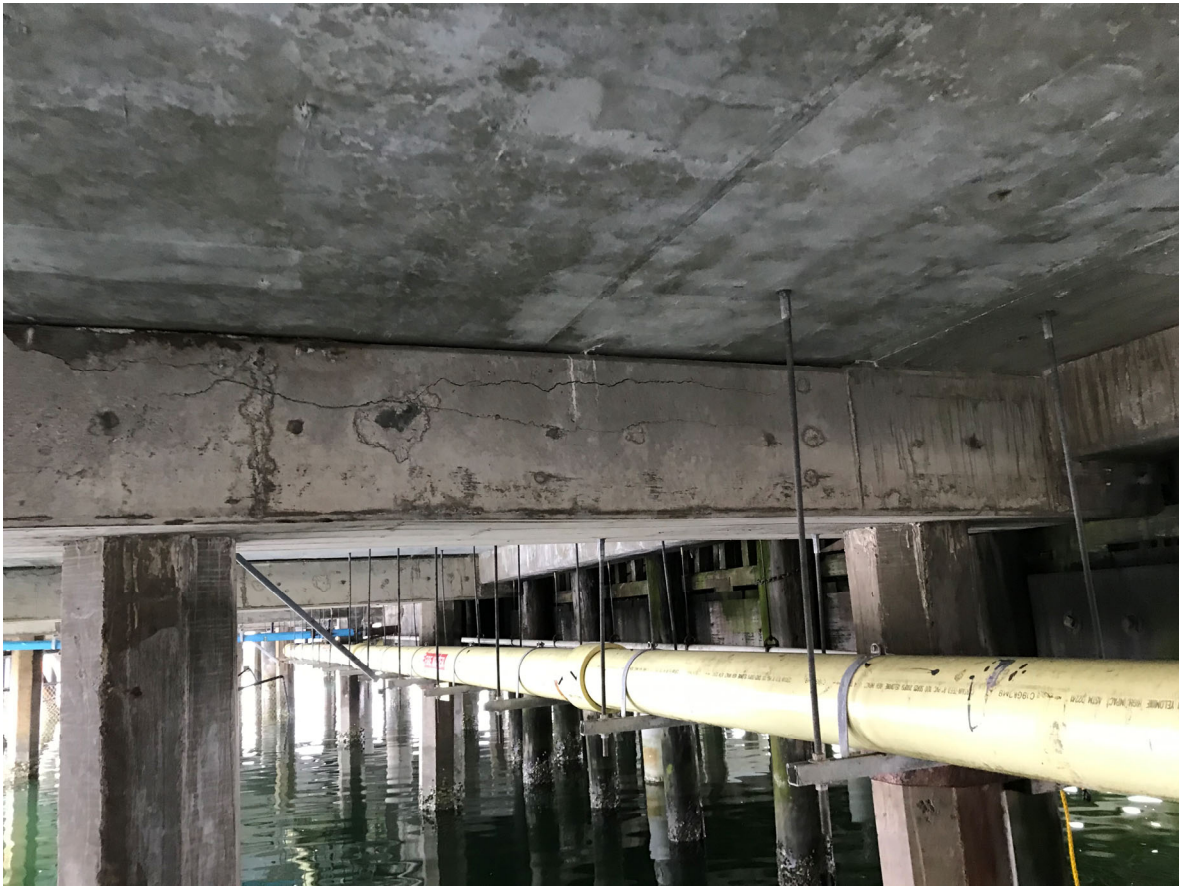
7 – View of overstress cracked beam and utilities under end of pier

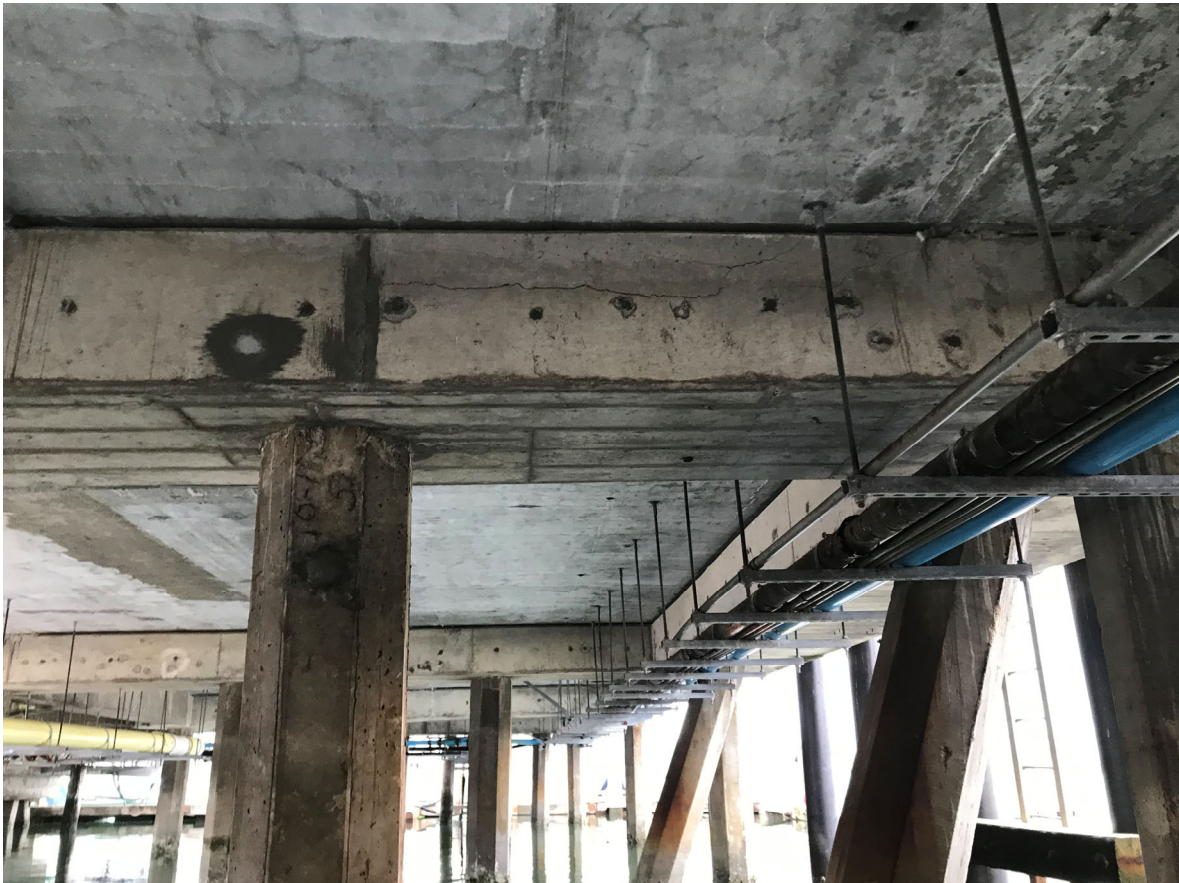
8 – View of overstress cracked beam and utilities under end of pier

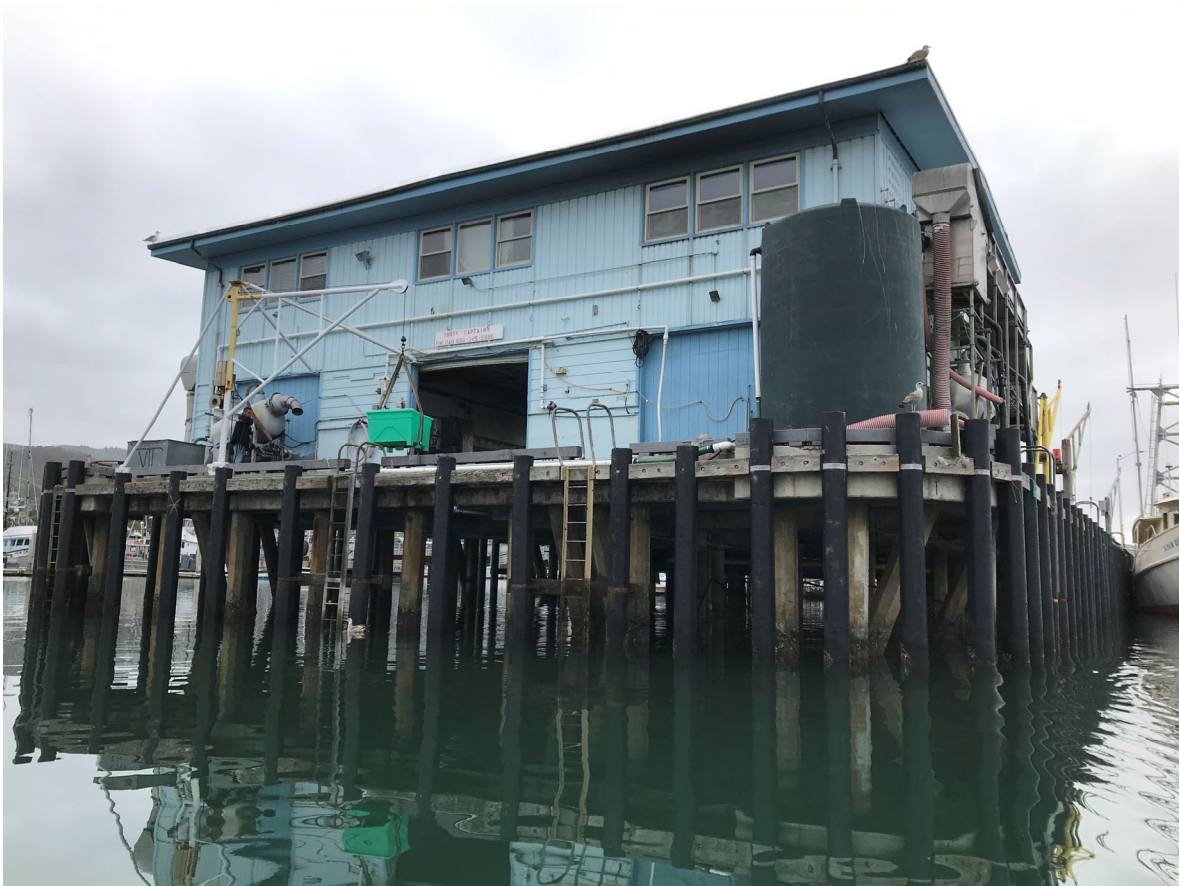
10 – View of overstressed pile and bent at end of pier

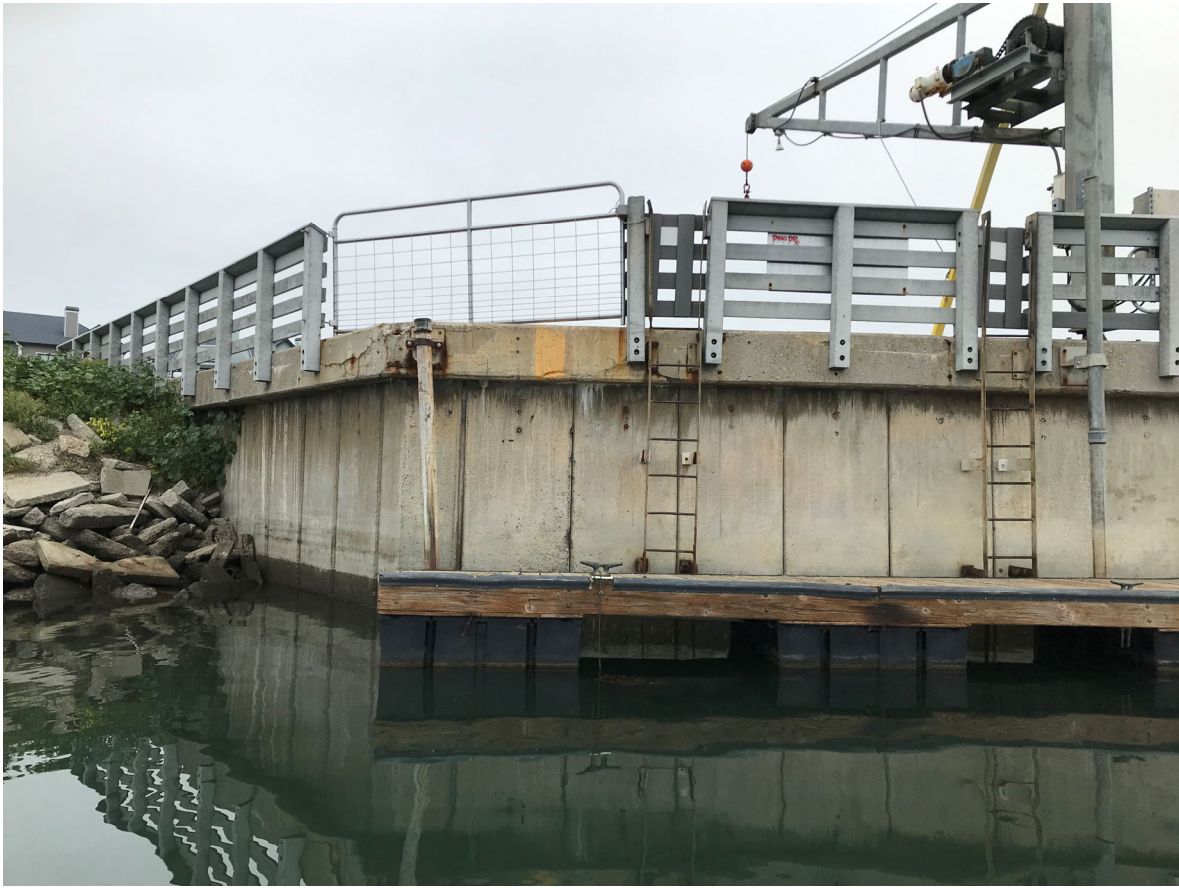
19 – View of promenade and east end of sheet pile wall (with exposed concrete block)

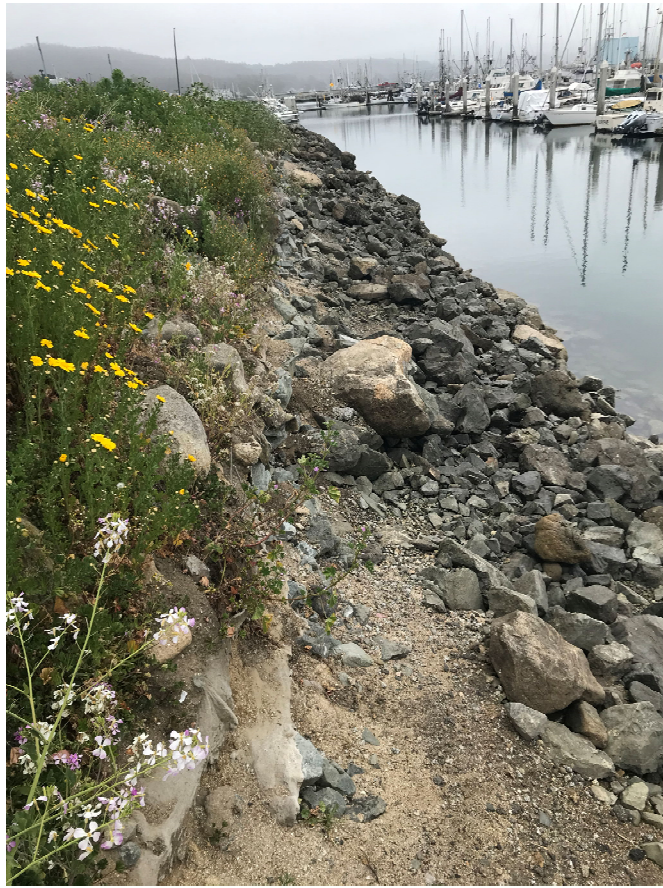
23 – View of failed rock slope protection

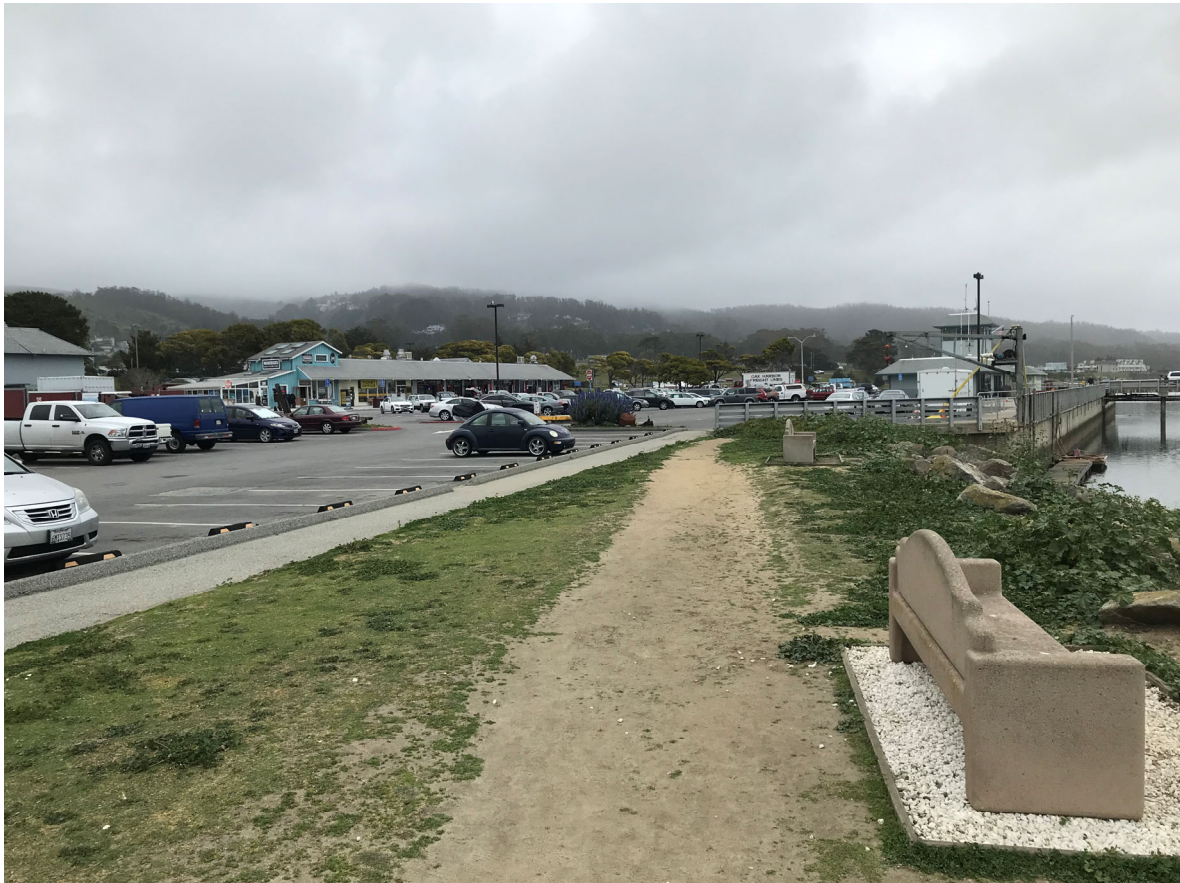
24 – View of failed rock slope protection
