SAN MATEO COUNTY HARBOR DISTRICT
STRATEGIC BUSINESS PLAN
**EXISTING INFRASTRUCTURE &
FACILITIES ASSESSMENT**
DRAFT, DECEMBER 2014

**A.3. MARINE INFRASTRUCTURE & HARBOR FACILITIES ASSESSMENT –
PILLAR POINT HARBOR**

**A.4. MARINE INFRASTRUCTURE & HARBOR FACILITIES ASSESSMENT –
OYSTER POINT MARINA PARK**

The purpose of this report is to provide a summary of the facility condition survey (FCS) performed at Pillar Point Marina (Pillar Point) located in Half Moon Bay, California. San Mateo County Harbor District (SMCHD) asked Moffatt & Nichol (M&N) to visually inspect and evaluate the conditions of the waterside and shoreside structures at the facility. This report identifies the components that require repairs, a prioritized schedule for repair and maintenance of each survey component (i.e., docks, hoists, buildings, etc.), and costs for repair.

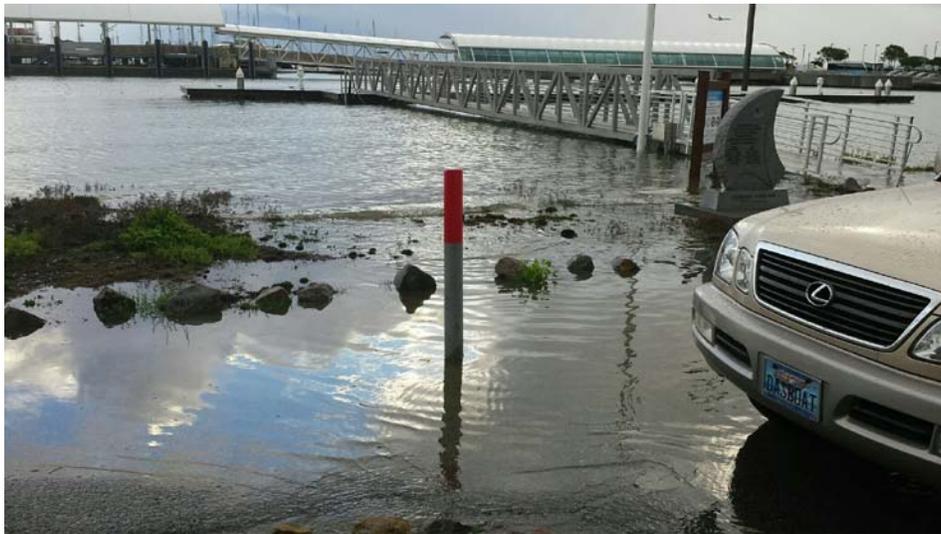
There is frequent flooding of the parking lot between the East and West Basins at the Harbormaster's office now (see Figure 1 and cover photo), which is caused by high tides. The flooding will only get more frequent in the next 10 years. The harbor office should be moved to higher ground as placing fill to raise the ground will increase surcharge and induce settlement on the compressible landfill below.

Photograph 1-Flooding at Oyster Pt.

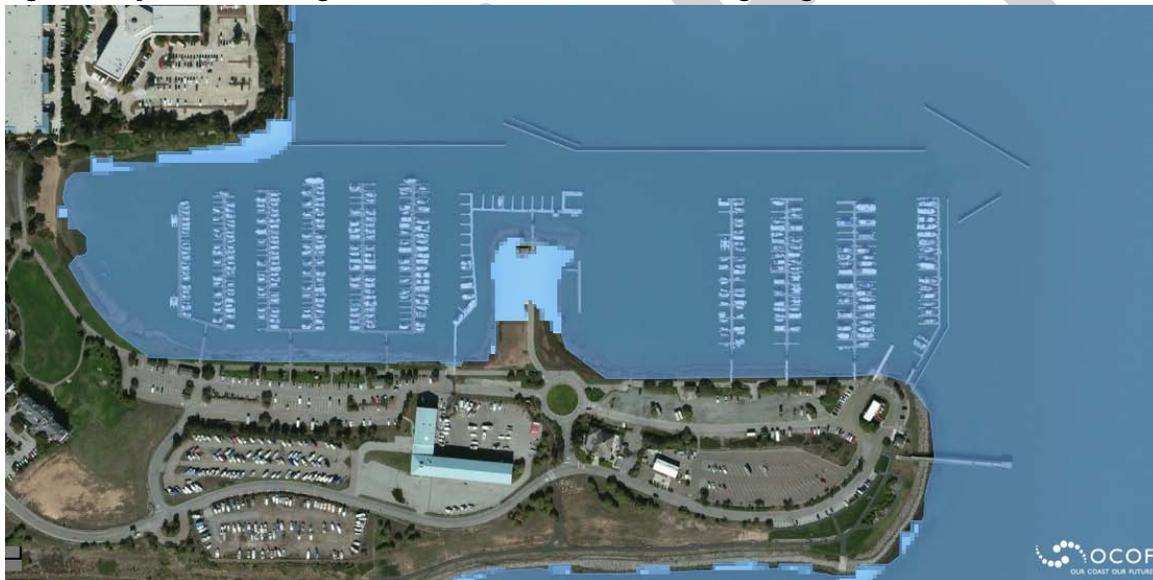
Figure 1-Oyster Pt, Existing Water Level (blue shade) During King Tides

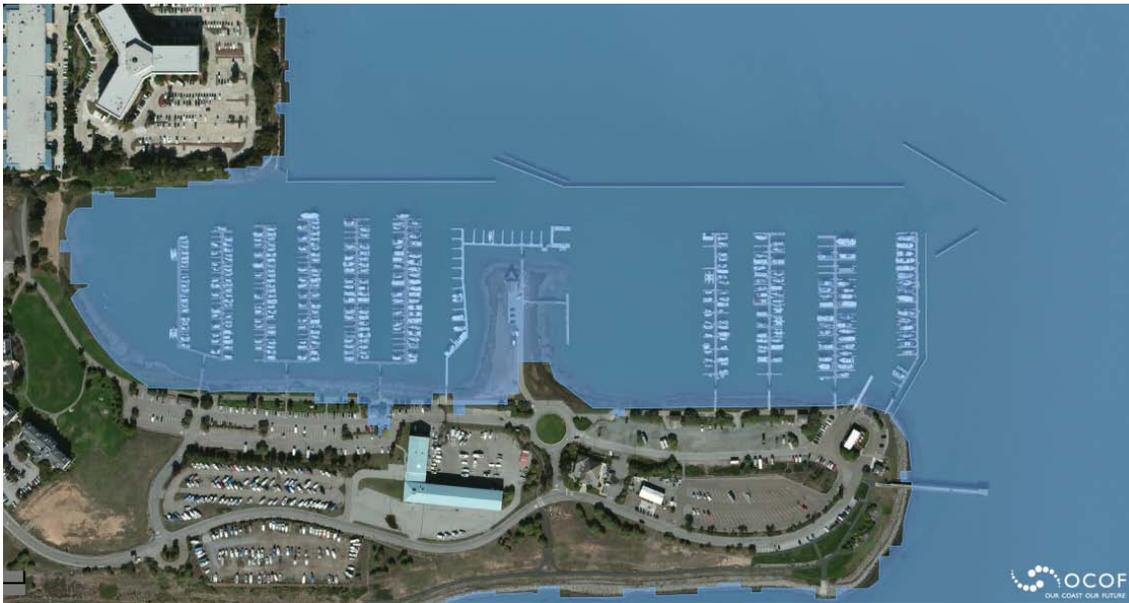
Other features that will be affected further into the future are the access gates to all the docks. Figures 2 and 3 show flooding in these areas with sea level rise from the table above. The tops of guide piles may need to be extended if they are not replaced by 2050. The elevations need to be confirmed to ensure the docks will still be restrained. The breakwater is an item of concern as well as it has been "overtopped" during combination high tides and storm surges.

Figure 2-Oyster Pt, Water Level (blue shade) During King Tides with 12 inches SLR

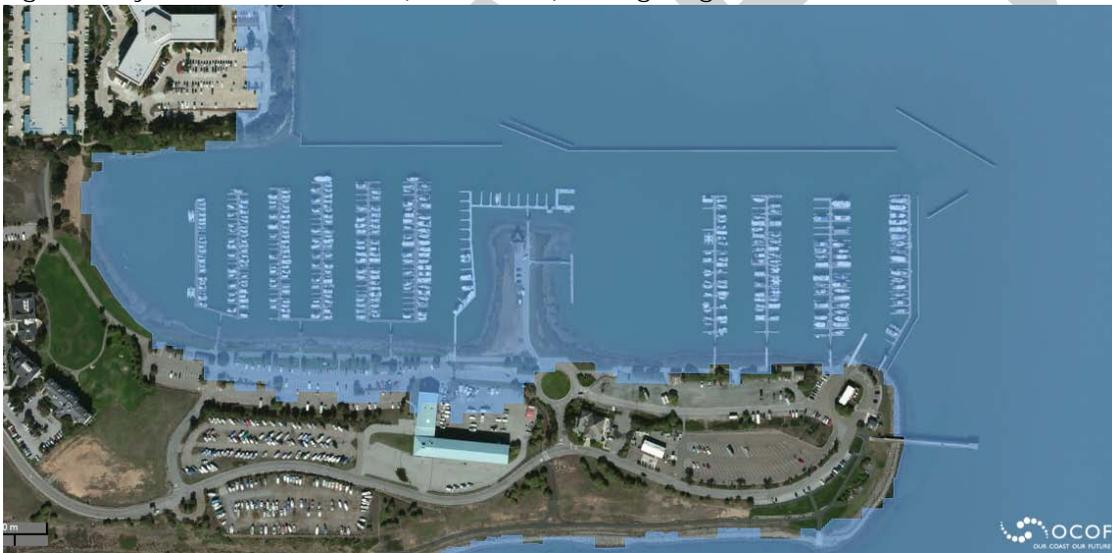
Figure 3-Oyster Pt, Water Level (blue shade) During King Tides with 36 inches SLR

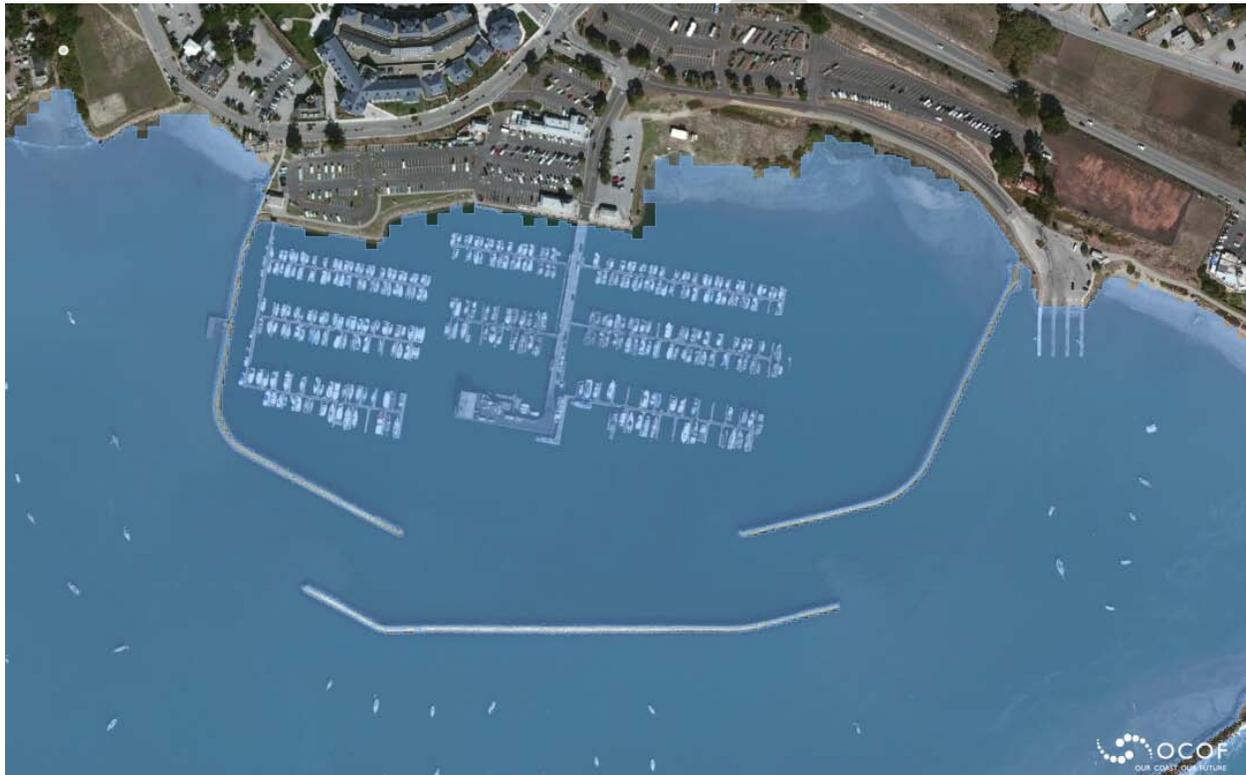
The current western slope within the harbor is sloughing down into the harbor, resulting in the rip rap falling and the soil being exposed. With SLR this will expose the bare slope to greater erosion and cutting back of the soil. The rip rap protection should be repaired or a seawall installed similar to the portion at the Harbormaster Building and East Basin.

Figure 4-Pillar Pt, Existing Water Level During King Tides

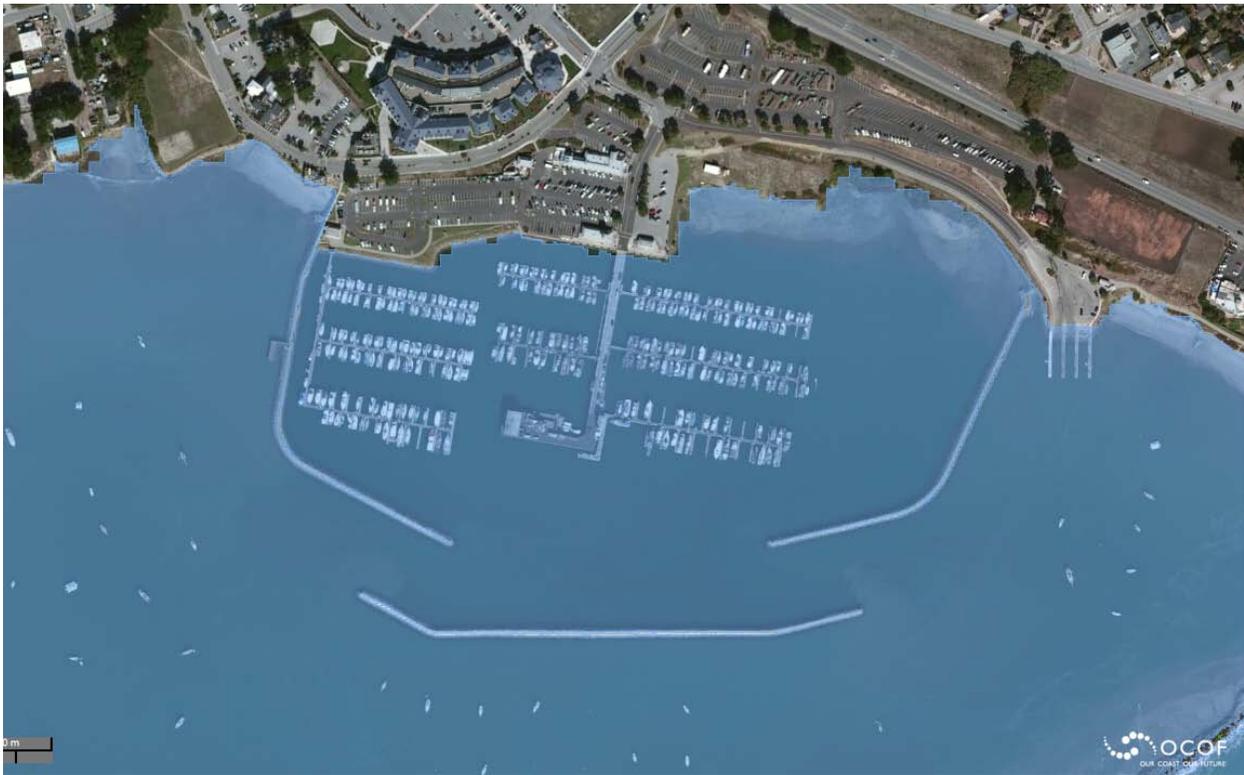
Figure 5-Pillar Pt, Existing Water Level During King Tides with 36 inches SLR

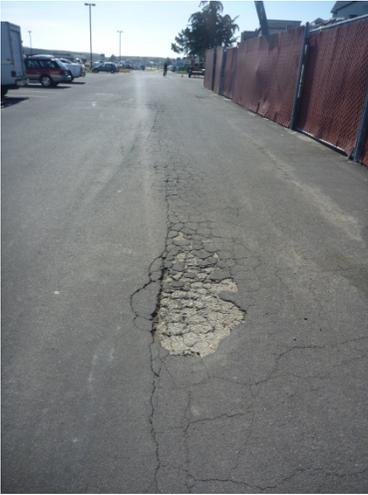
PHOTOGRAPH 13: POTHoles & ALLIGATOR CRACKING WEST PARKING LOT

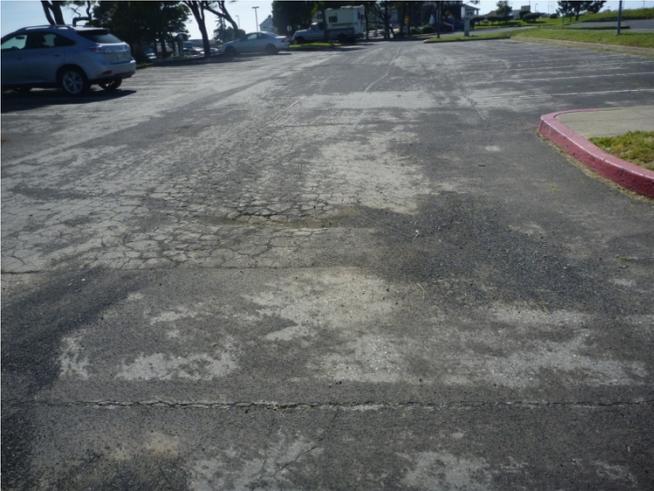
PHOTOGRAPH 14: ALLIGATOR CRACKING NORTH PARKING LOT

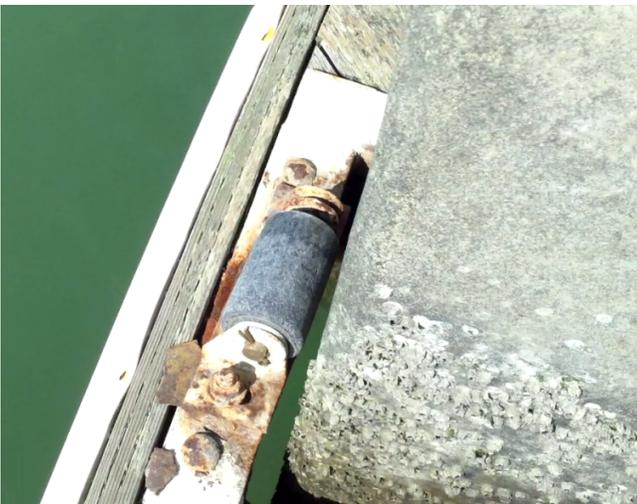
PHOTOGRAPH 2: PILE GUIDE DAMAGE – DOCK 1,
SLIP 6-8

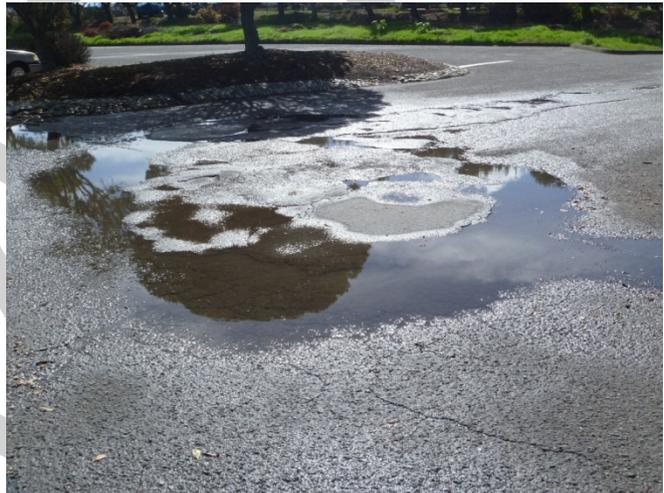
PHOTOGRAPH 9: POTHoles & ALLIGATOR
CRACKING

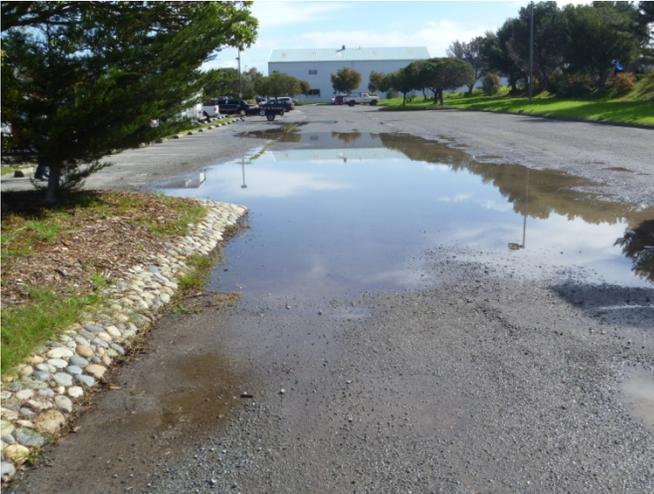
PHOTOGRAPH 10: STANDING WATER

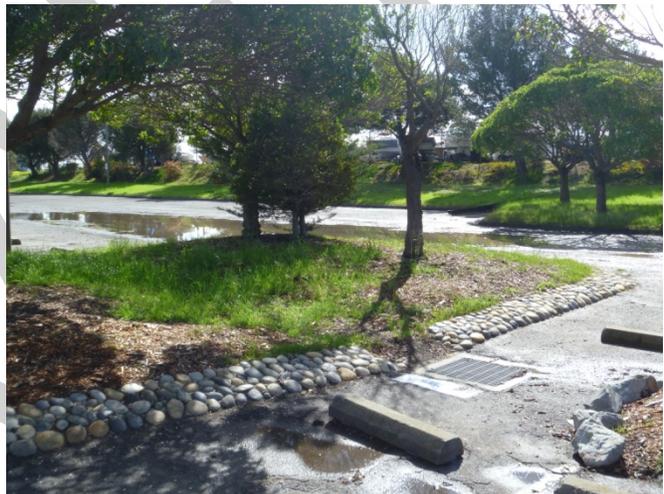
PHOTOGRAPH 14: STORM DRAIN AND STANDING WATER IN OYSTER POINT PARKING LOT
