Oyster Point Marina

Updated Marina Facility Condition Survey Report

Prepared for:
San Mateo County
Harbor District

May 2021

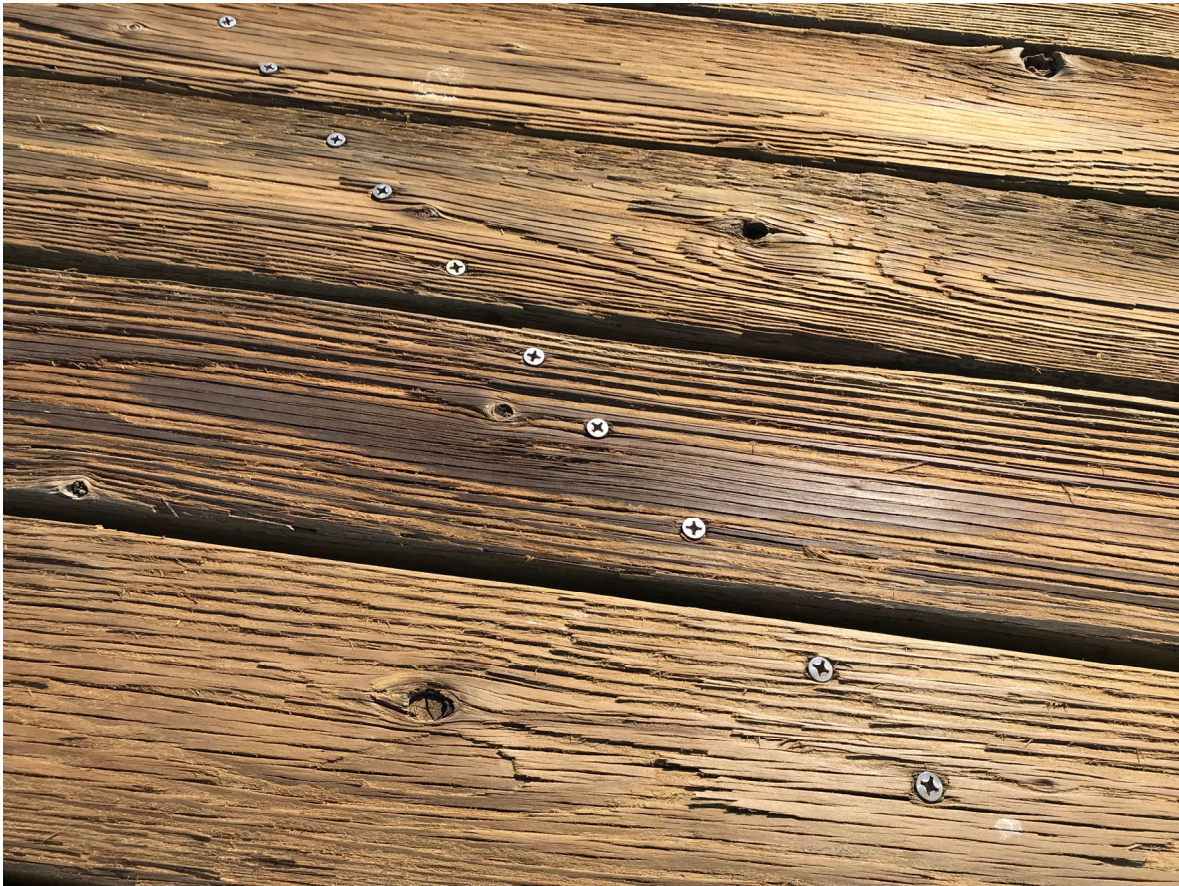
8 – View of stainless steel deck screw on Dock 2

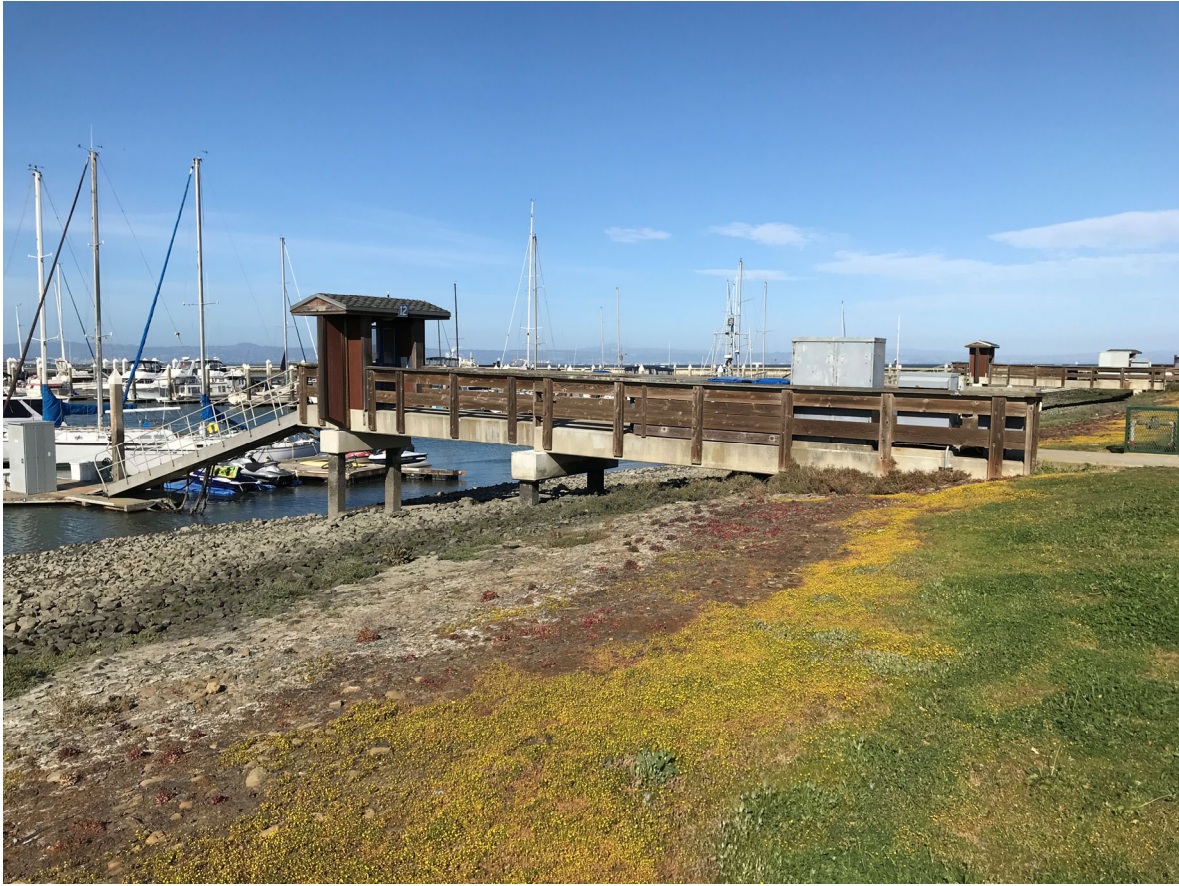
32 – View of Dock 12 gangway platform

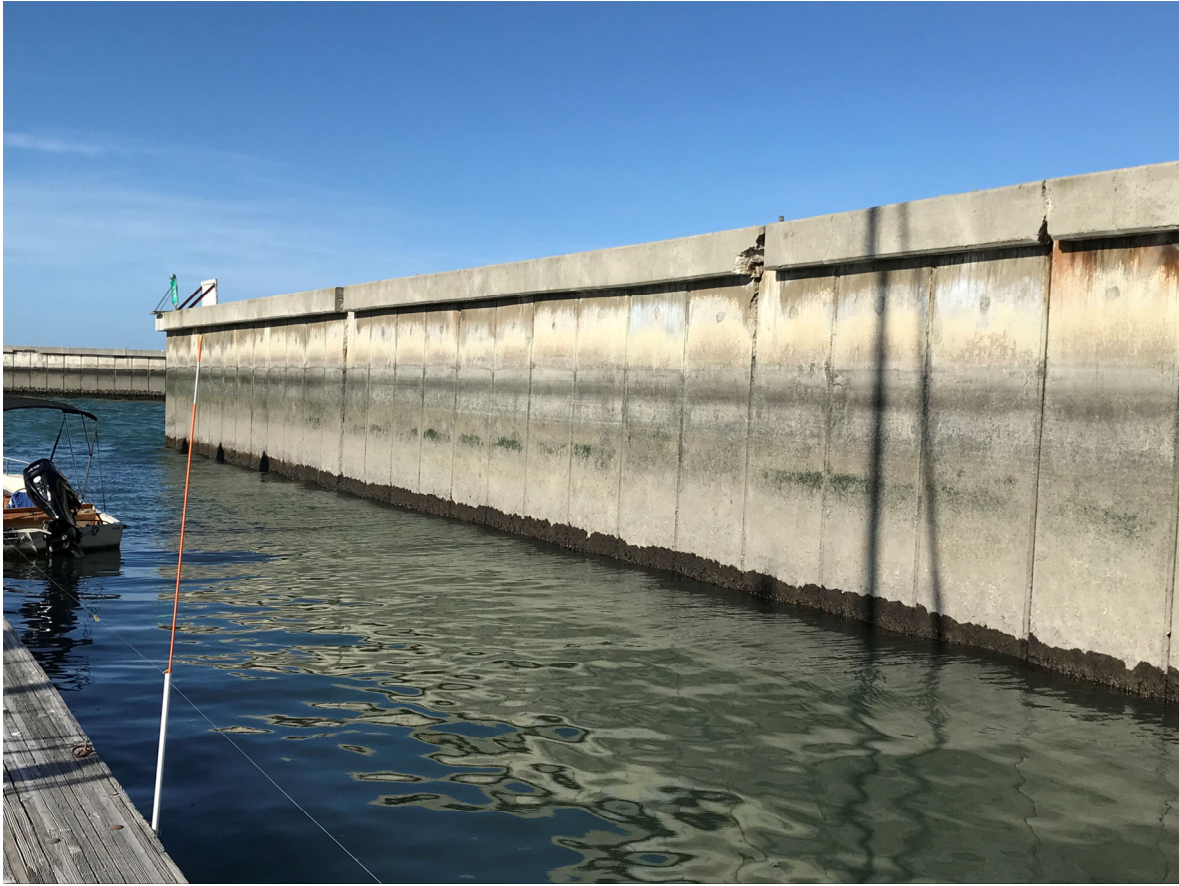
46 – View of seawall

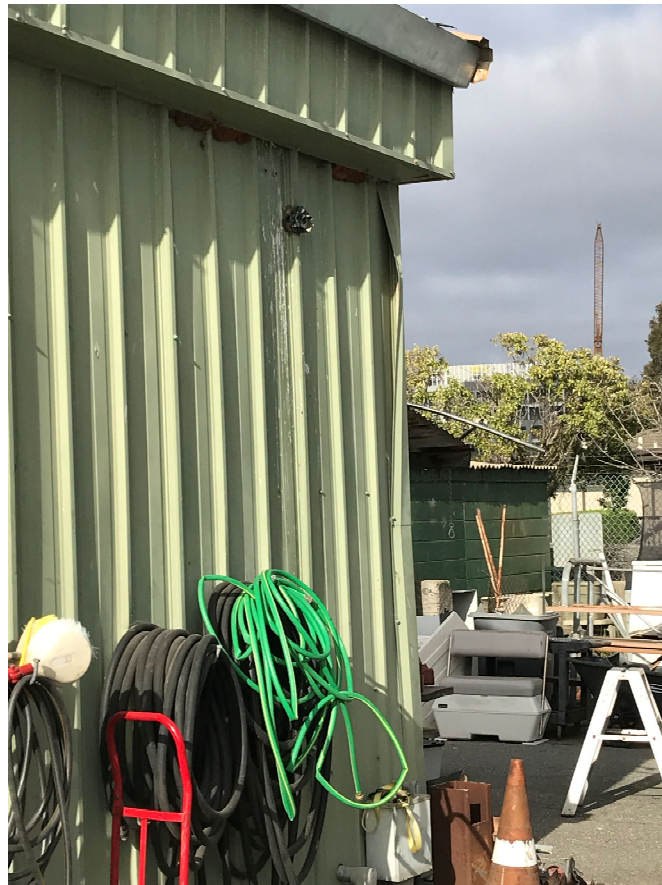
53 – View of warped northwest corner of Maintenance Building

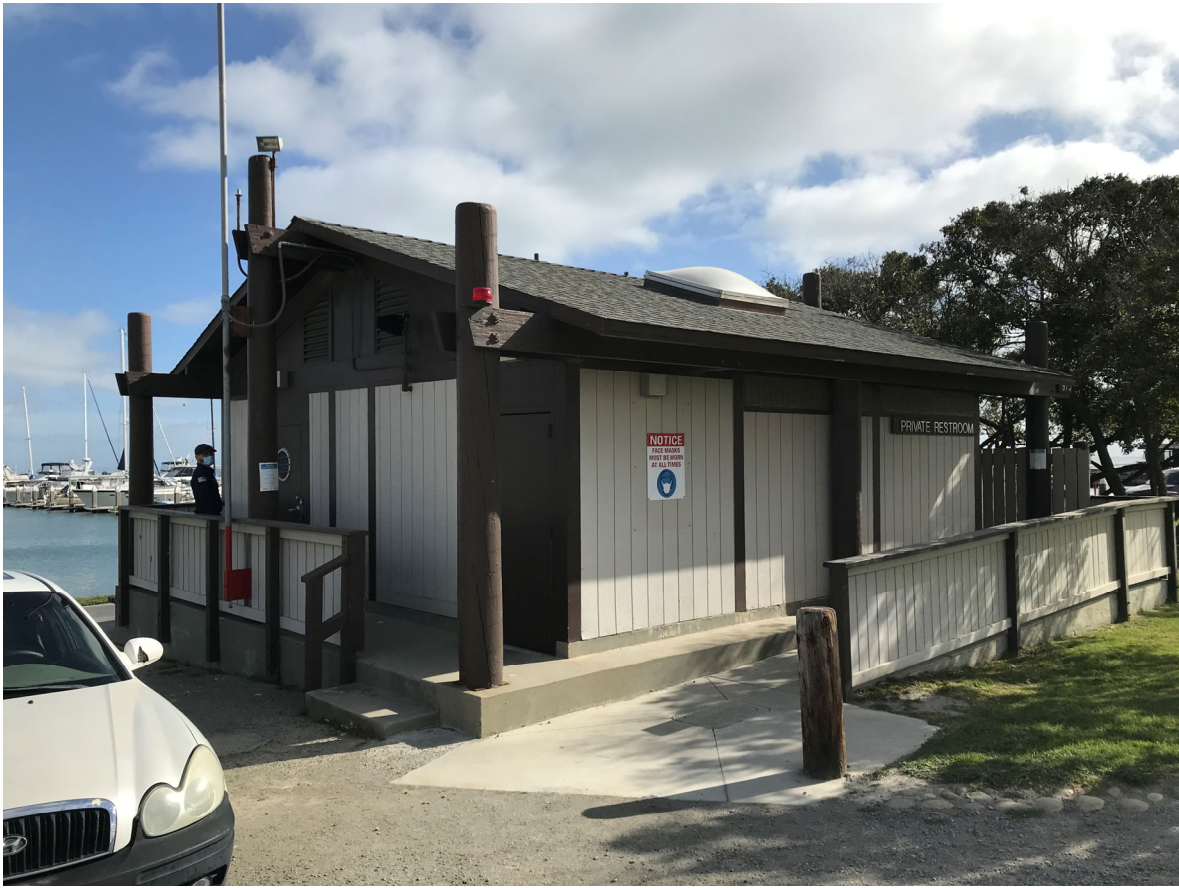
58 – View of East Basin Restroom 2 near Docks 12 and 13

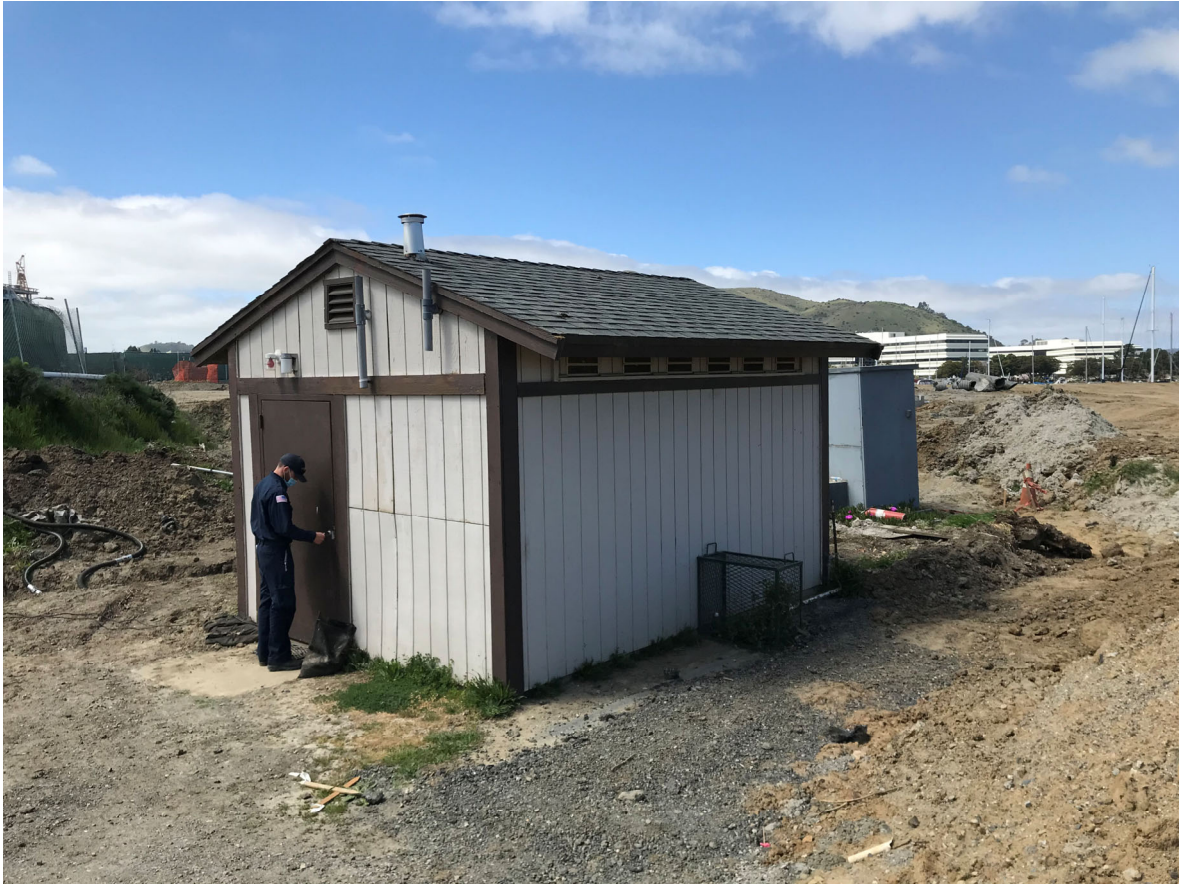
70 – View of Sewer Vacuum and Ejection Building (lift station) and surrounding new site grading

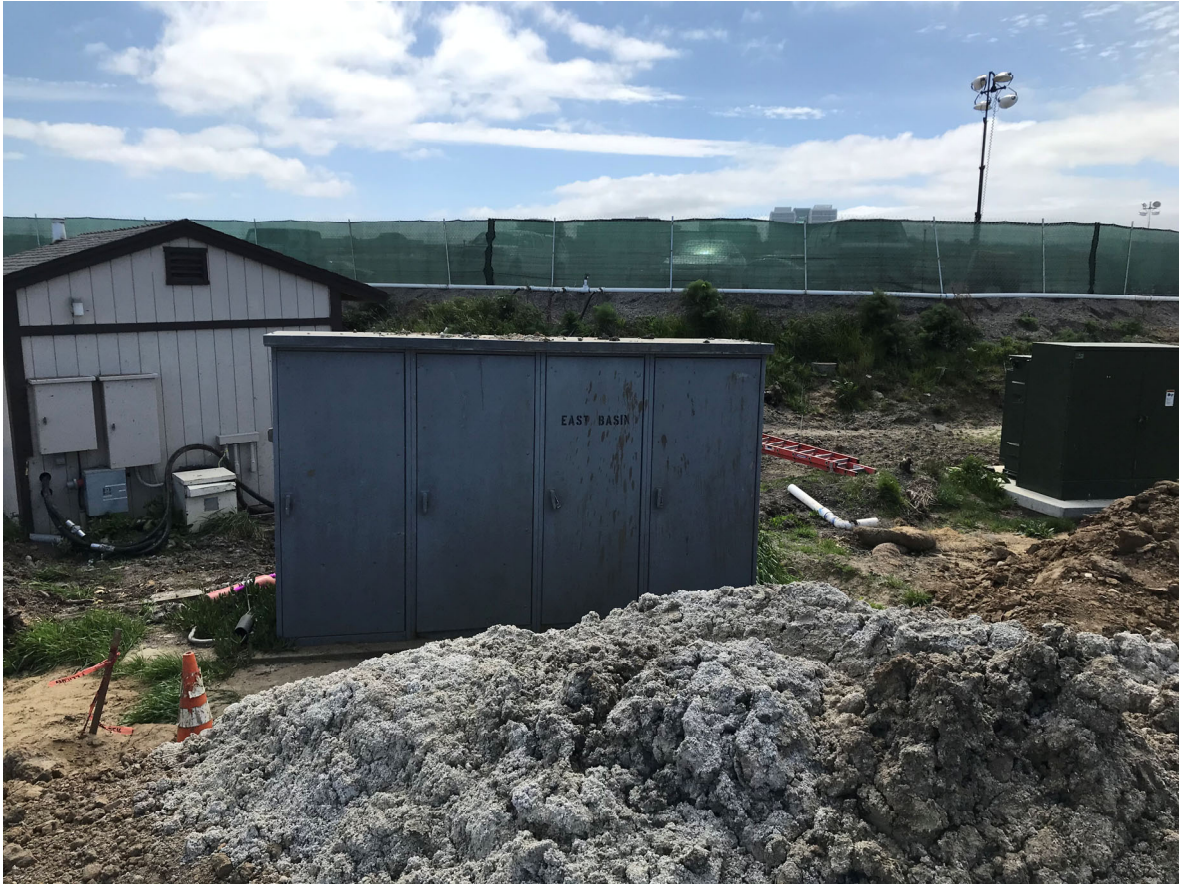
72 – View of Edison and Marina electrical distribution enclosures next to Vacuum Building

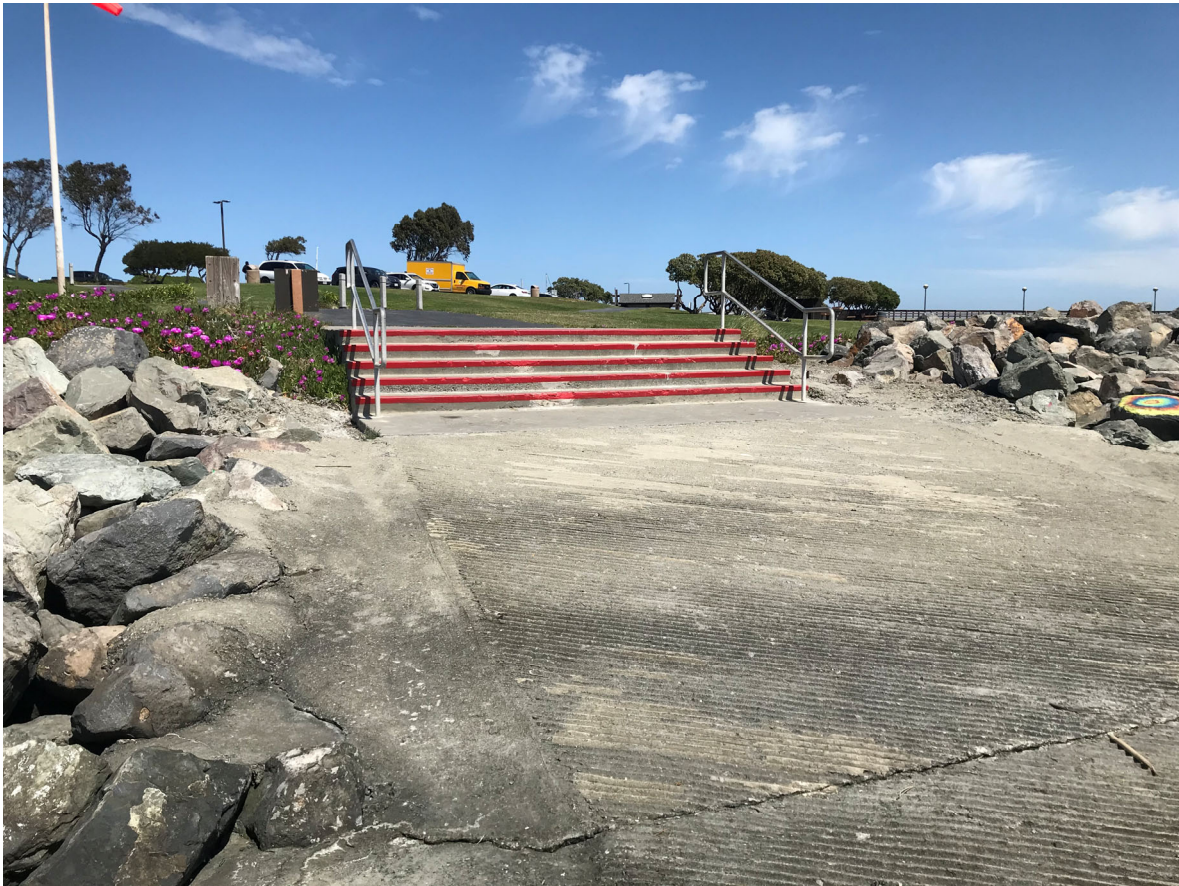
76 – View of Windsurfer launch area

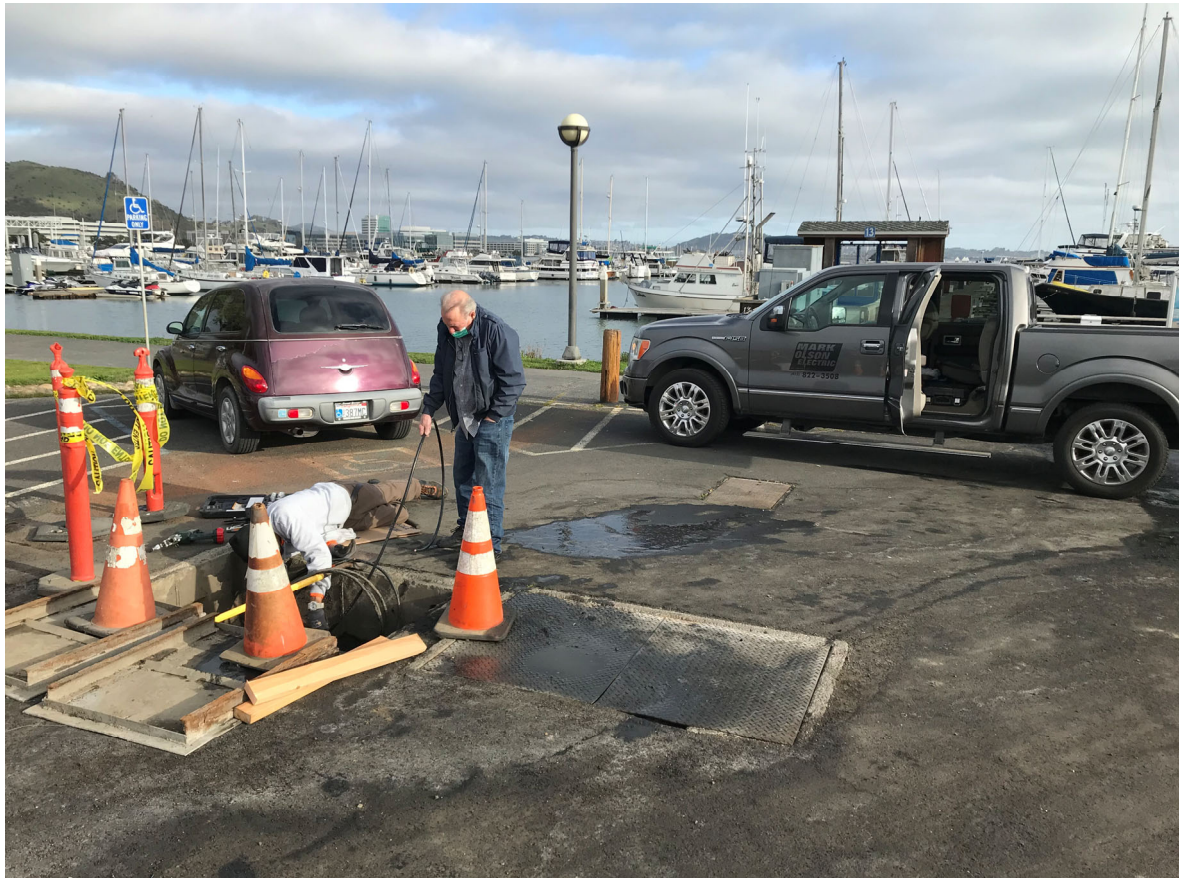
77 – View of electrical vault near Dock 13 being maintained

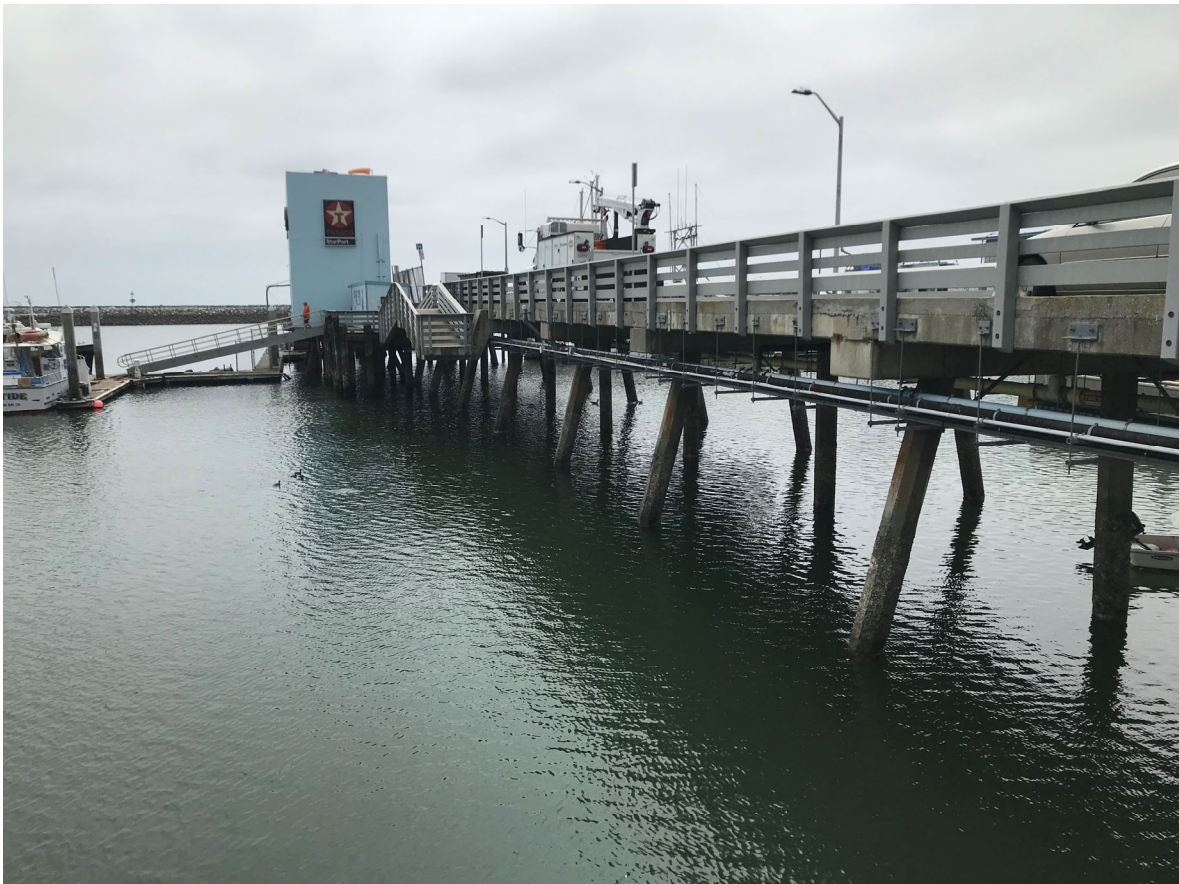
3 – View of east side of Johnson Pier

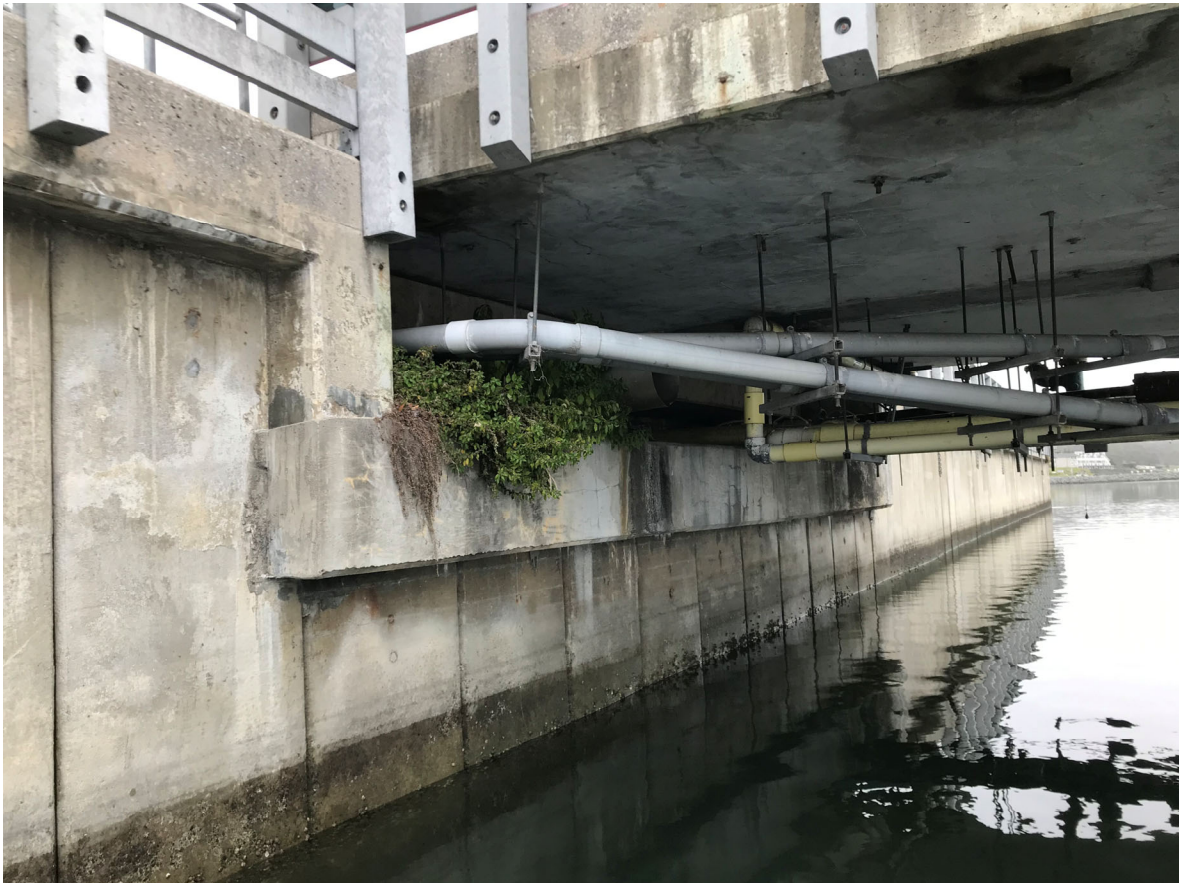
5 – View of utilities under base of pier

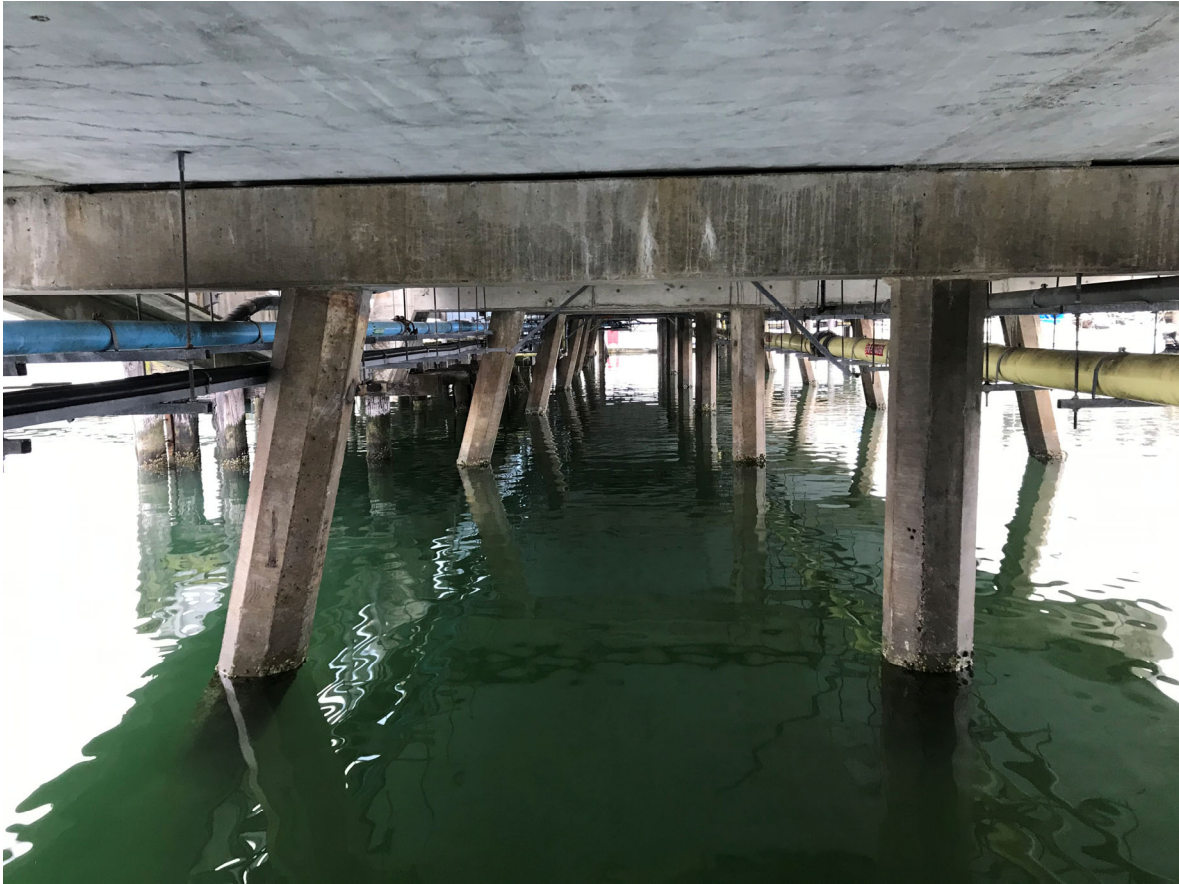
6 – View of support piles, deck, bents and utilities under pier

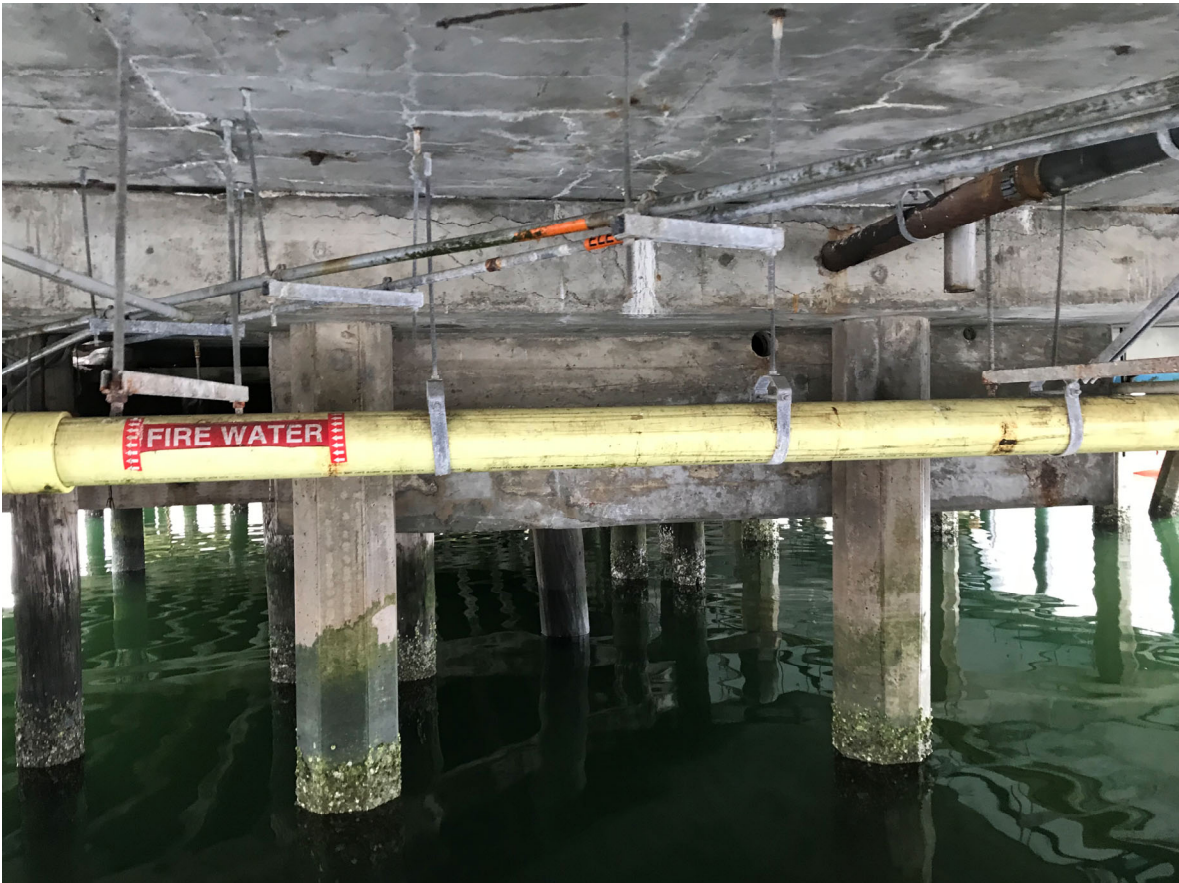
7 – View of support beam and utilities under end of pier

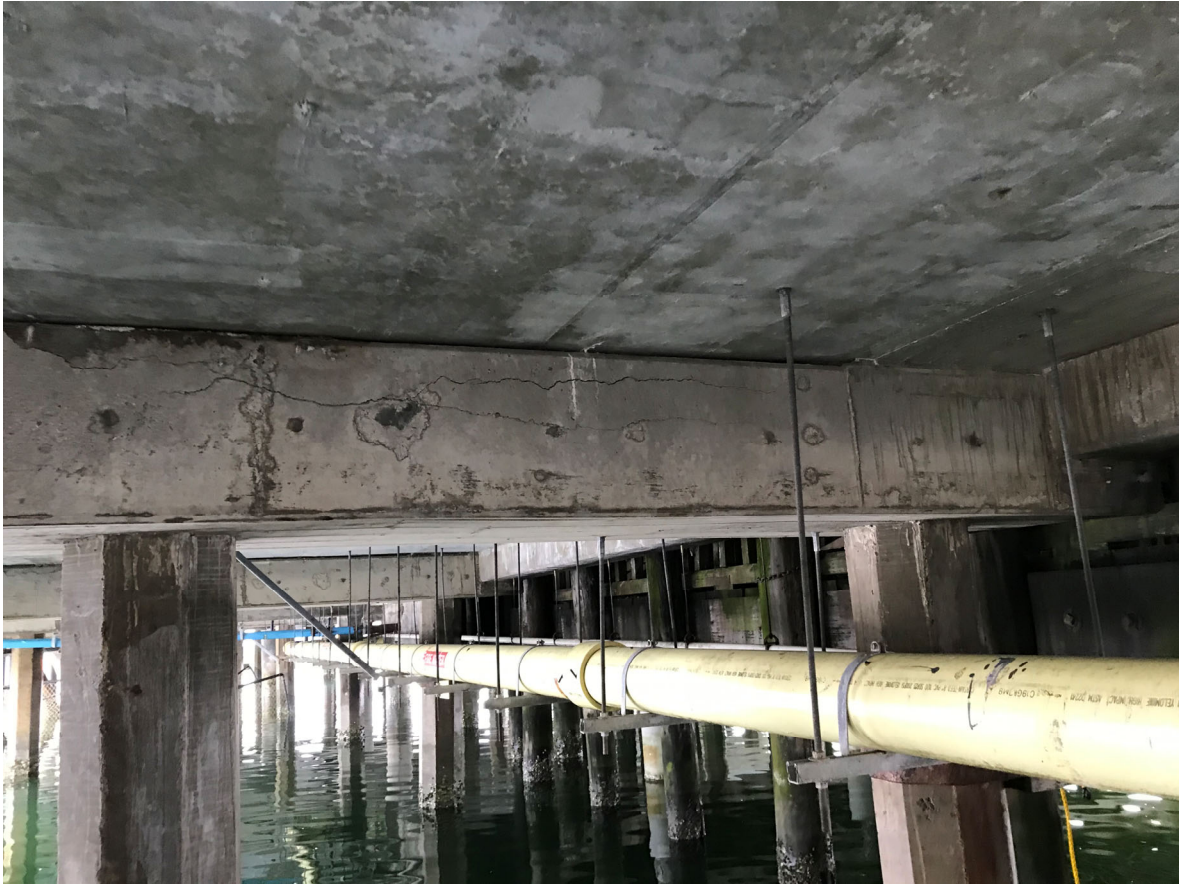
8 – View of support beam and utilities under end of pier

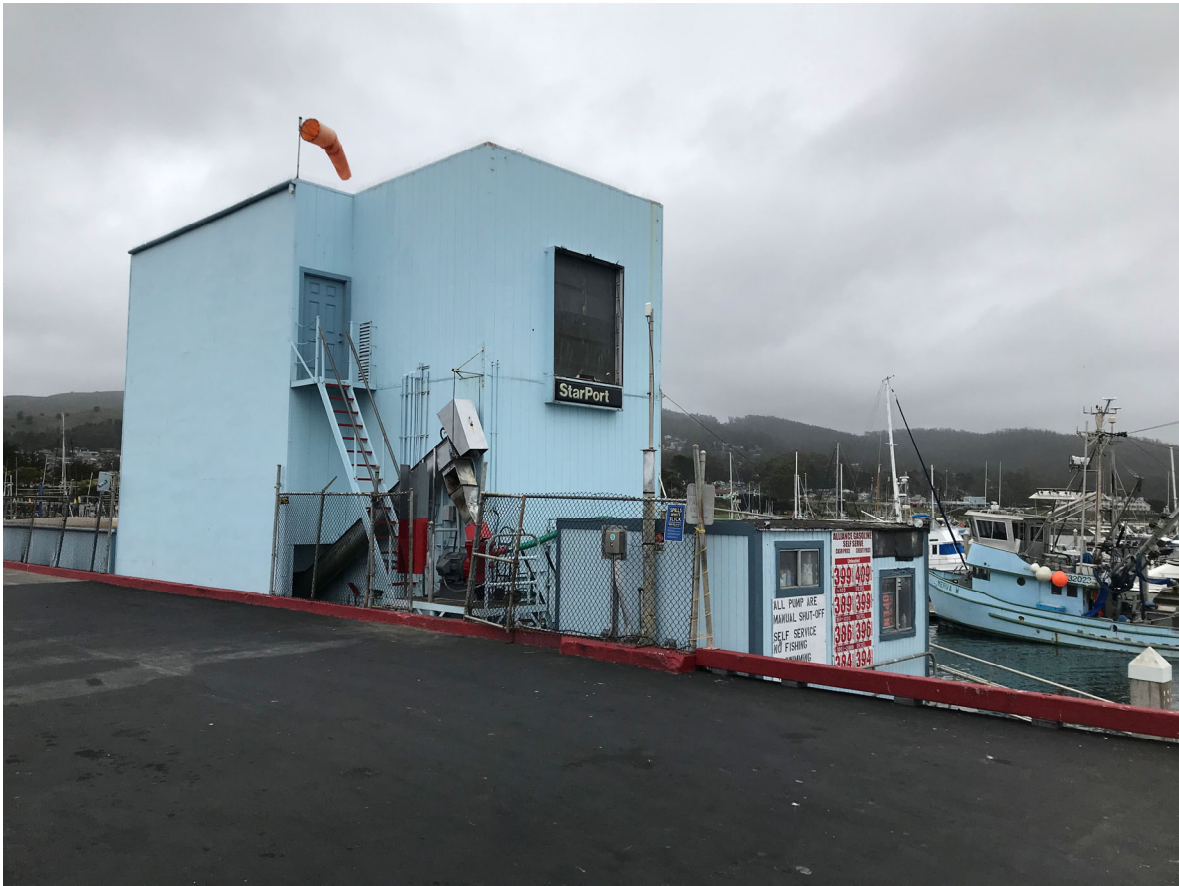
14 – View of Ice House Building and Fuel Dock modular office

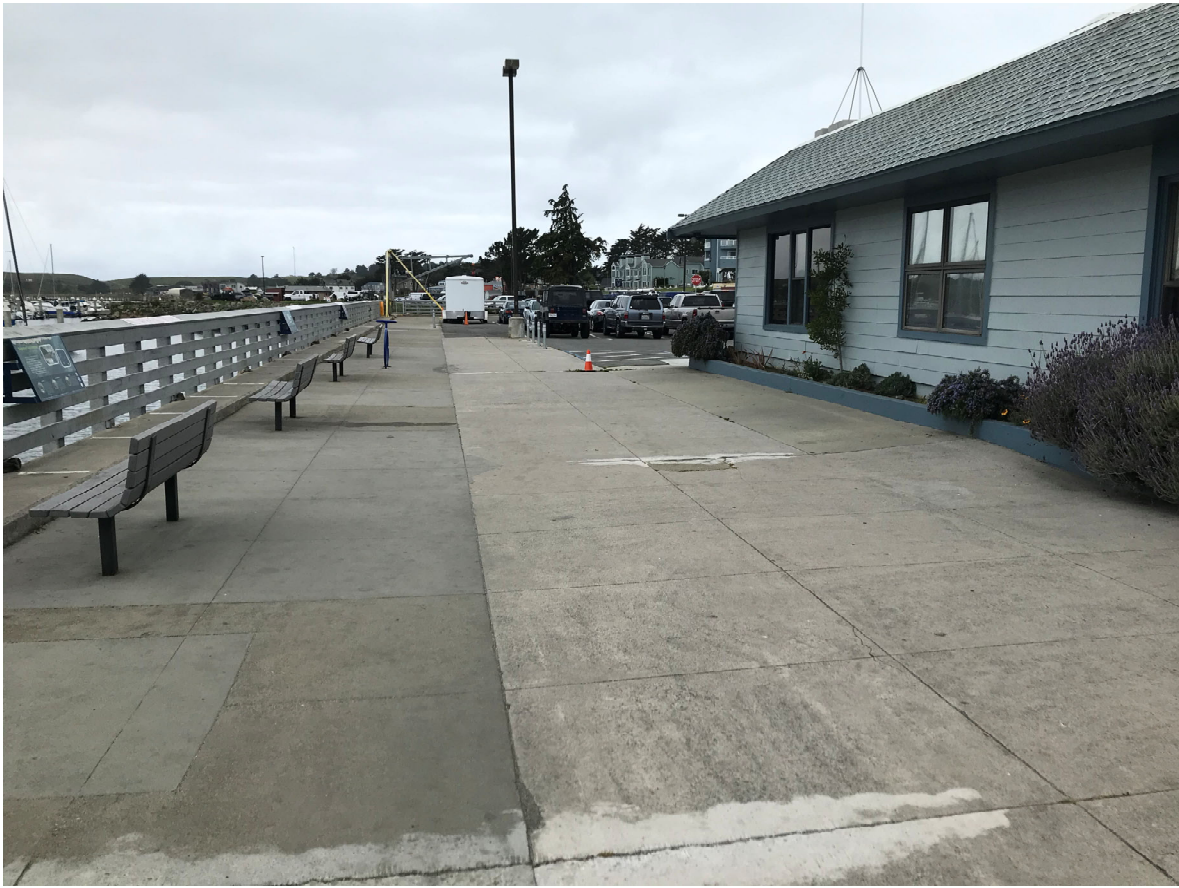
18 – View of promenade in front of Harbor Office Building

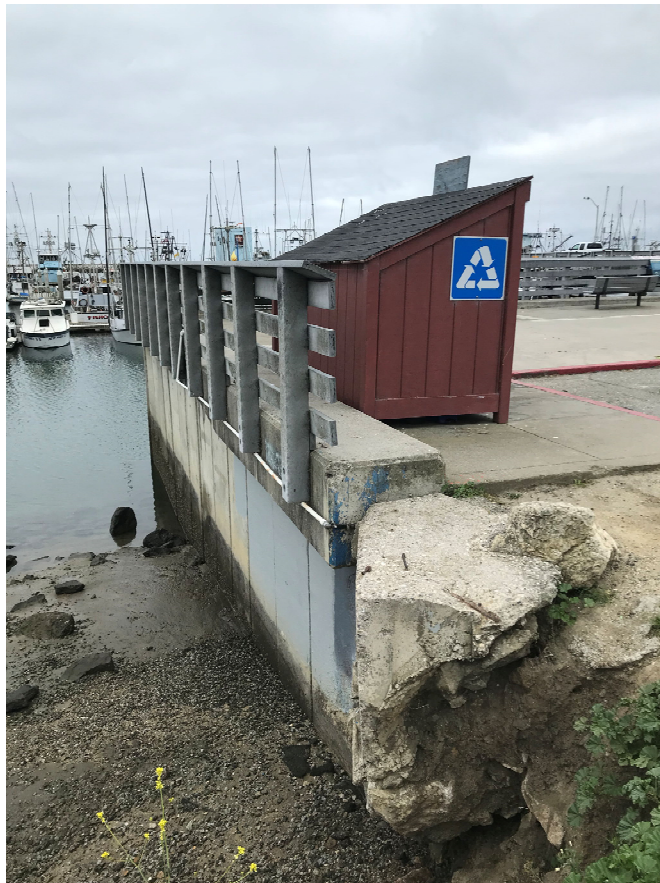
19 – View of promenade and east end of sheet pile wall (with exposed concrete block)

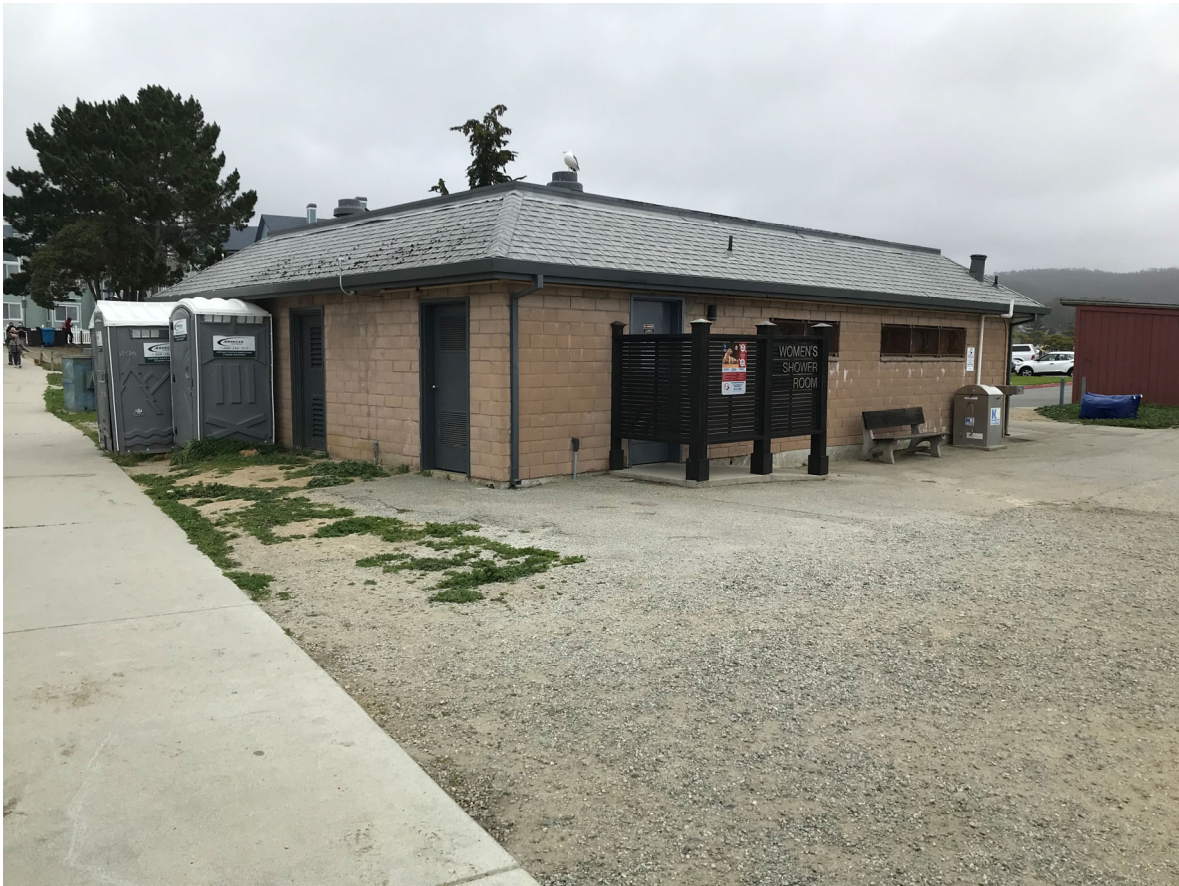
26 – View of West Restroom adjacent to A-C Docks

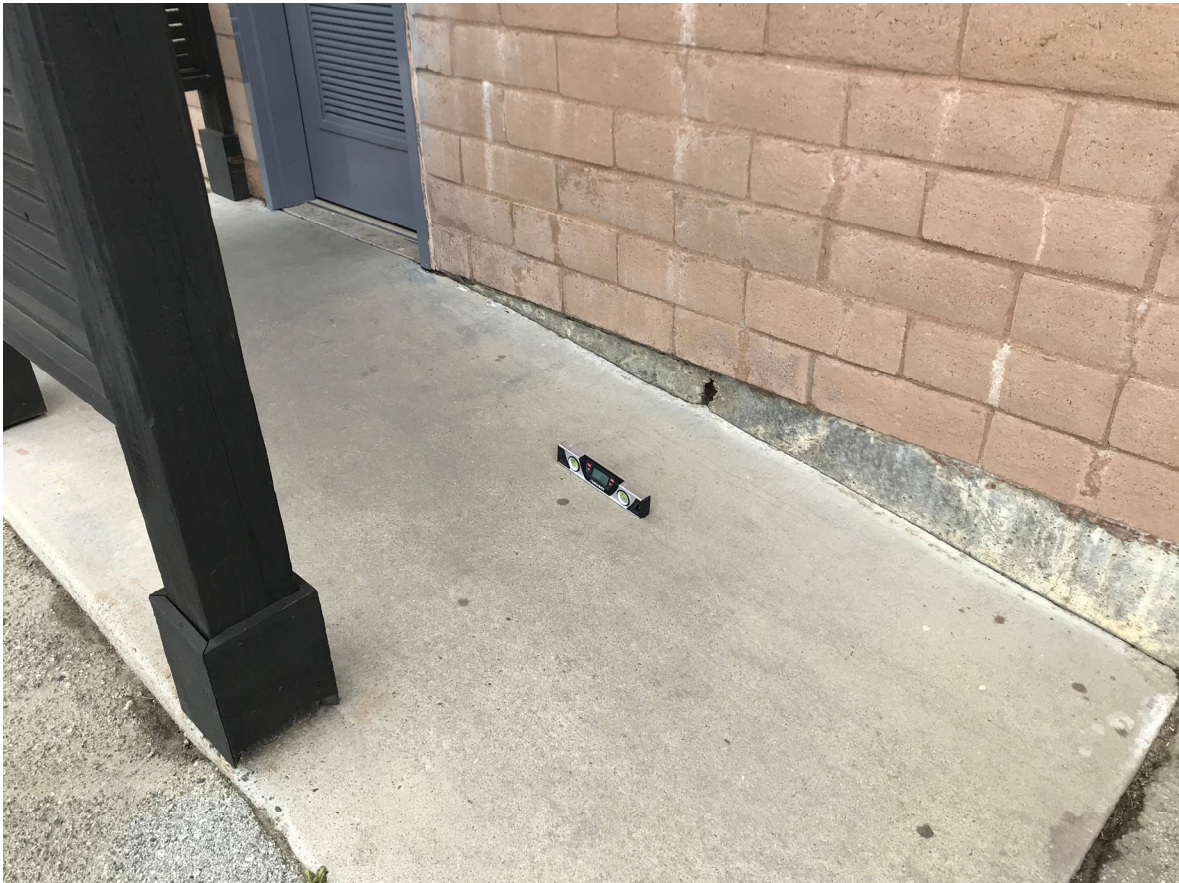
27 – View of West Restroom concrete ramp to shower room (does not meet ADA slope requirements)

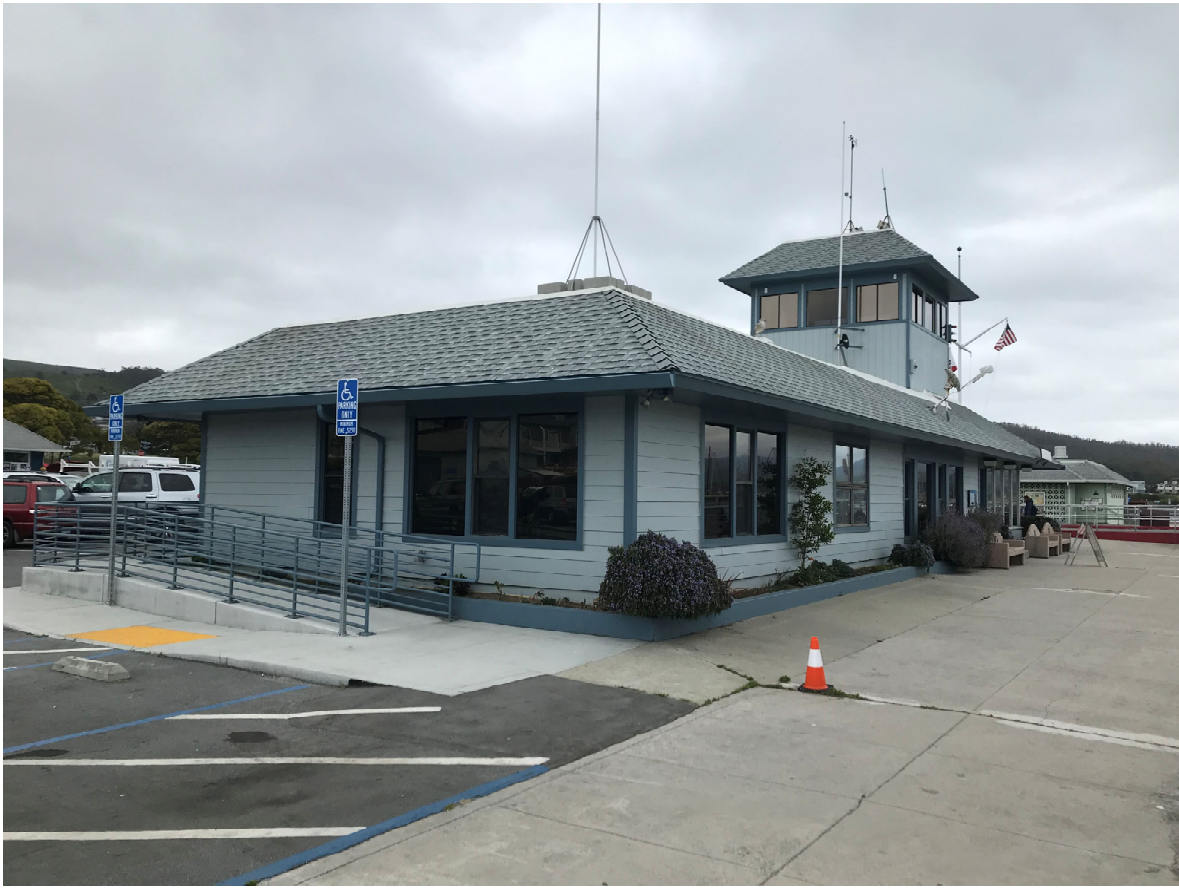
30 – View of Harbor Office Building (recently renovated and ADA improvements added)

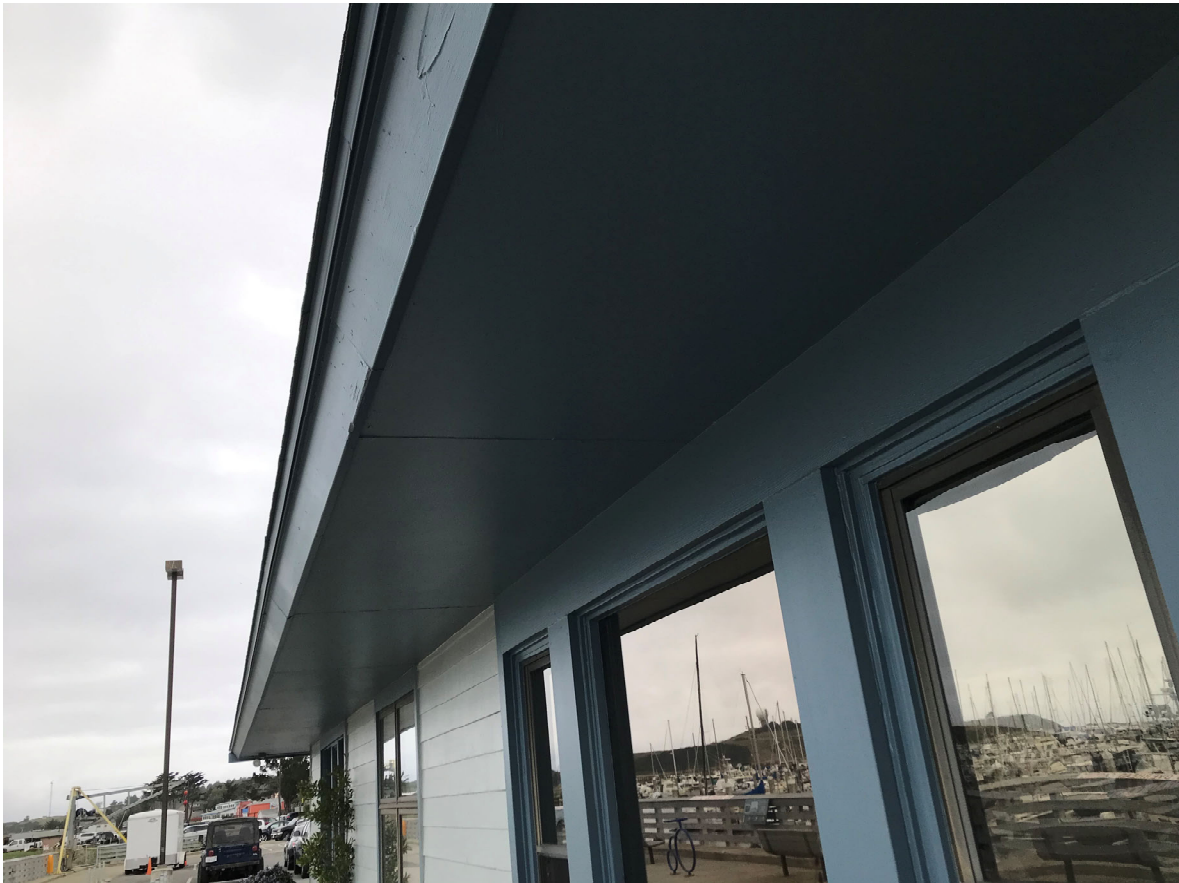
31 – View of Harbor Office Building exterior soffit and added security lighting

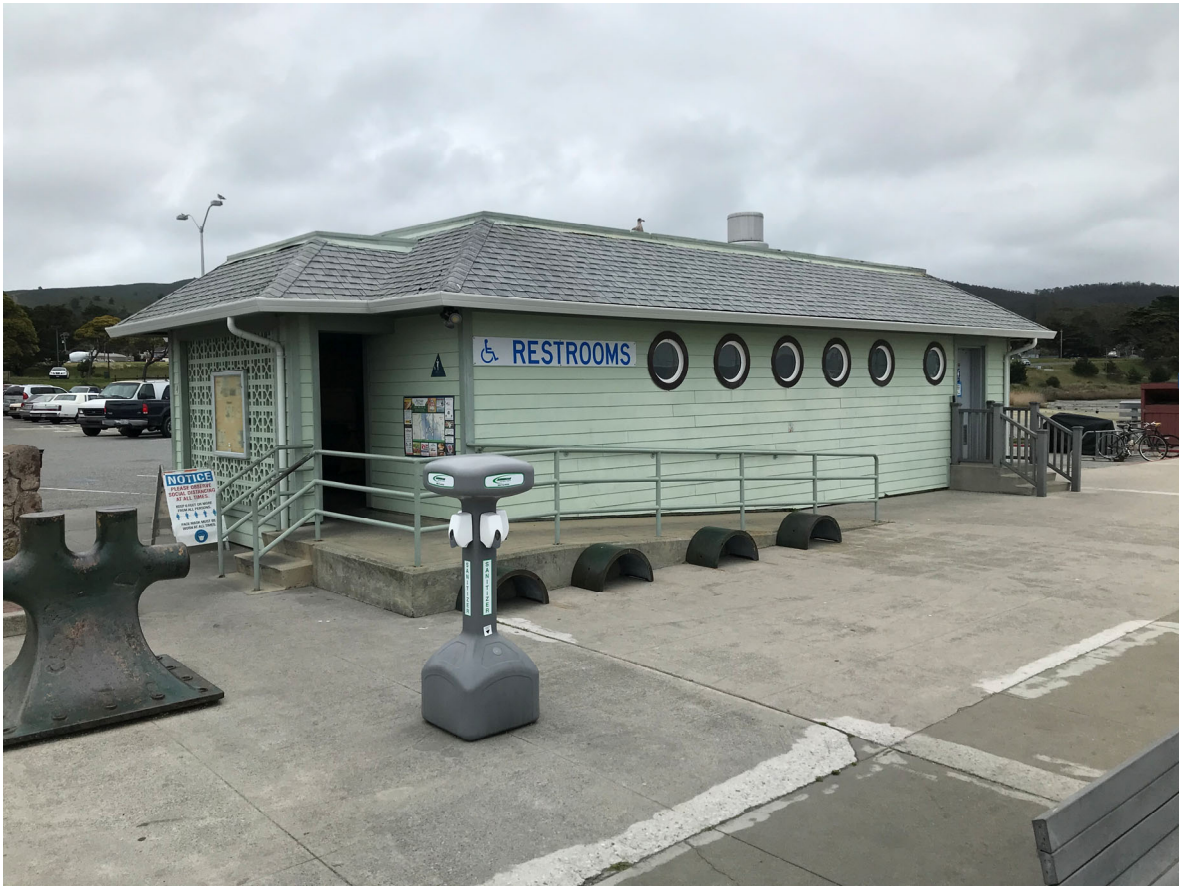
32 – View of Central Restroom exterior and access
