Oyster Point Marina

Updated Marina Facility Condition Survey Report

Prepared for:
San Mateo County
Harbor District

May 2021

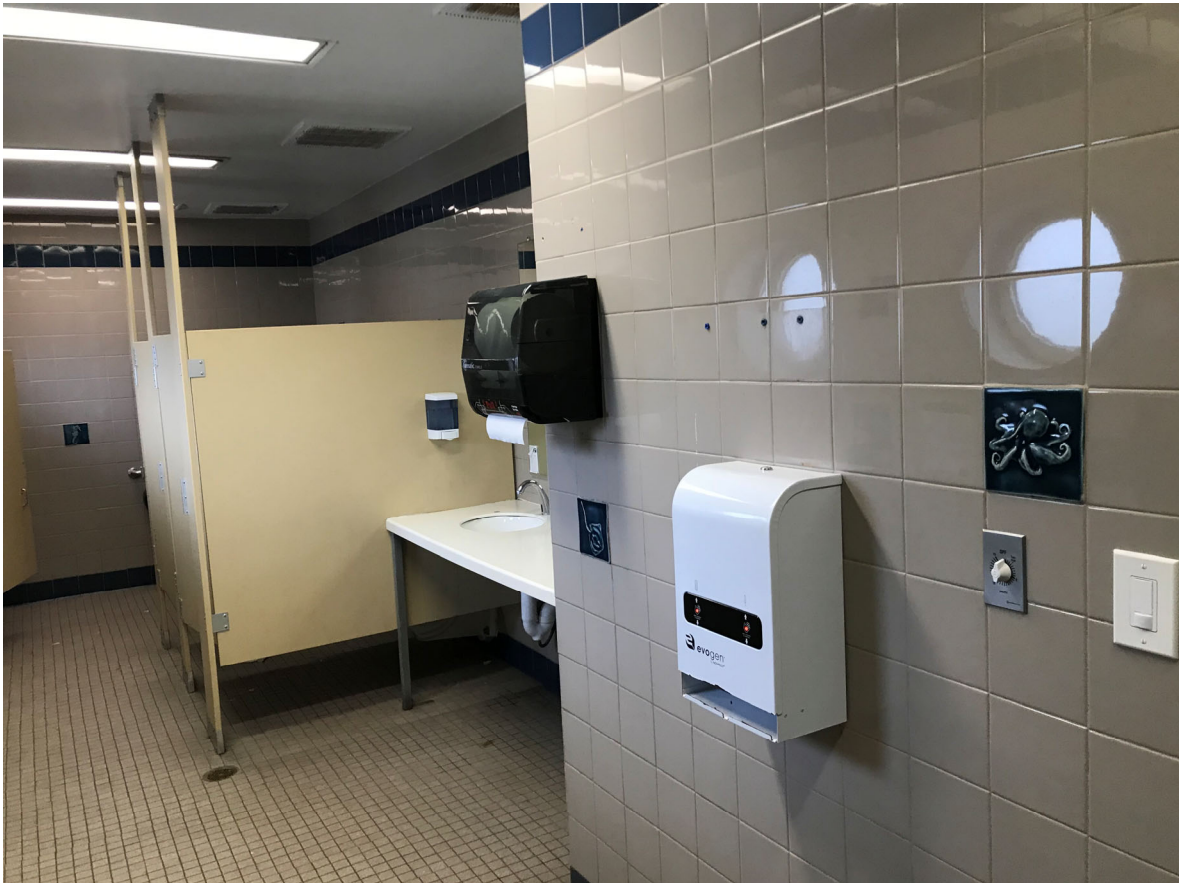
33 – View of Central Restroom interior

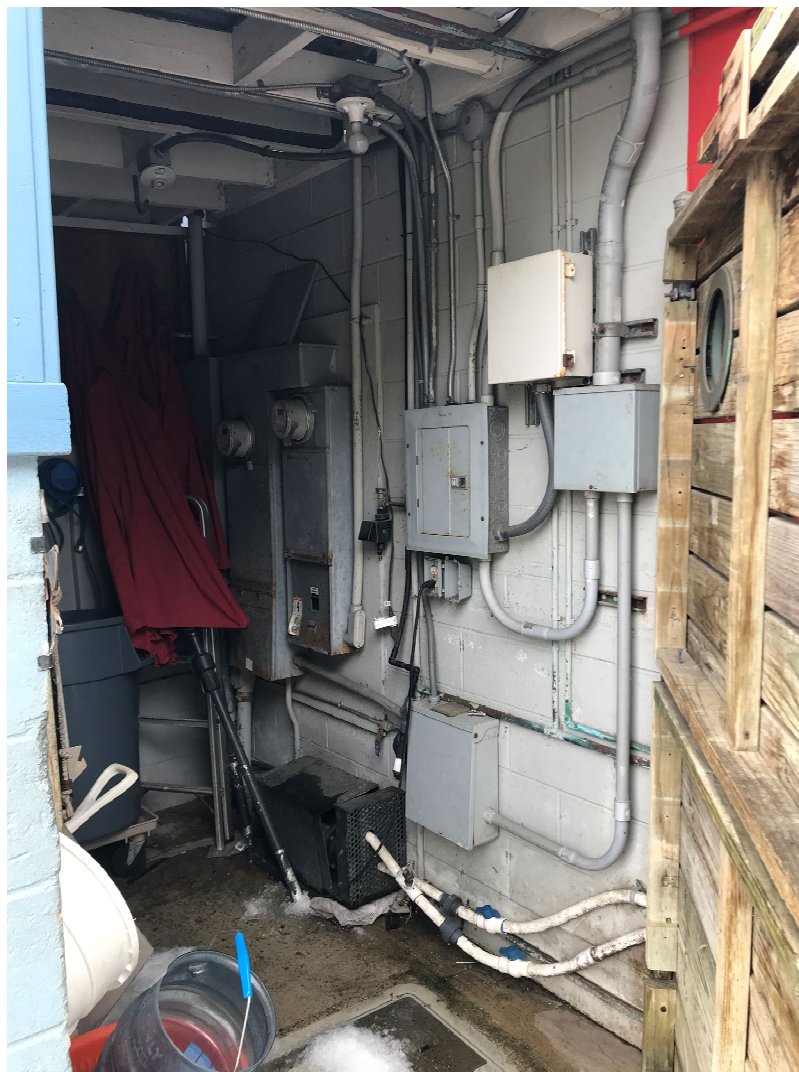
35 – View of Tenant Row Building electrical panels and storage area

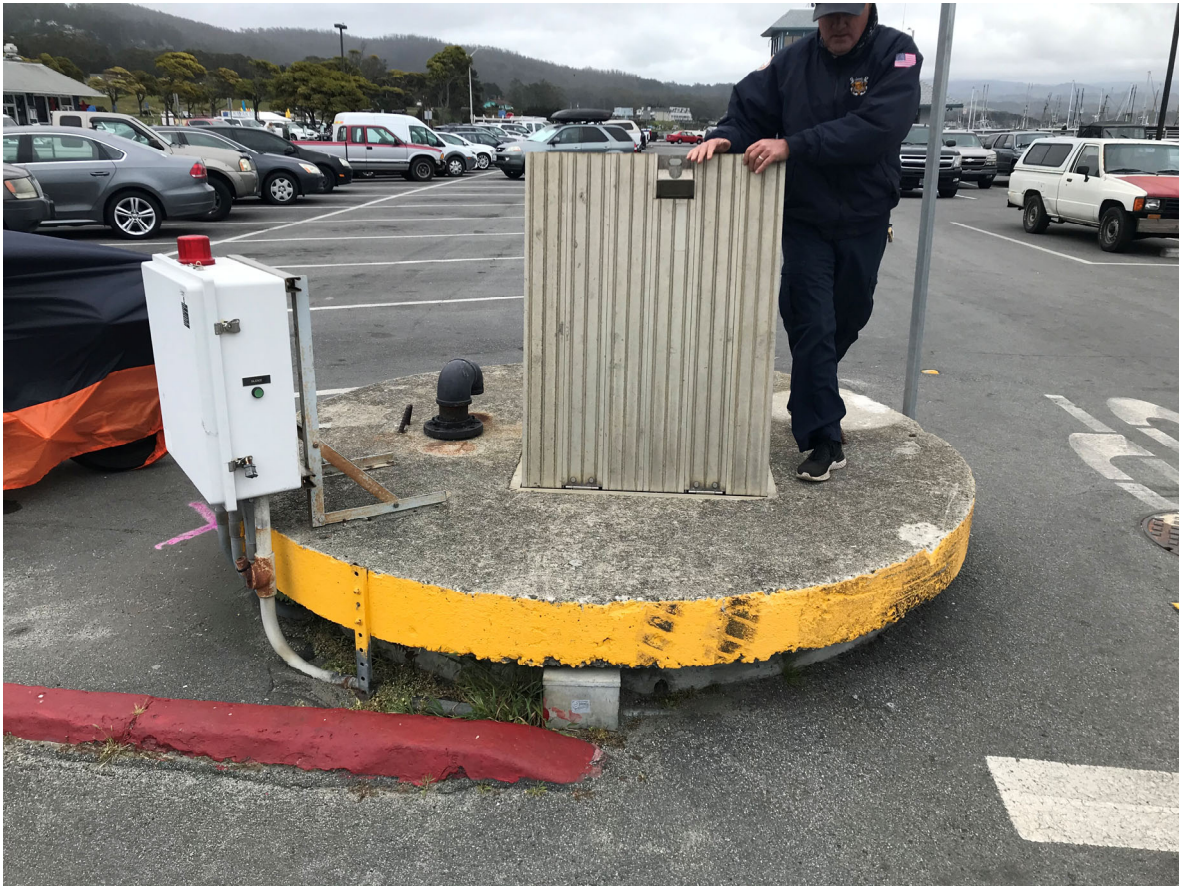
36 – View of sewer lift station in Parking Lot A

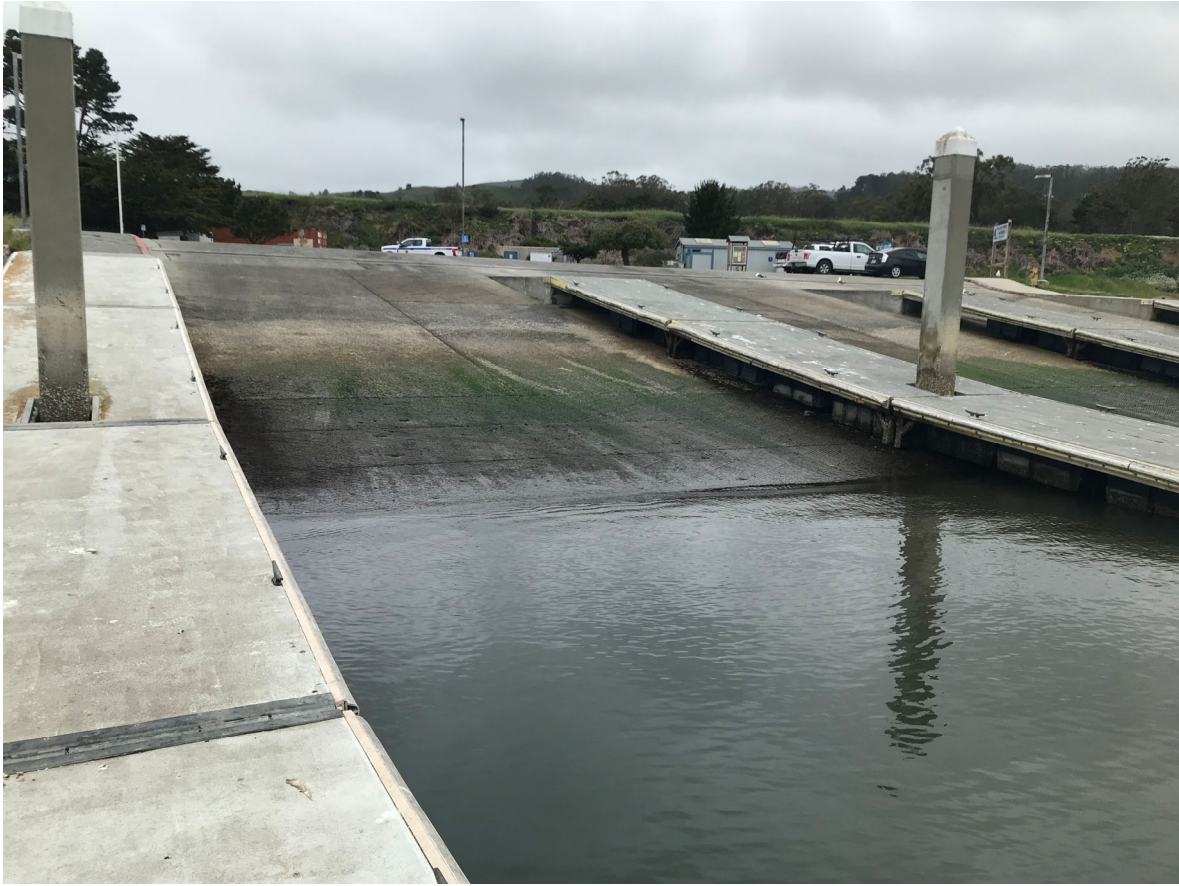
42 – View of boat launch ramp and boarding docks

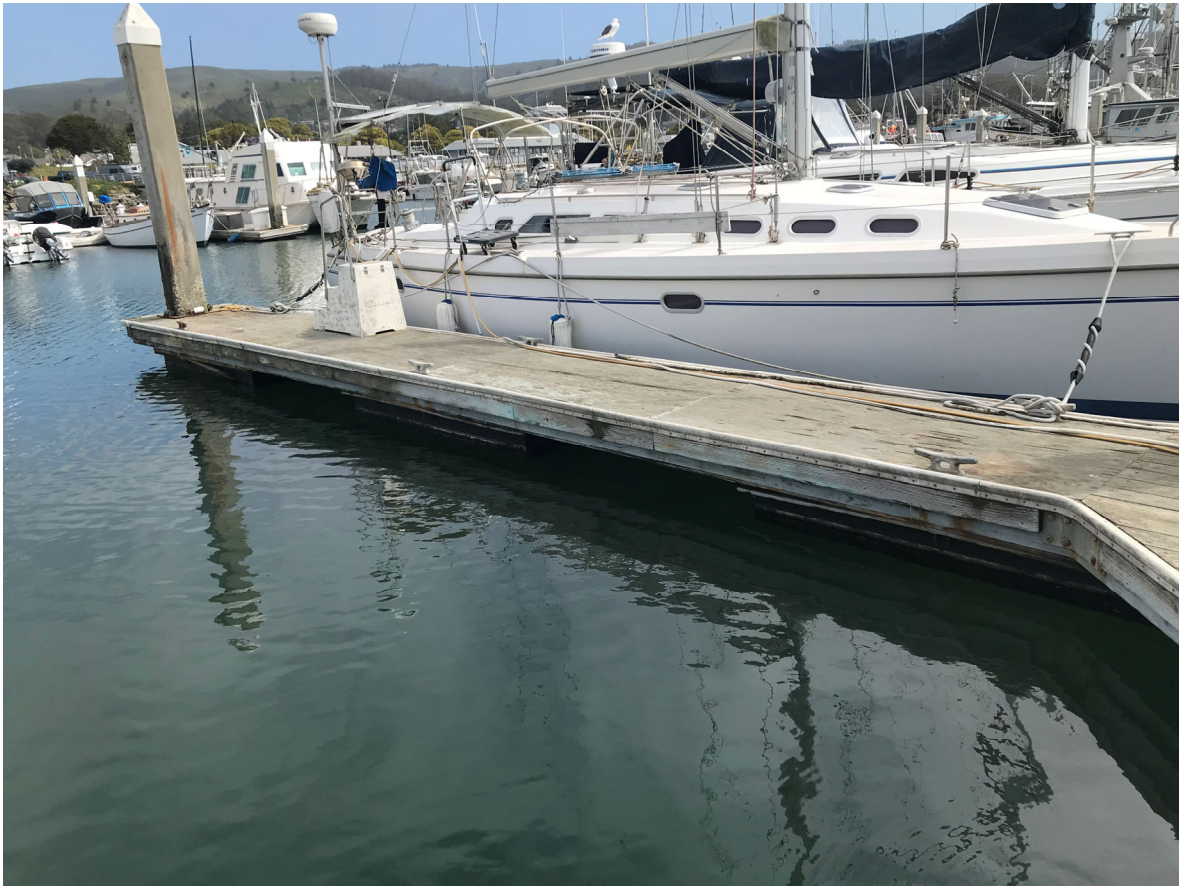
54 – View of typical Dock B finger

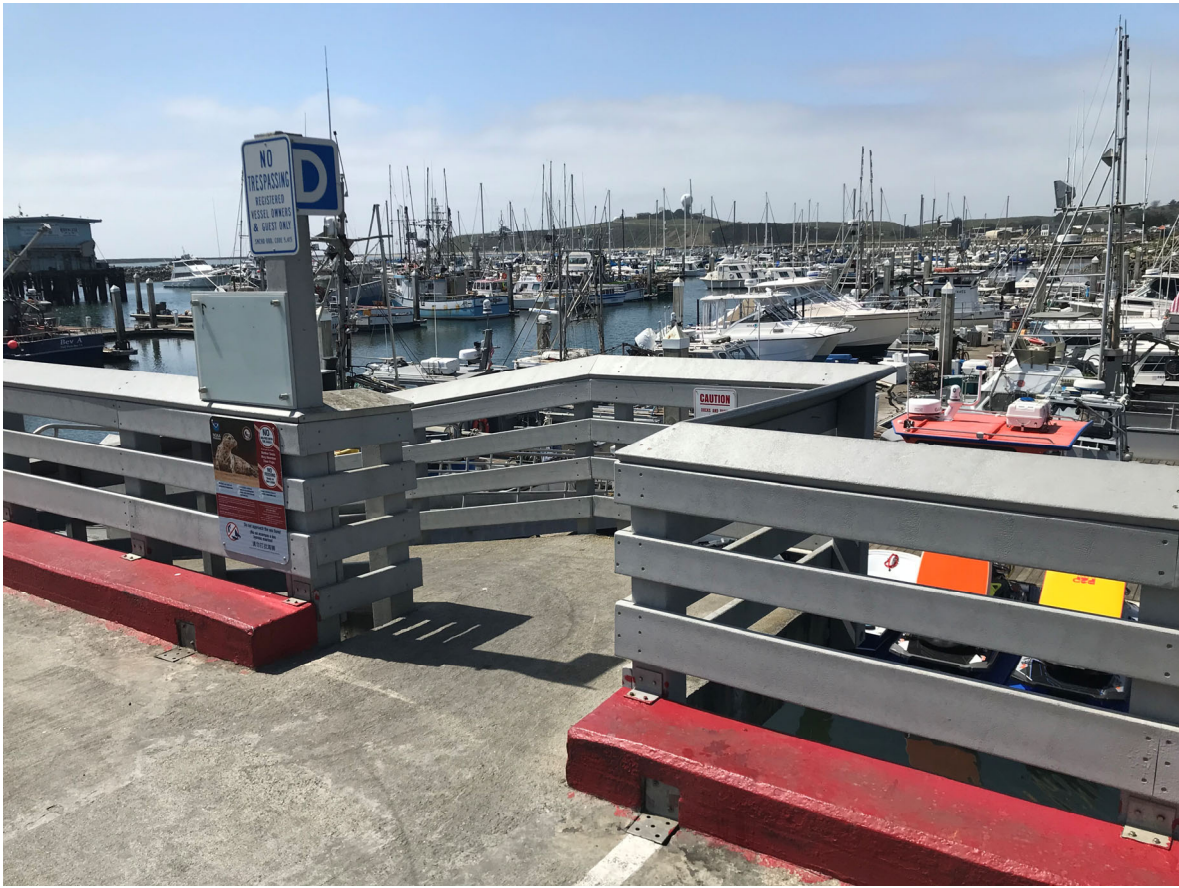
56 – View of access to D Dock from pier

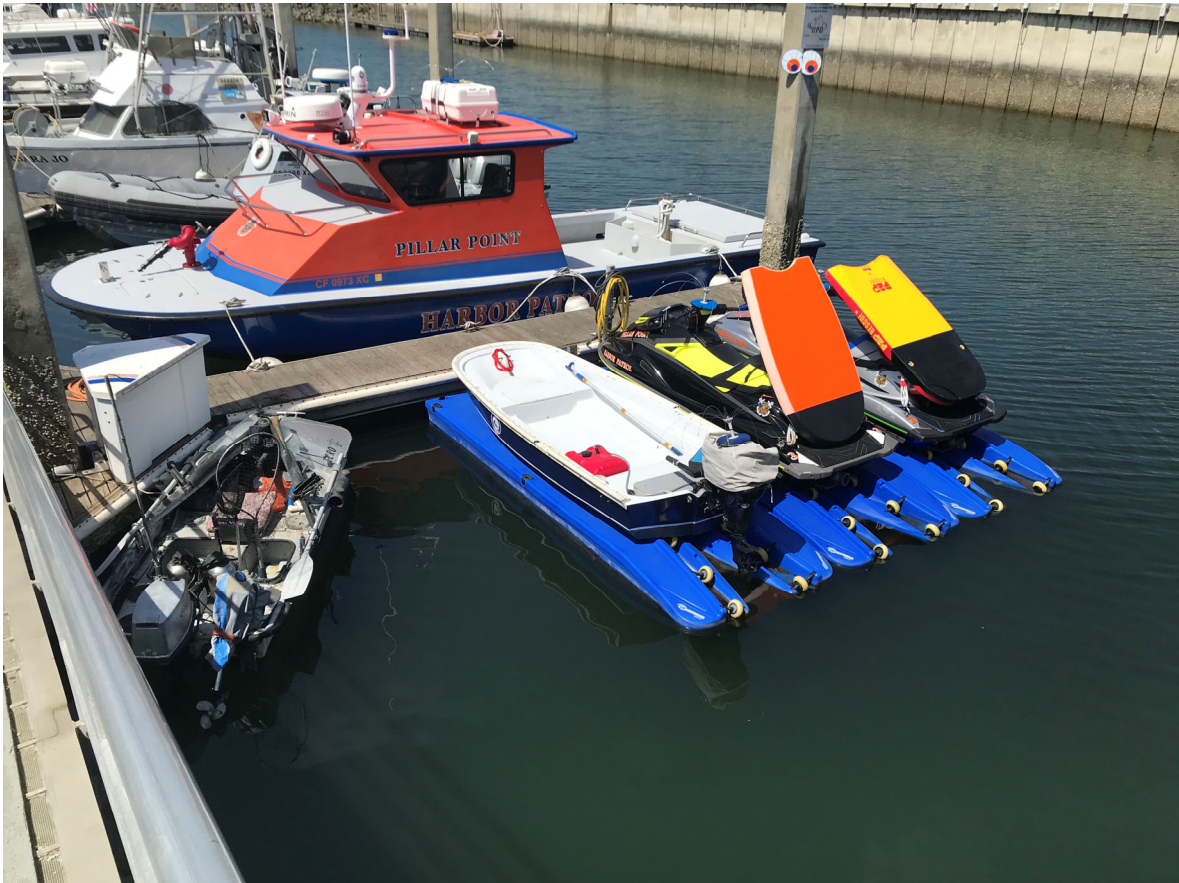
57 – View of harbor patrol berth on D Dock

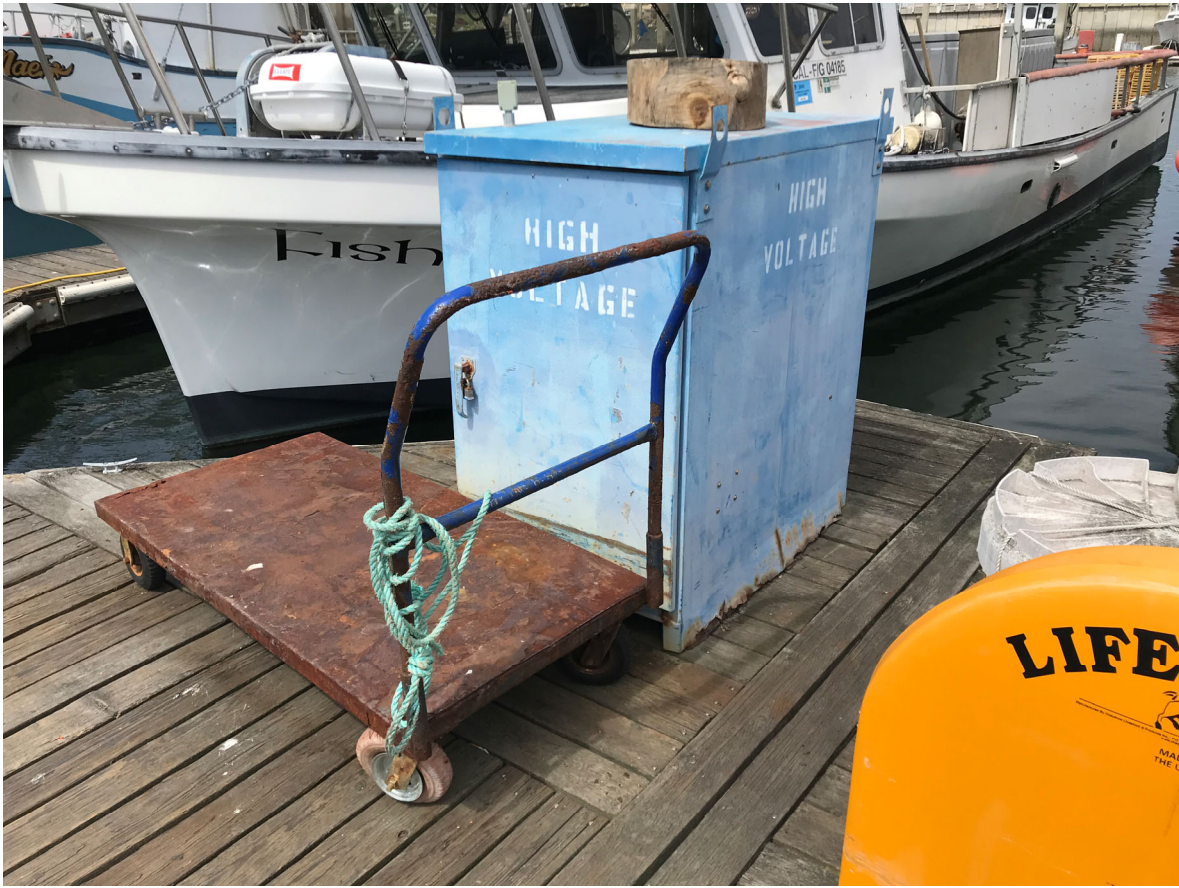
62 – View of Dock E electrical transformer

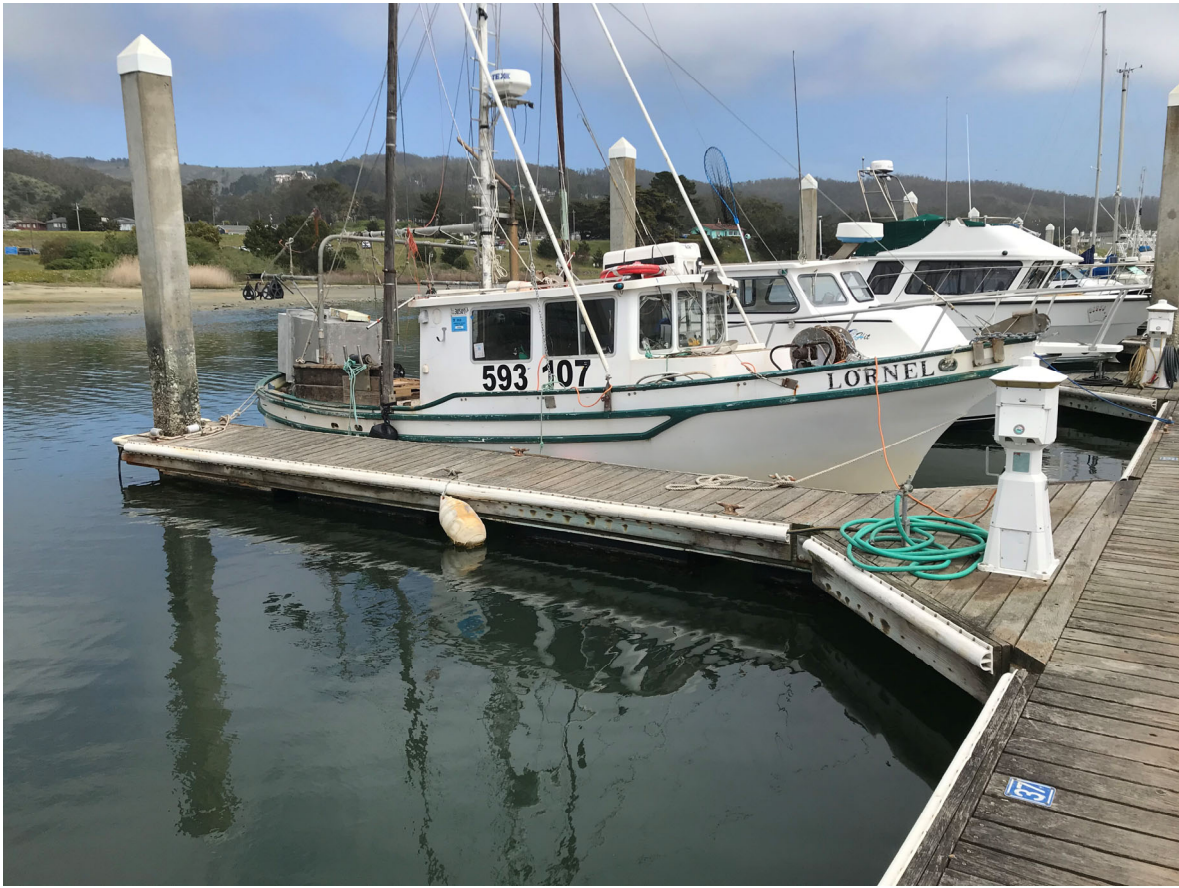
64 – View of typical Dock F finger

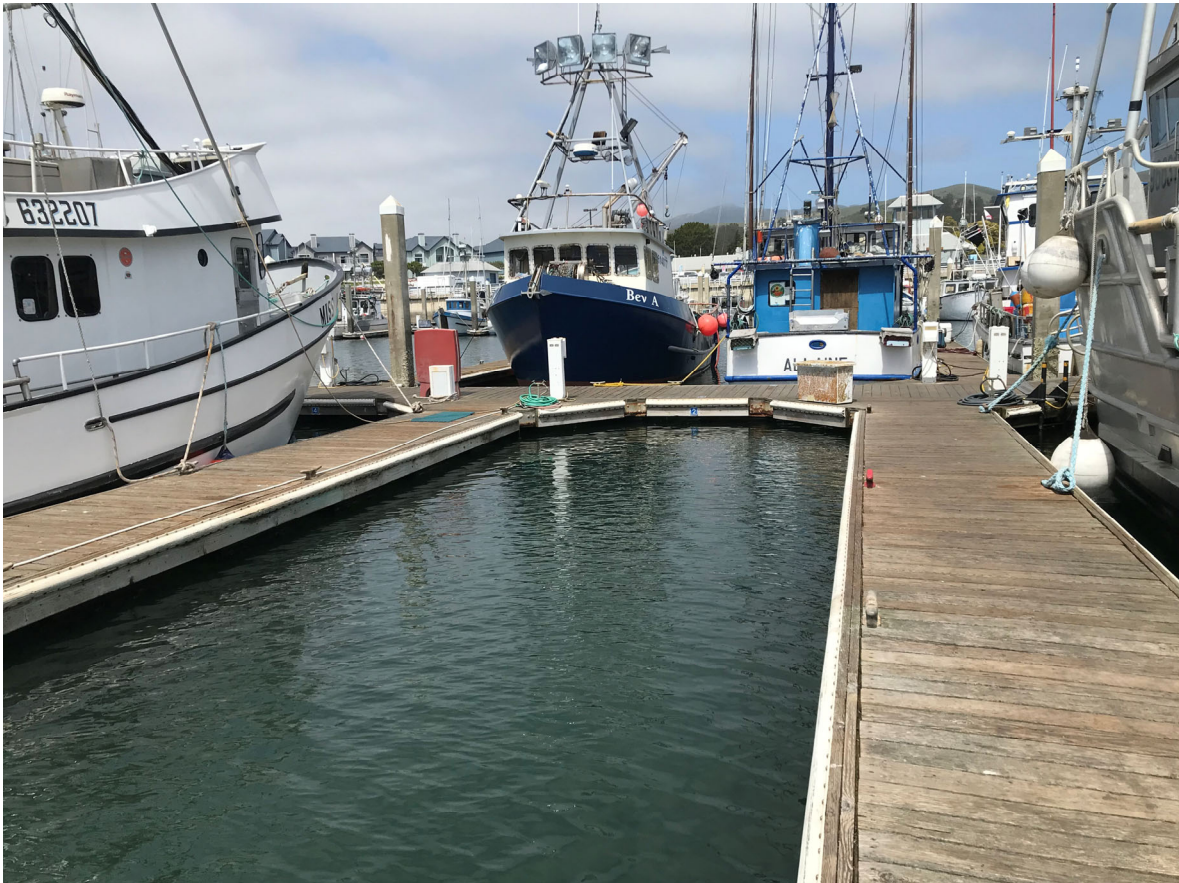
67 – View of Dock H berth

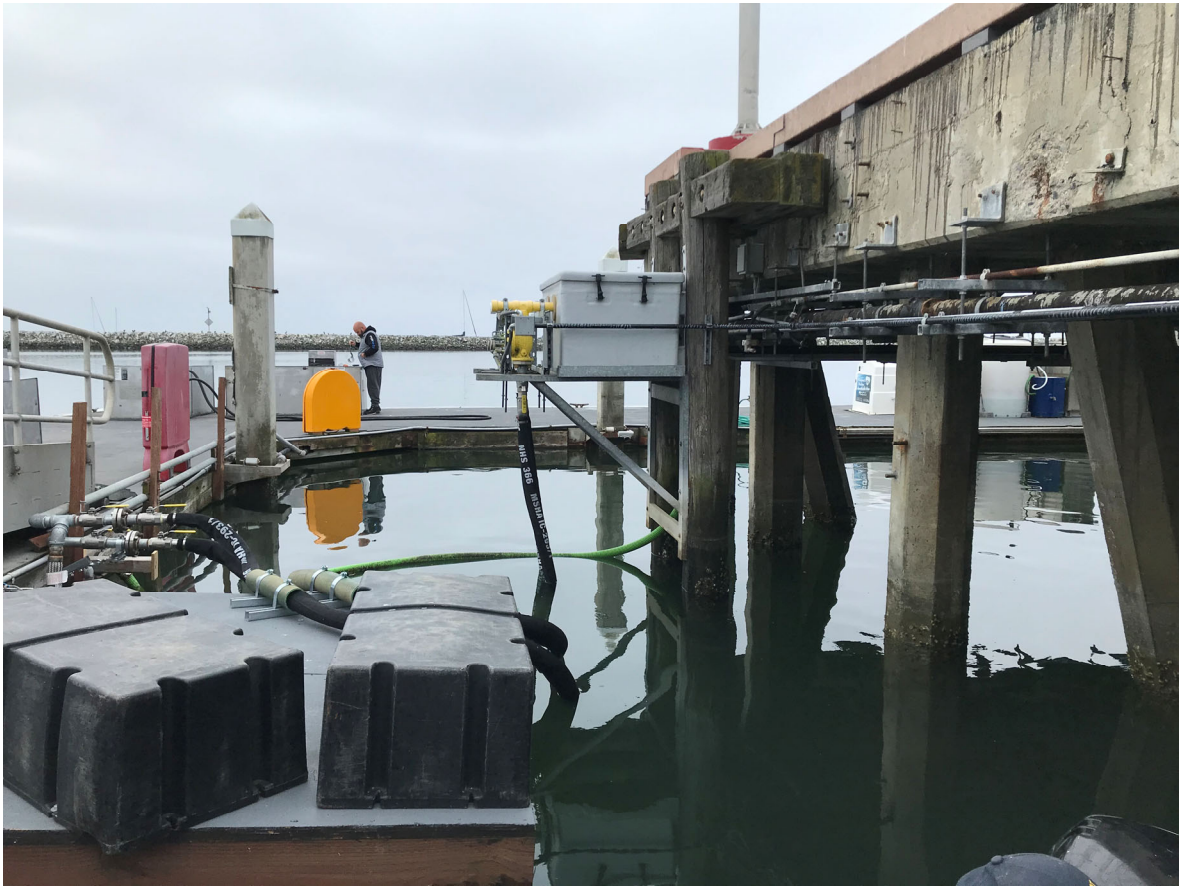
70 – View of Fuel Dock piping from pier to dock

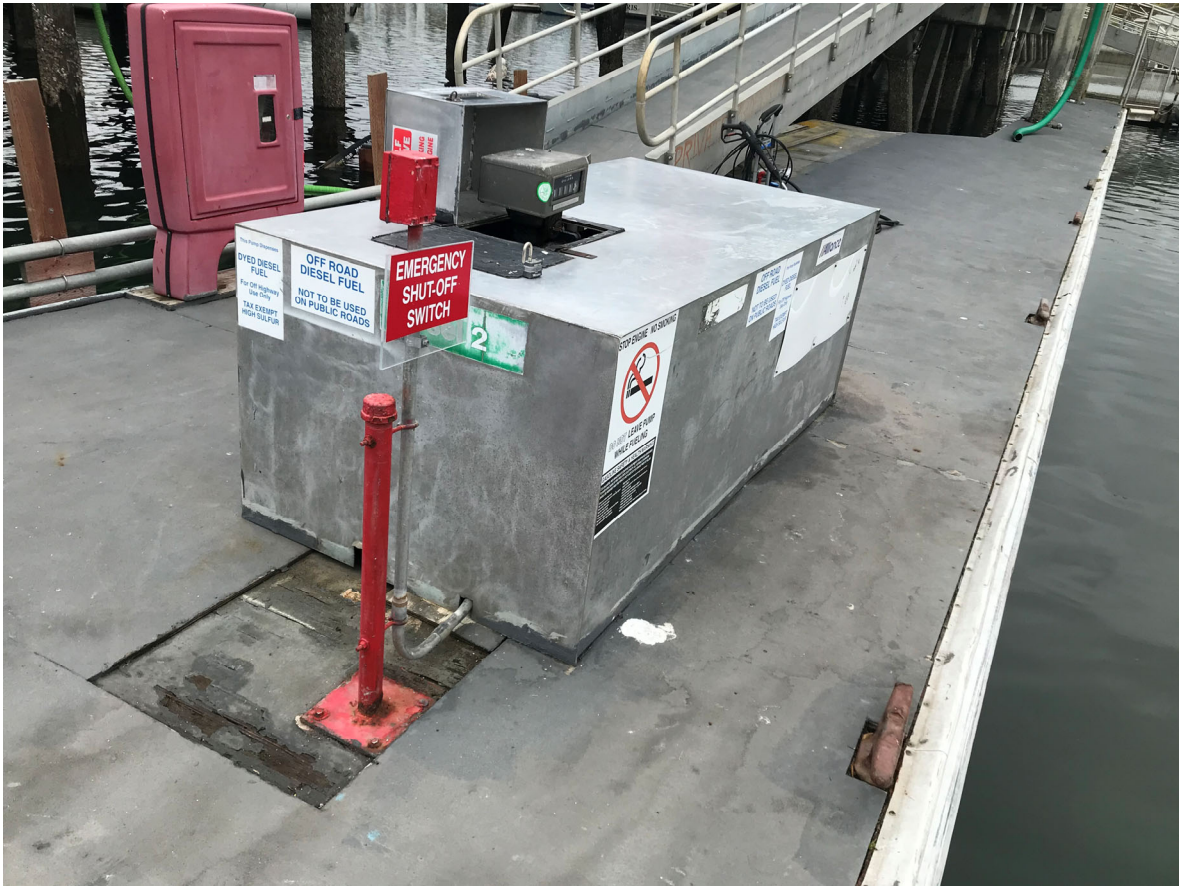
72 – View of Fuel Dock dispenser and emergency shut-off switch
