Appendix A
Site Photos

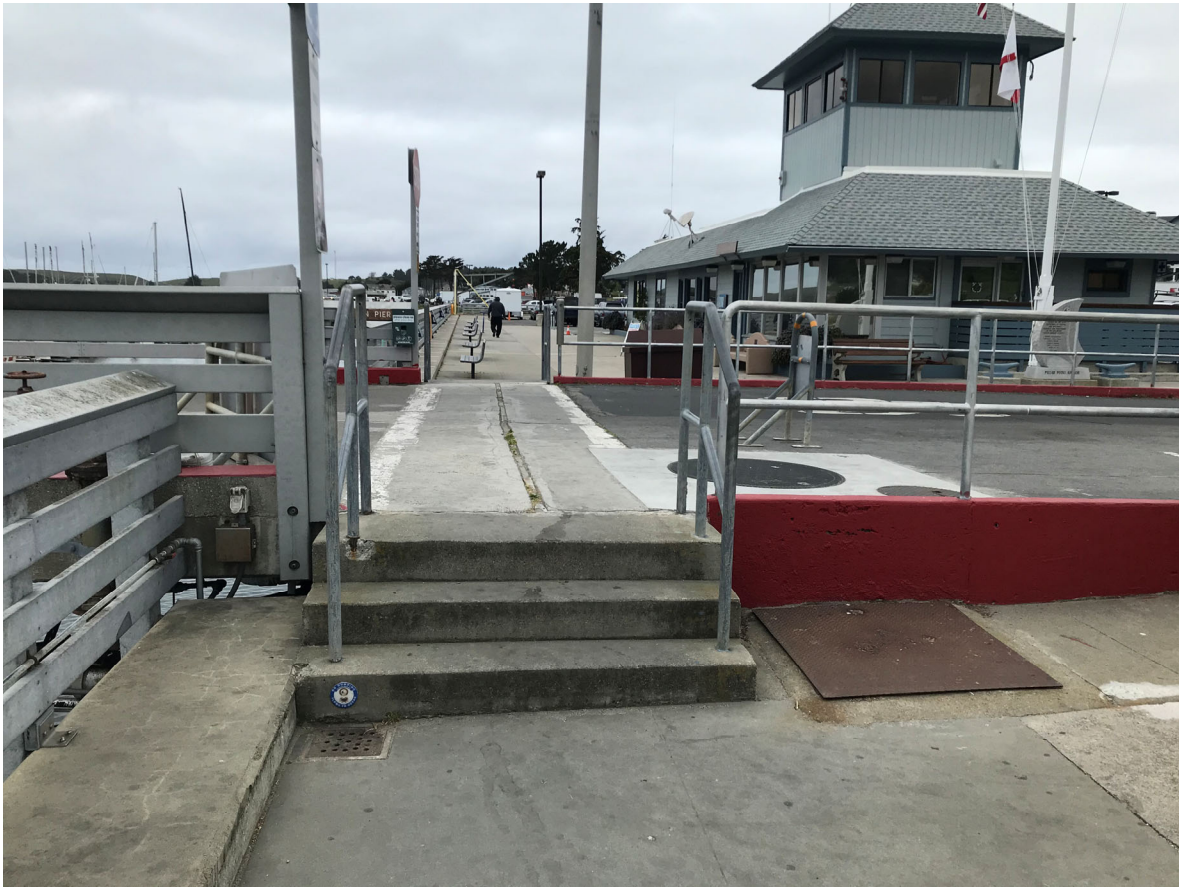
4 – View of 3-step stairs at base of pier

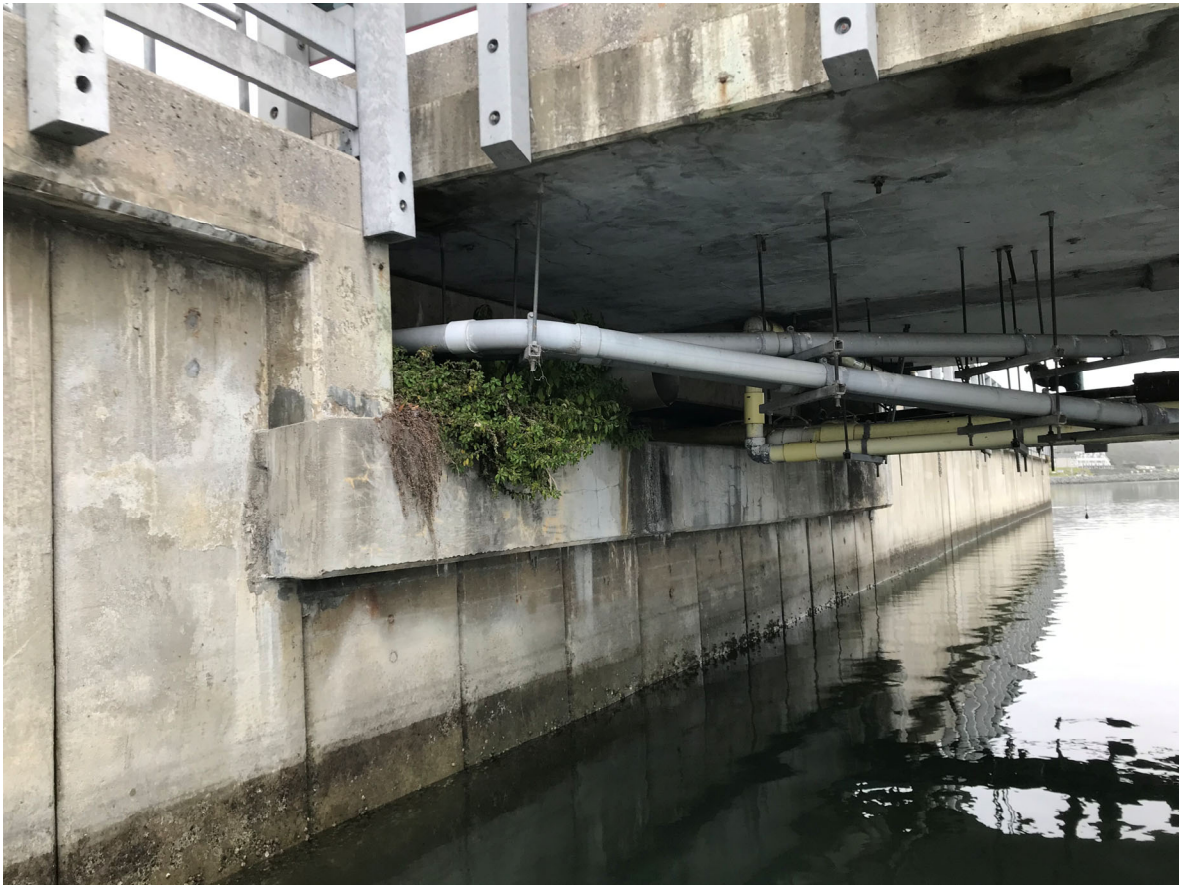
5 – View of utilities under base of pier

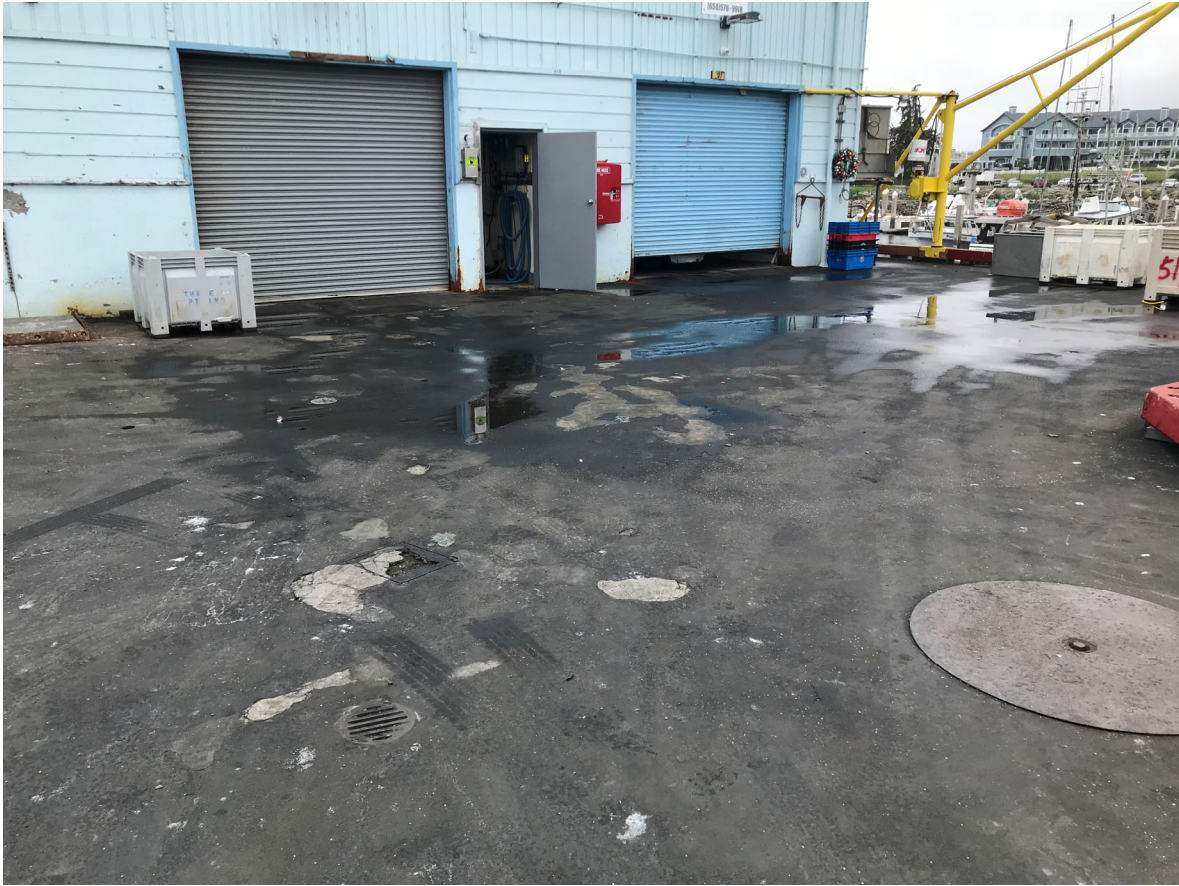
12 – View of high traffic area of pier deck next to Fish Buyer Building

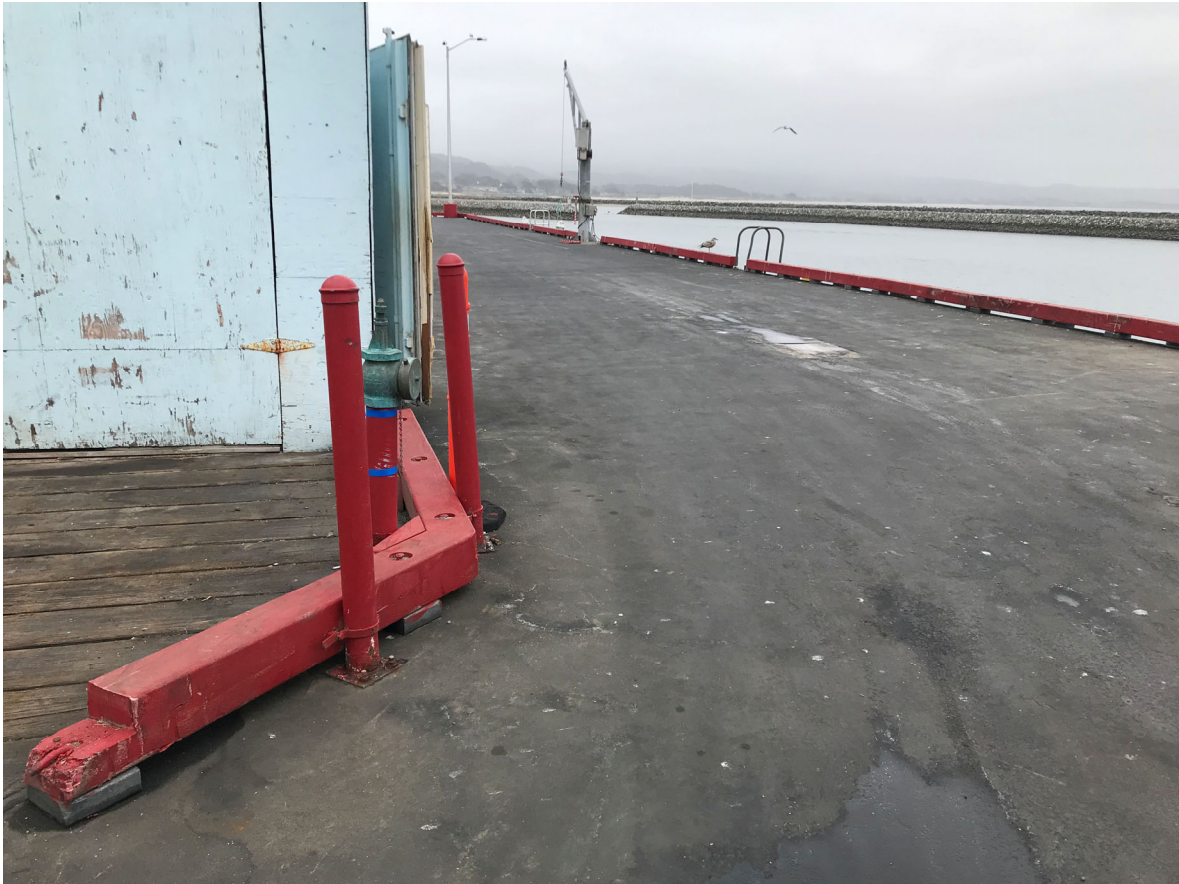
13 – View of high traffic area of pier deck next to Fish Buyer Building

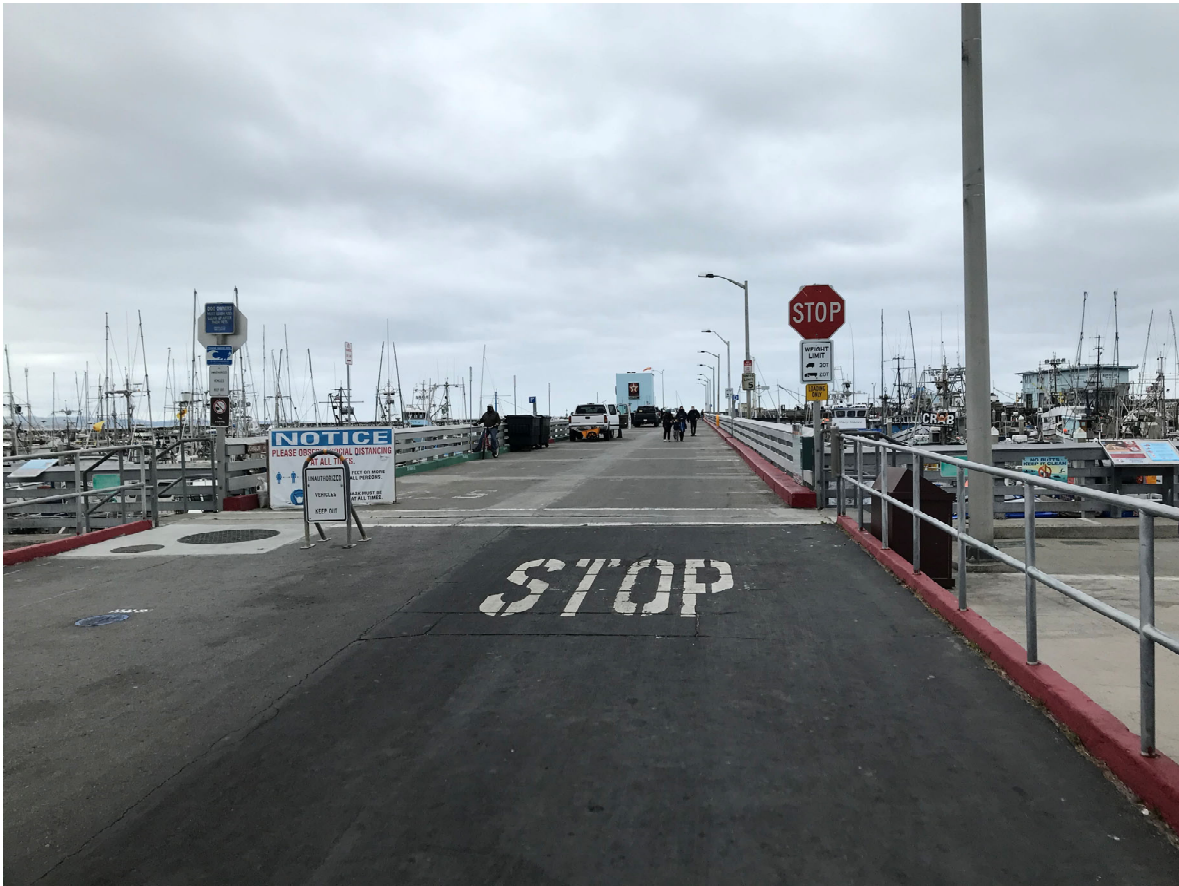
16 – View of pier from landside promenade / access road

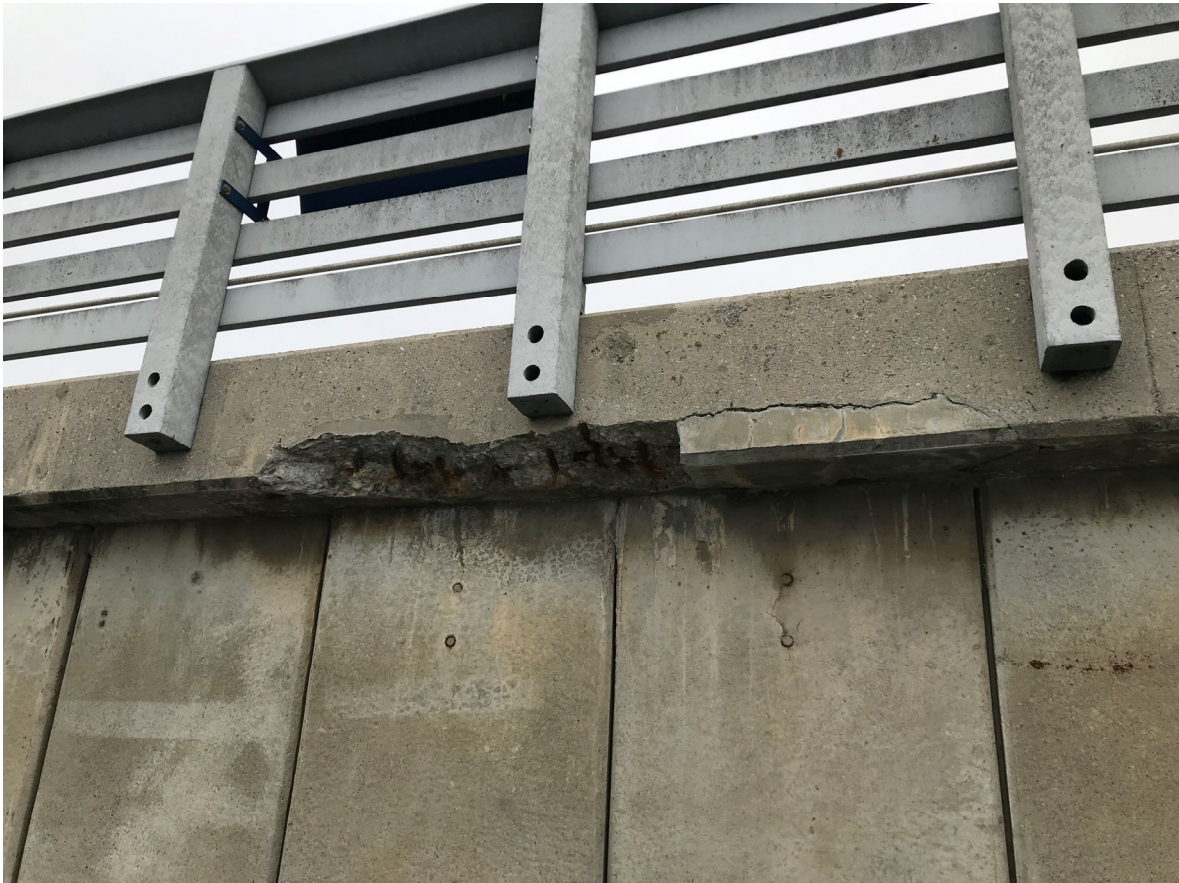
21 – View of distressed sheet pile wall concrete cap

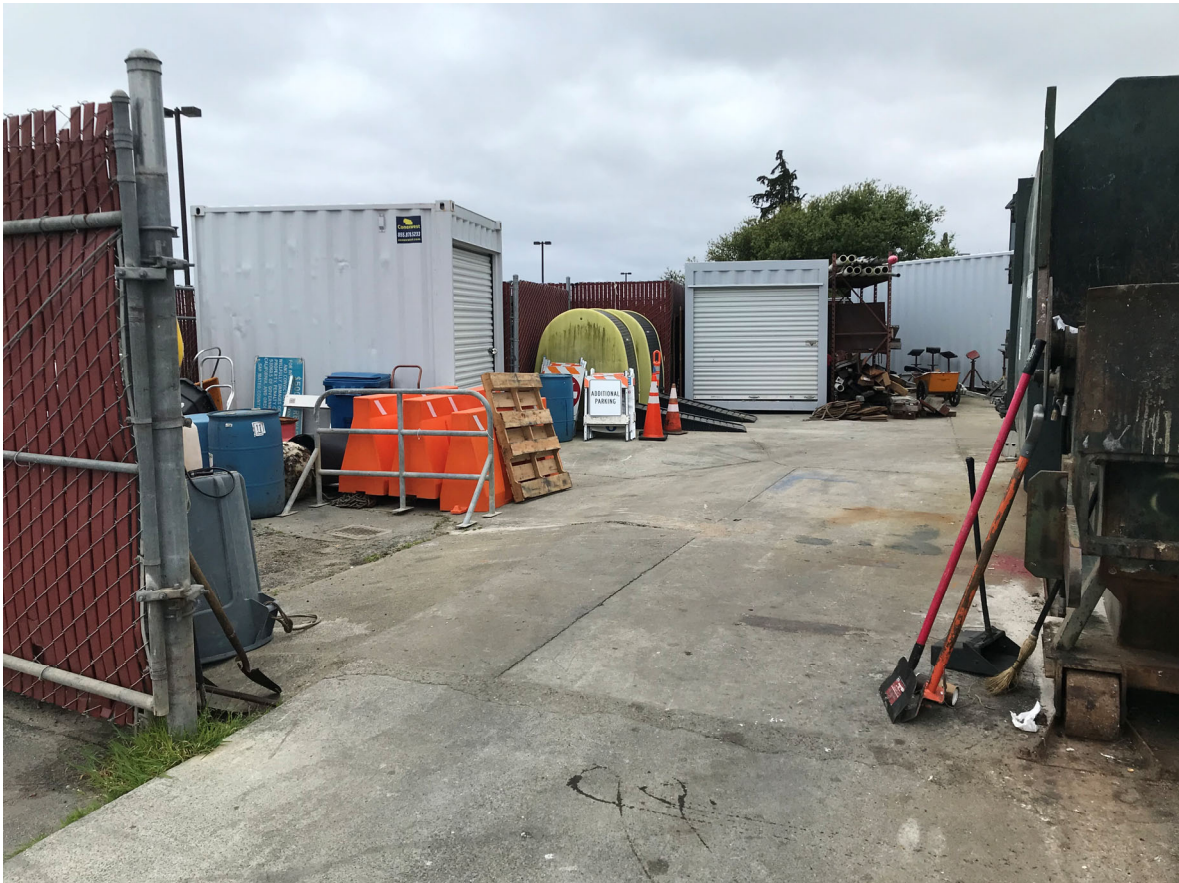
29 – View of maintenance yard and storage area (with filtered catch basin)

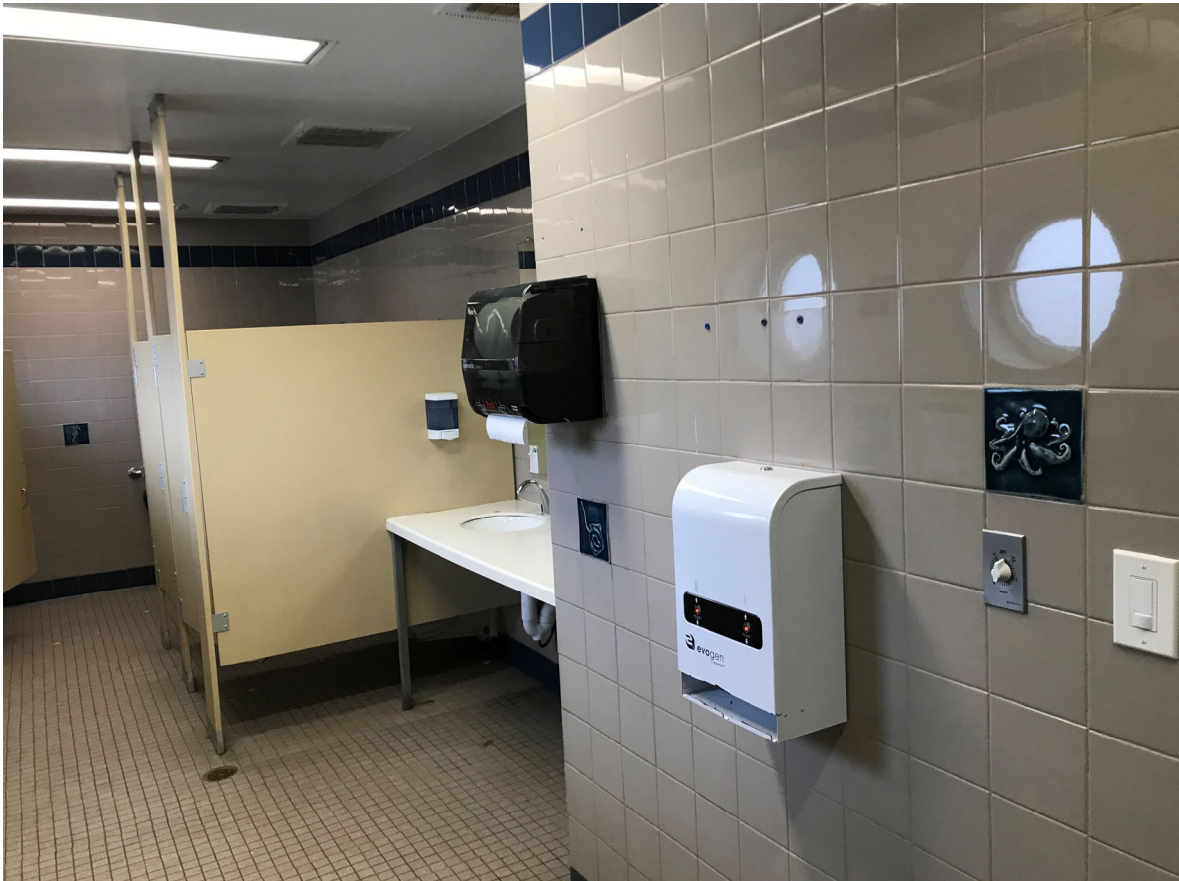
33 – View of Central Restroom interior

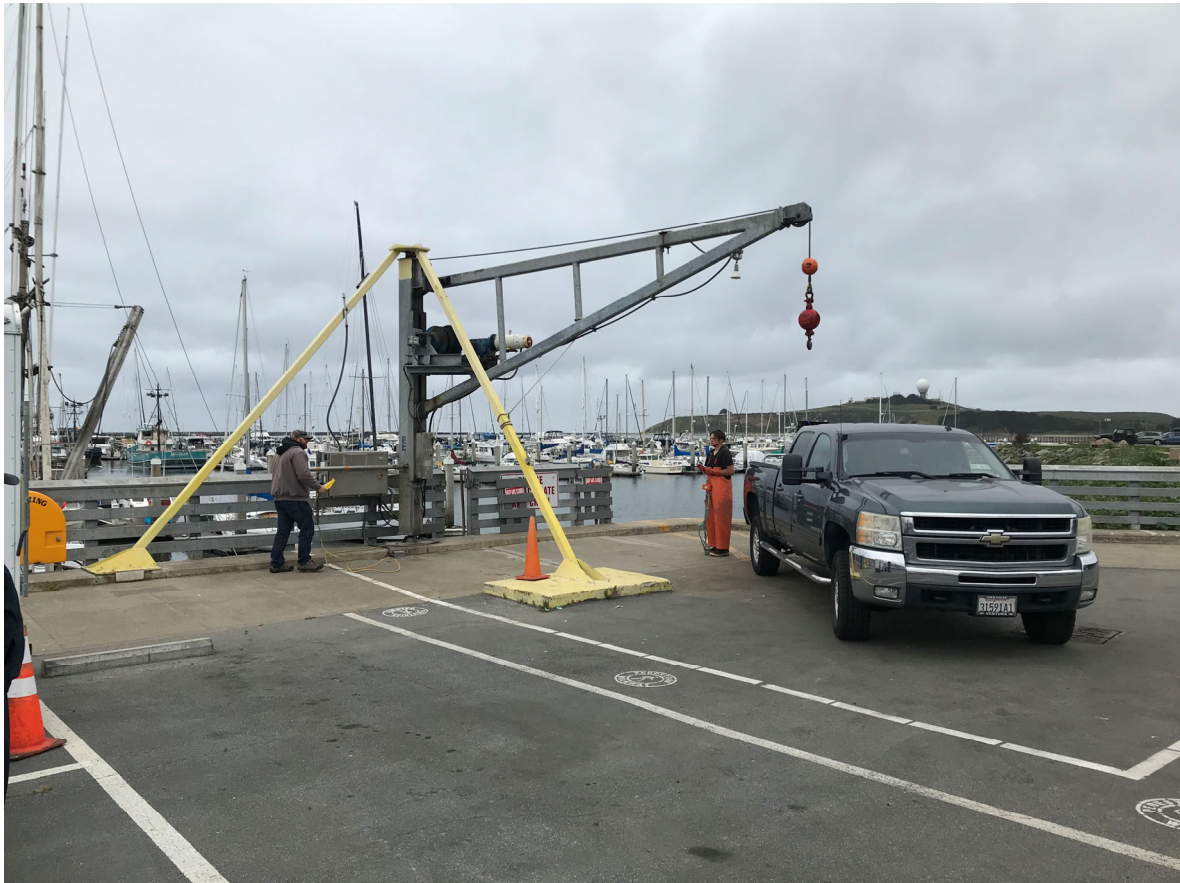
39 – View of public hoist

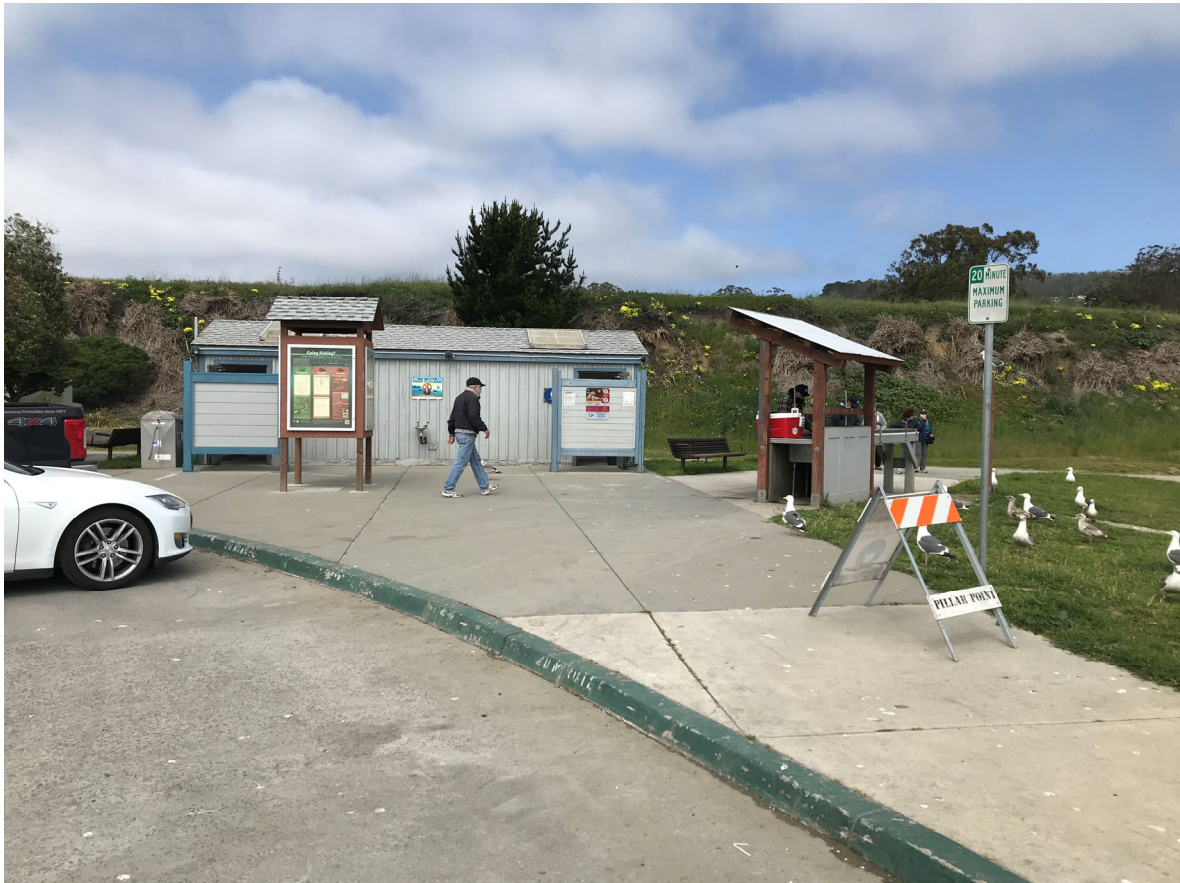
45 – View of East Restroom and fish cleaning station

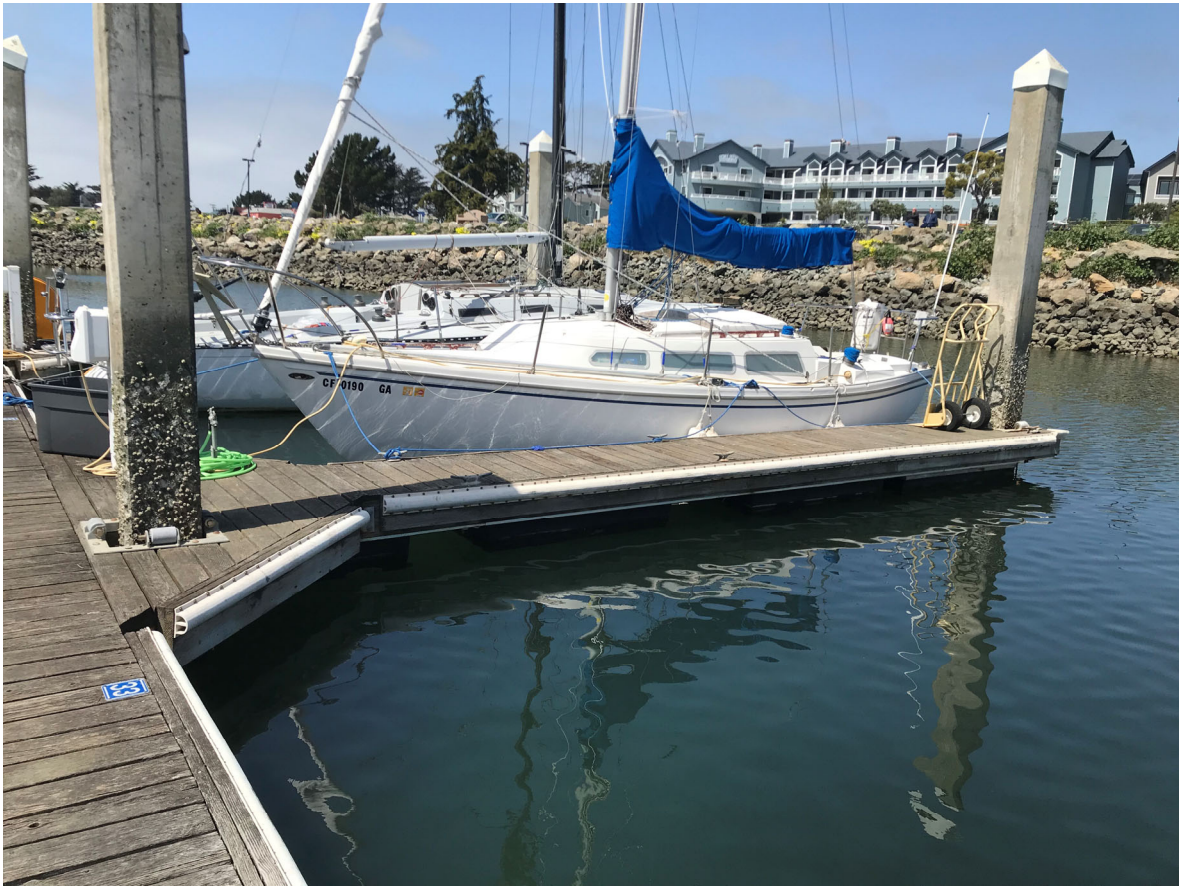
58 – View of typical Dock D finger

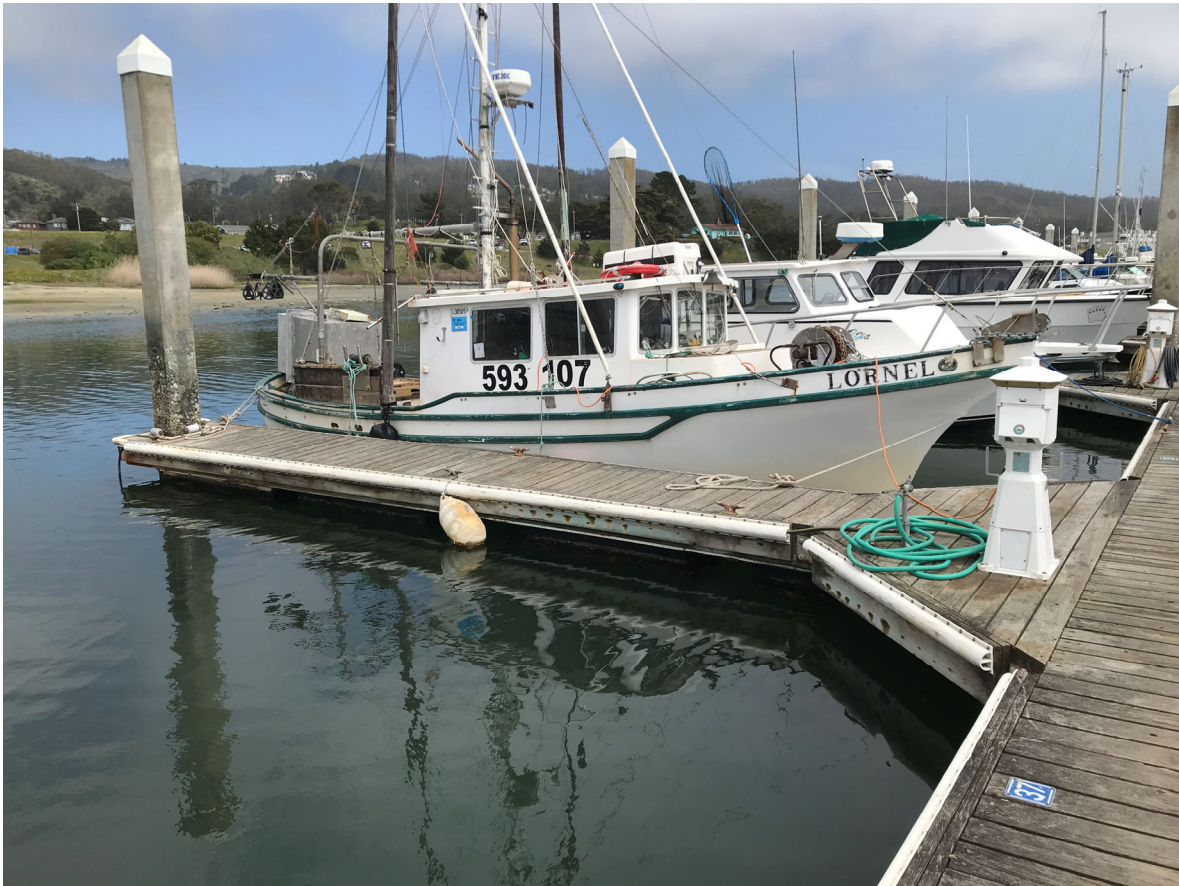
63 – View of entrance to Dock F

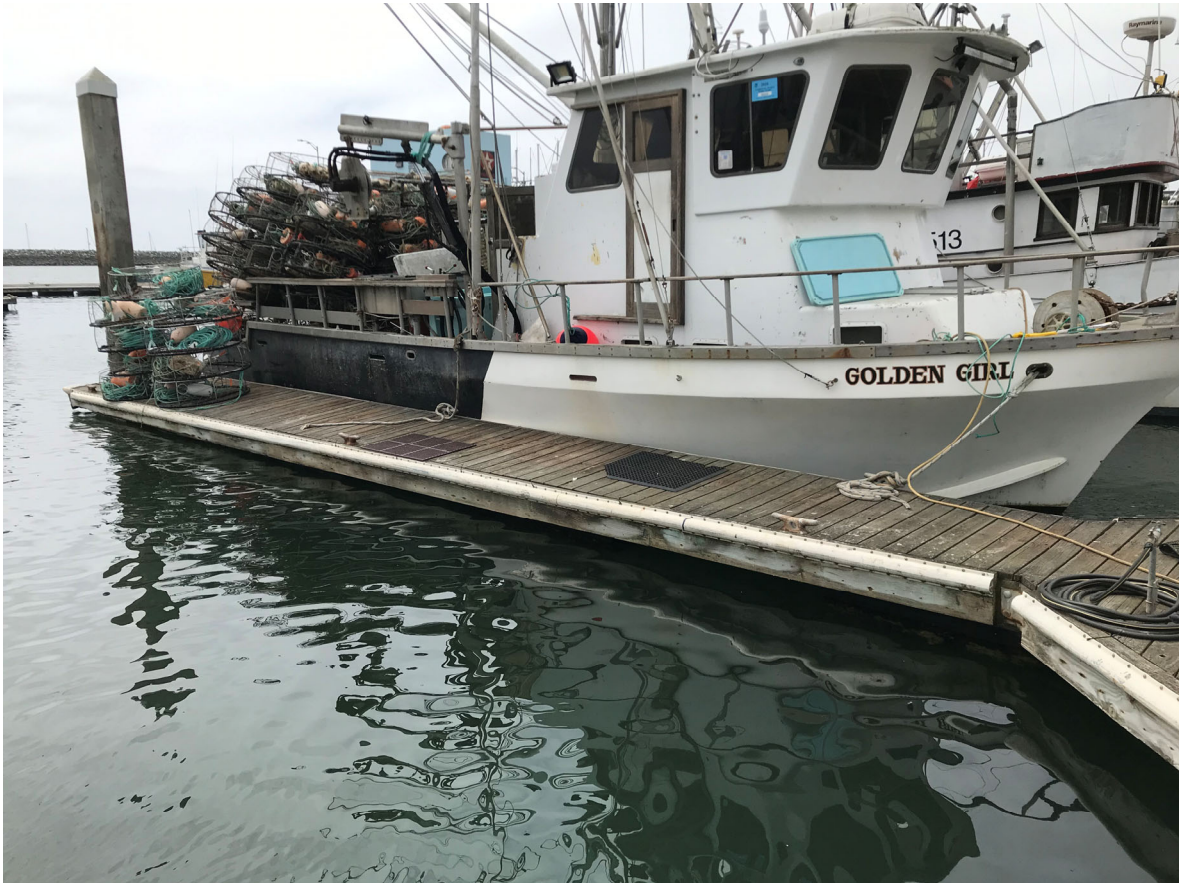
64 – View of typical Dock F finger
