SAN MATEO COUNTY HARBOR DISTRICT
STRATEGIC BUSINESS PLAN
**EXISTING INFRASTRUCTURE &
FACILITIES ASSESSMENT**
DRAFT, DECEMBER 2014

**A.3. MARINE INFRASTRUCTURE & HARBOR FACILITIES ASSESSMENT –
PILLAR POINT HARBOR**

**A.4. MARINE INFRASTRUCTURE & HARBOR FACILITIES ASSESSMENT –
OYSTER POINT MARINA PARK**

The purpose of this report is to provide a summary of the facility condition survey (FCS) performed at Pillar Point Marina (Pillar Point) located in Half Moon Bay, California. San Mateo County Harbor District (SMCHD) asked Moffatt & Nichol (M&N) to visually inspect and evaluate the conditions of the waterside and shoreside structures at the facility. This report identifies the components that require repairs, a prioritized schedule for repair and maintenance of each survey component (i.e., docks, hoists, buildings, etc.), and costs for repair.

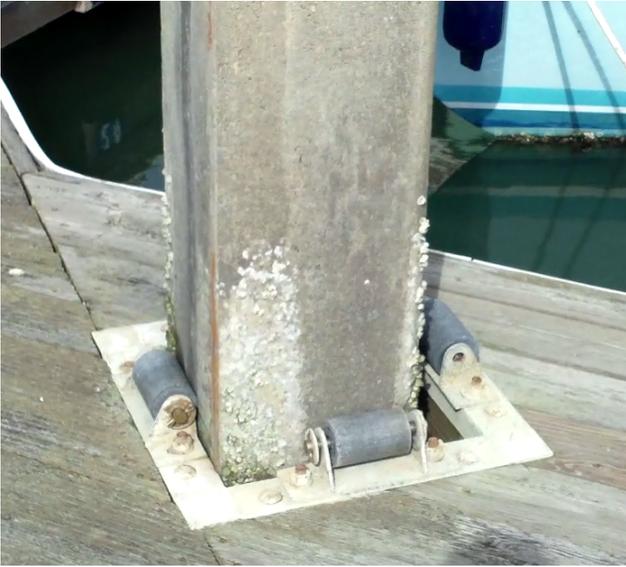
PHOTOGRAPH 1: TYPICAL PILE GUIDE -GOOD
CONDITION (DOCK)

The pile guides at all the docks consist of steel angles bolted to the dock surface. Photograph 1 in Attachment A shows a typical pile guide in good condition. The pile guides are generally in good condition, with a few exceptions. The following pile guides should be replaced within the next two years due to missing bolts or corrosion, four pile guides at Dock 1 (Photograph 1 and Photograph 2,) one at Dock 2, and one at Dock 3.

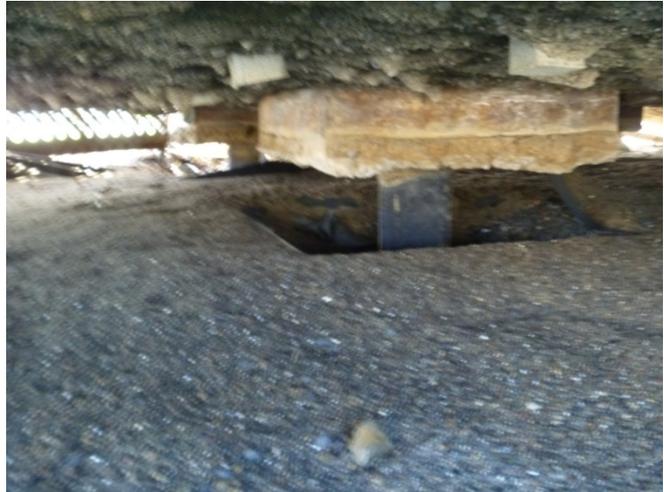
PHOTOGRAPH 3: HARBOR MASTER'S OFFICE BUILDING

This one story 1,220 square foot building was constructed in the early 1980s and structurally appears to be in fair condition. The roof consists of 1/2" plywood over 2x6 decking with heavy timber framing supported by timber pole columns. The foundation consists of a 12" thick reinforced concrete mat over nine 12" square by 125 foot long concrete pilings. The lateral force resisting system appears to be conventional wood framed shear walls. The finishes consist of wood shake roofing, exterior T1-11 wood siding and interior gypsum board. It is evident that the ground has settled significantly below this building (Photograph 3). The stability of the building is not compromised by this condition due to the deep foundations. It was reported that during high tides of +6.9 or greater the access road to this building and its parking lot are below water.

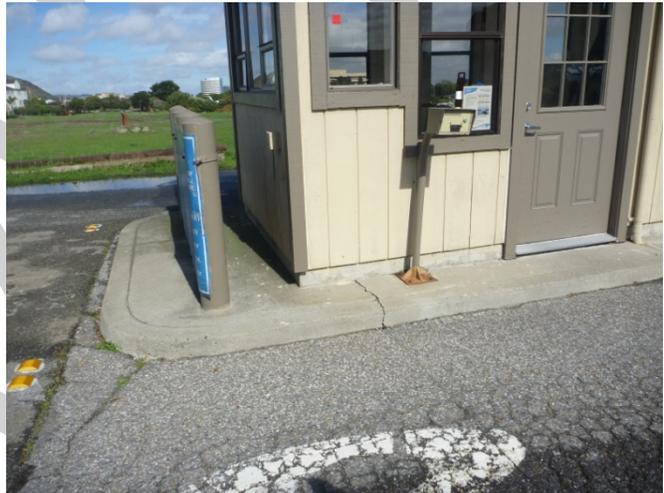
PHOTOGRAPH 4: KIOSK BUILDING

This is a small one story 100 square foot building constructed in the early 1980s and structurally appears to be in fair condition. The roof consists of conventional wood framing over stud walls with a 4" thick slab on grade. The finishes consist of wood shake roofing, exterior T1-11 wood siding and interior gypsum board. The raised concrete pad beyond the kiosk's foundation appears to have settlement cracks (Photograph 4).

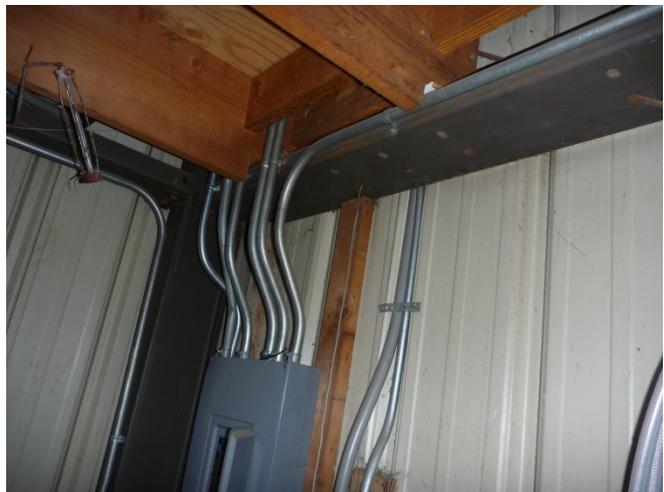
PHOTOGRAPH 5: MAINTENANCE BUILDING

This one story 2,300 square foot prefabricated metal building was constructed in the early 1980s and structurally appears to be in fair condition. The roof consists of standing seam metal panels over cold formed steel purlins over rigid steel frames. The exterior has metal siding with horizontal wall girts between frame columns. The foundation consists of a slab on grade with a masonry retaining wall on the south side of the building. The interior space has been in filled with partition walls with gypsum board finishes. A wood framed mezzanine has been added to the west end of the building. The mezzanine is supported by wood posts at its center and supported by wall girts on its north side and a masonry wall on its south side. It appears that the mezzanine's load on the wall girt may have bowed out the wall at the northwest corner of the building (Photograph 5).

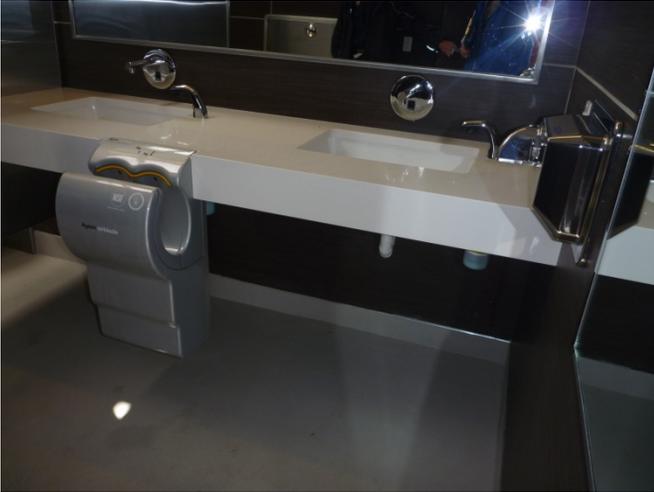
PHOTOGRAPH 6: RESTROOM #1

These structures are one story prefabricated metal buildings originally constructed in the early 1980s and recently refurbished (Photograph 6). The buildings appear to be in good condition structurally. The roofing is cedar shake over 1x4 wood skip sheathing over 22 gauge standing seam roofing supported by cold formed steel roof framing. The walls are constructed of 18 gauge cold formed steel studs with T1-11 exterior wall siding and 18 gauge metal interior wall panels. Restrooms #1 and #2 are approximately 560 square foot and restroom #3 is approximately 440 square foot. The foundations consist of reinforce concrete slab foundation with raised curbs. The exterior of the building has ornamental timber poles and roof outriggers.
