Pillar Point Harbor

Updated Marina Facility Condition Survey Report

Prepared for:
San Mateo County
Harbor District

May 2021

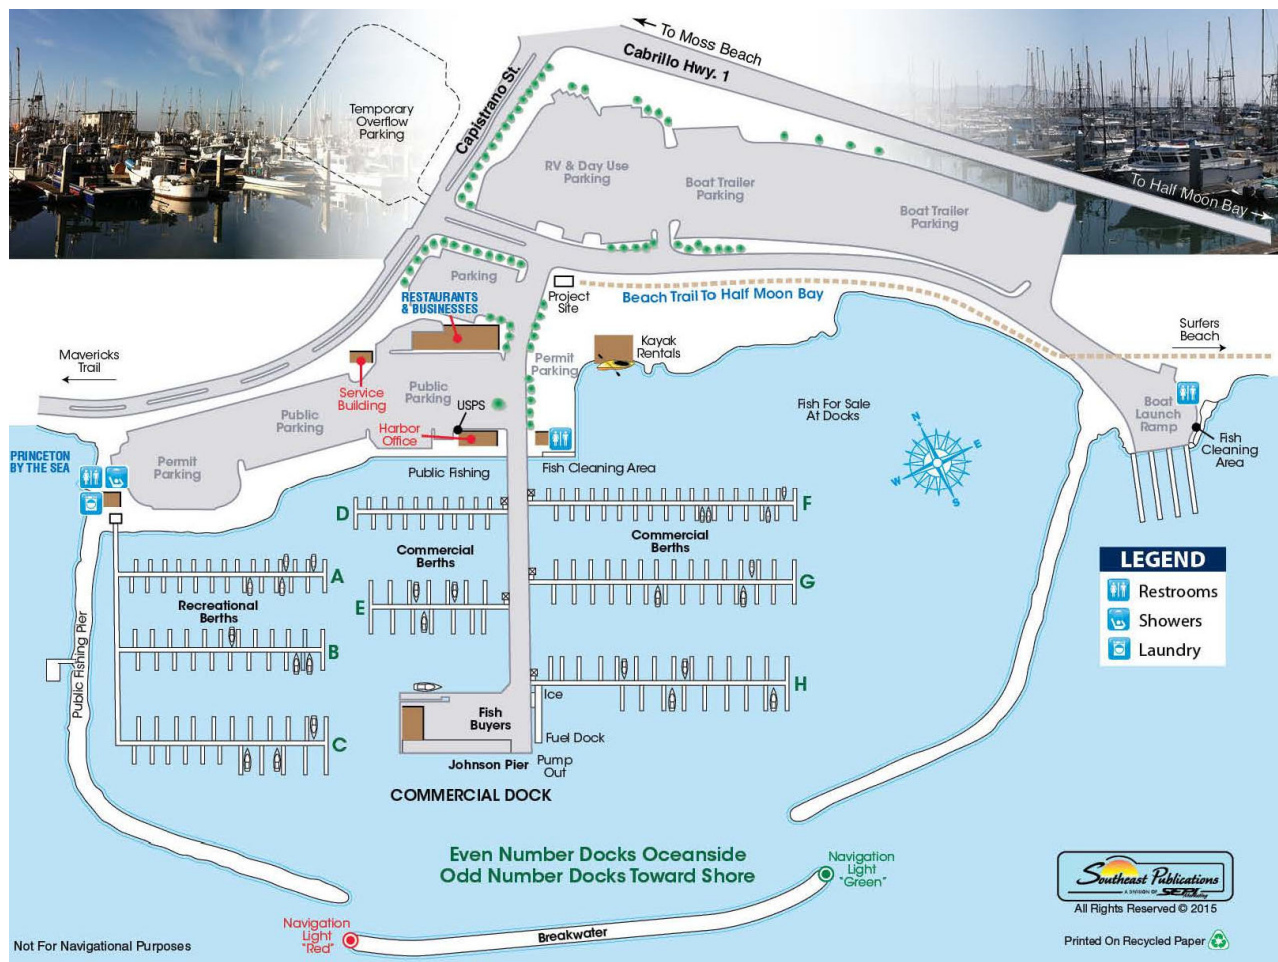
Figure 1 - Pillar Point Harbor Map (source: SMCHD website)

Pillar Point Harbor serves a large commercial fishing fleet, recreational boating, kayaking and standup paddling needs, and other public waterfront experiences at the various restaurants, shops, piers, trails and promenade. The extent of this inspection includes the harbor district facilities within the inner breakwater, as well as the boat launch ramp just east of the inner breakwater as shown below in Figure 1.
