Oyster Point Marina

Updated Marina Facility Condition Survey Report

Prepared for:
San Mateo County
Harbor District

May 2021

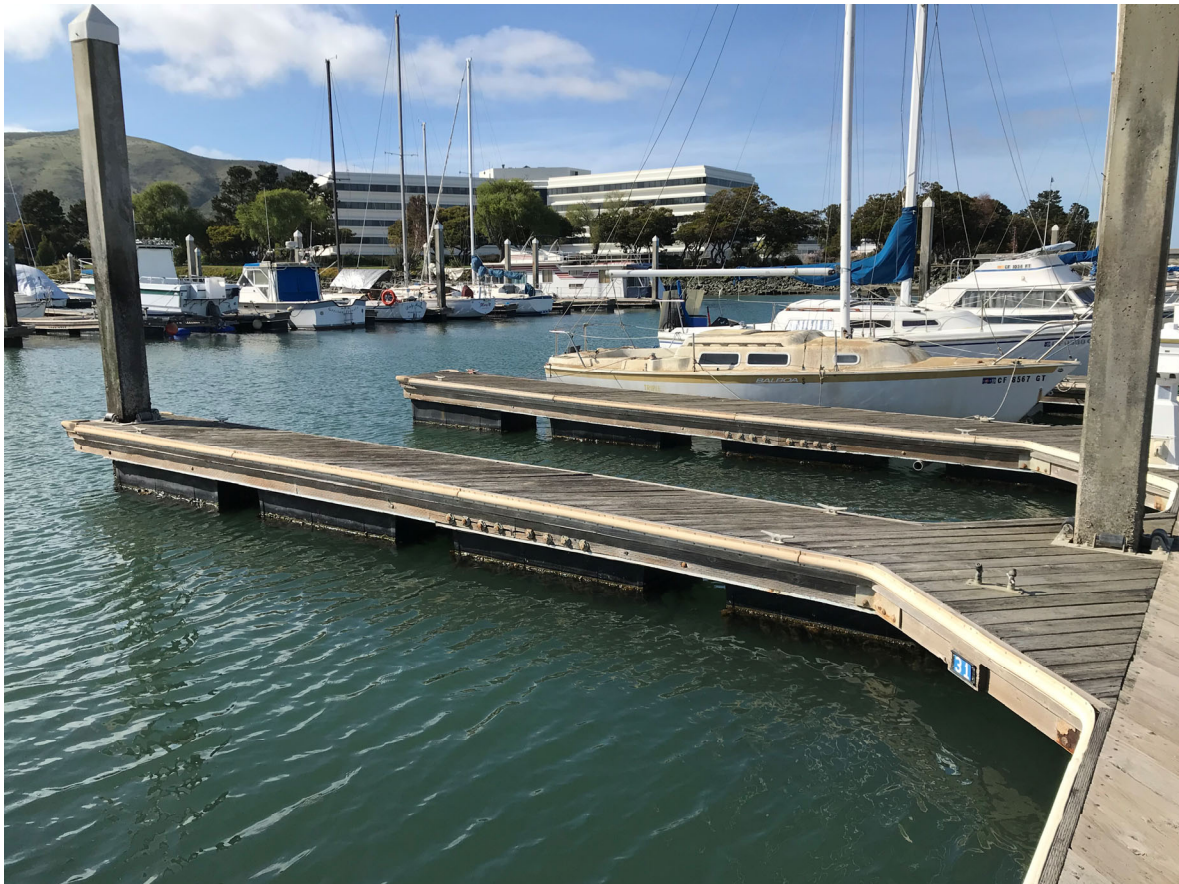
17 – View of West Basin Dock 4 fingers

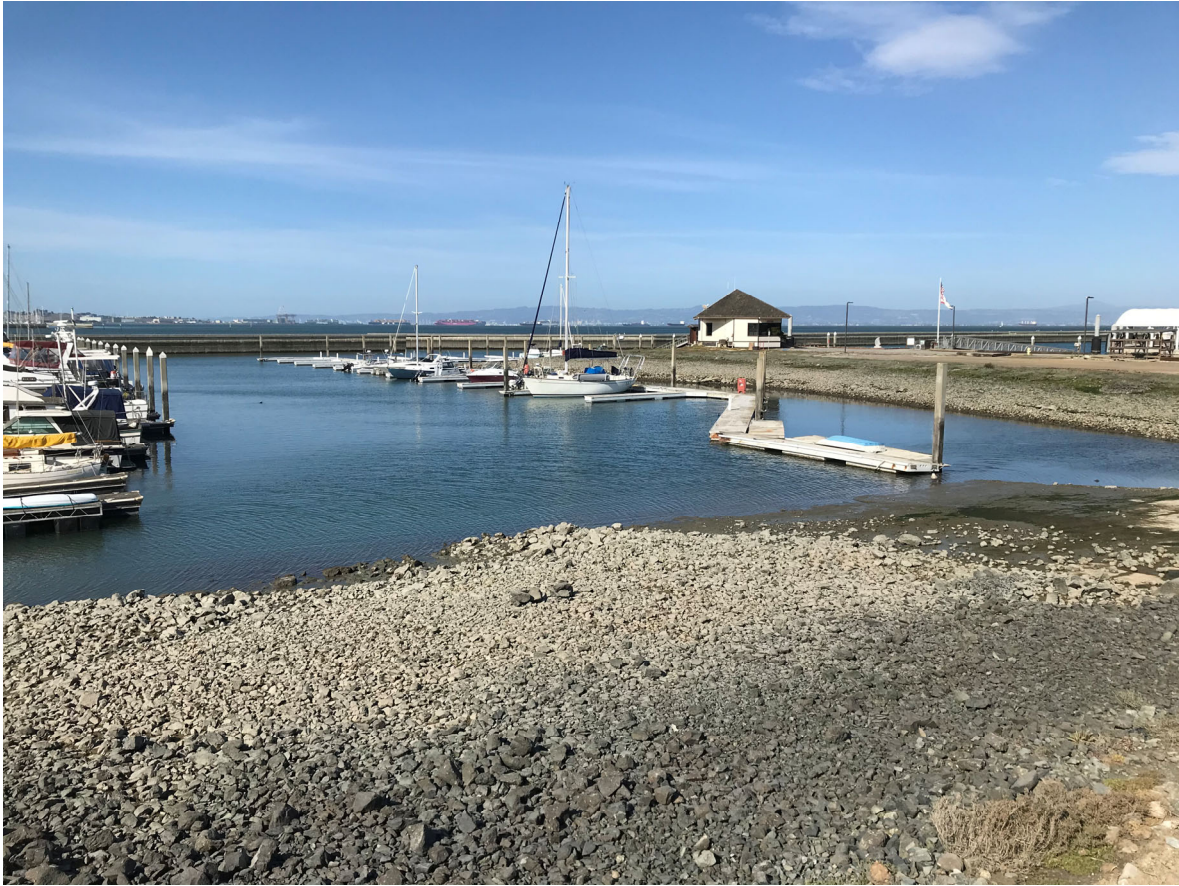
- West Basin – Reserved Dock 7: Observed to be in “critical” condition and in need of removal or replacement with an anticipated remaining useful life of 0 to 2 years

24 – View of West Basin Dock 7 and Harbormaster Building spit

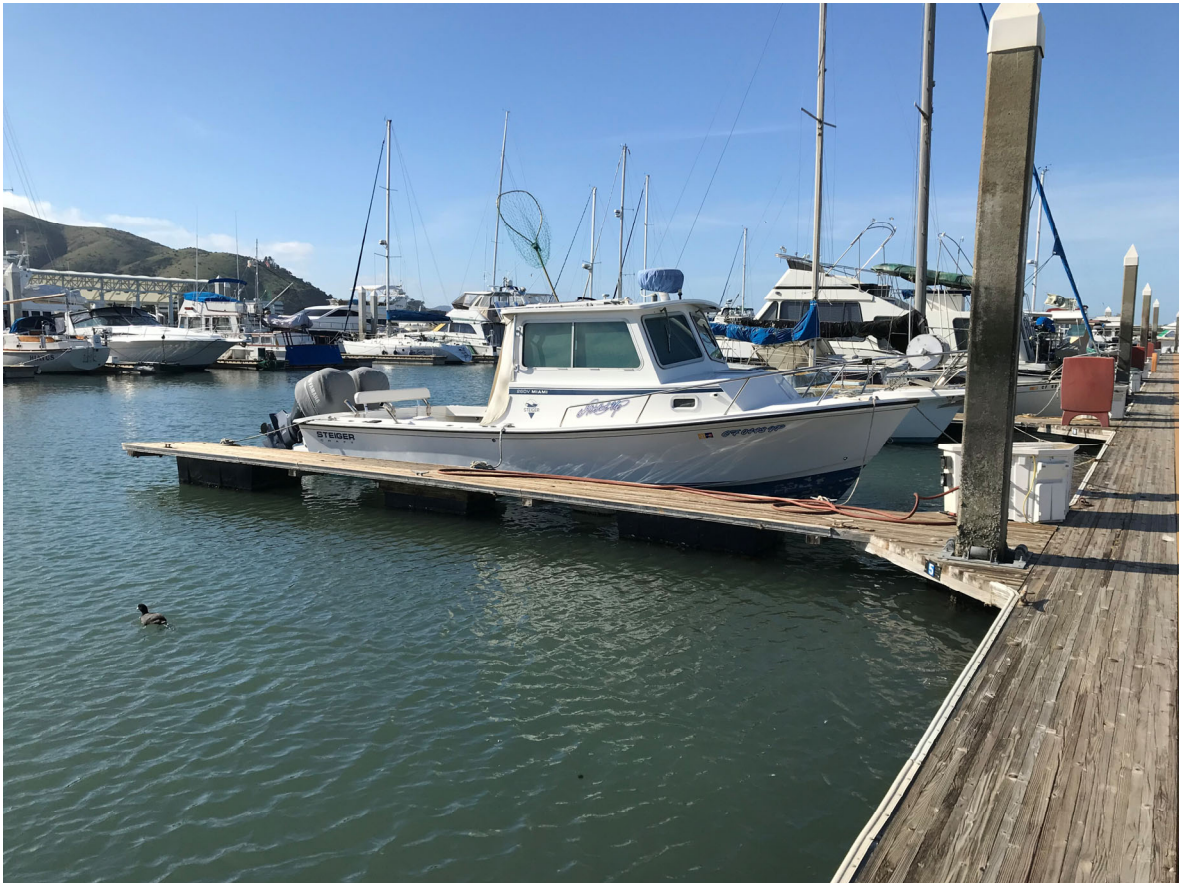
37 – View of East Basin Dock 12 finger

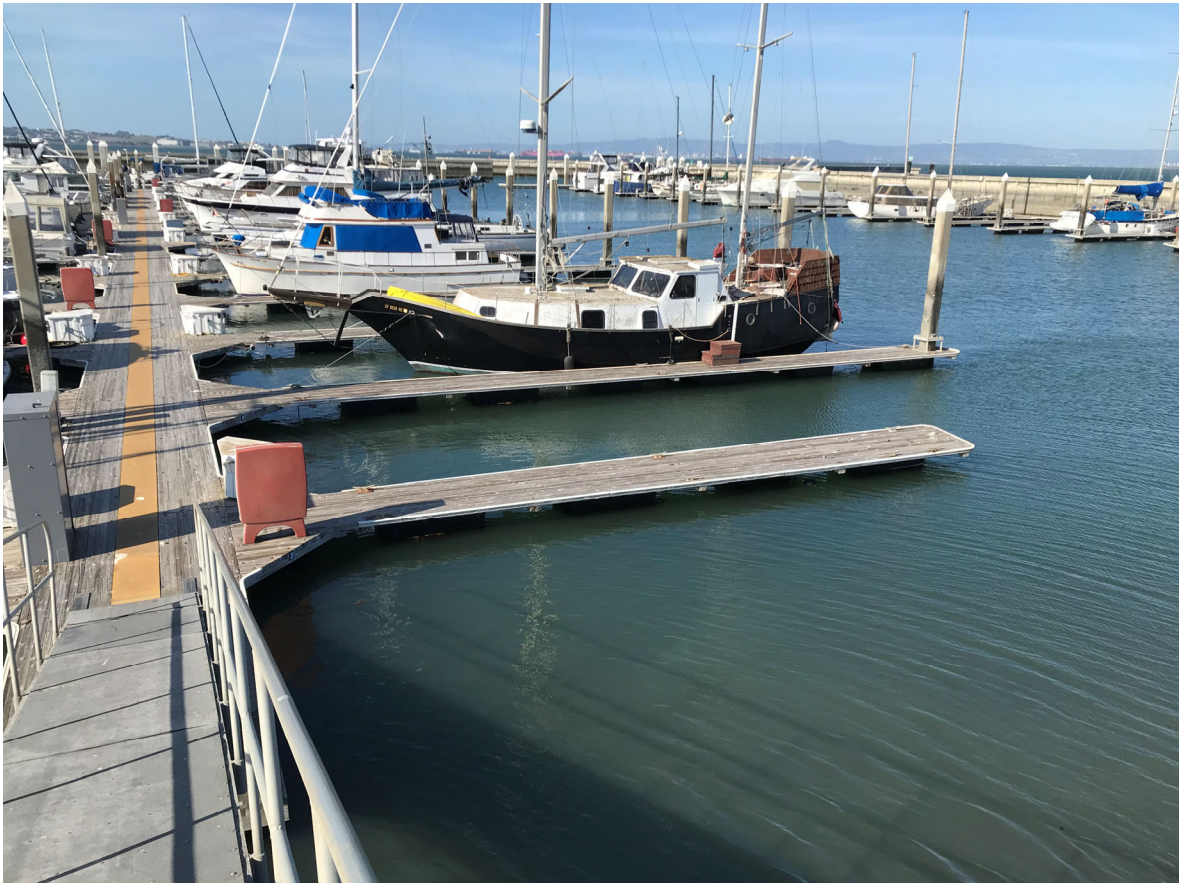
41 – View of East Basin Dock 13

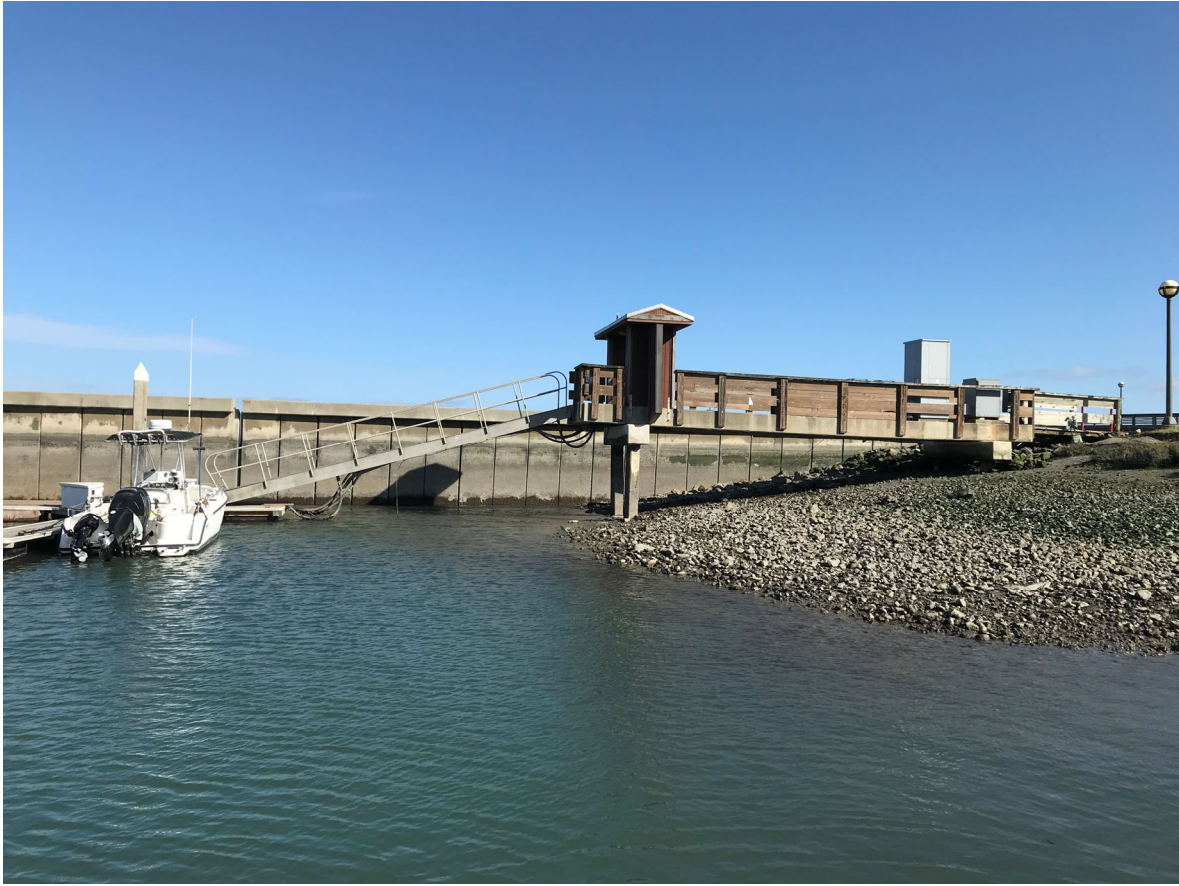
42 – View of East Basin Dock 14 gangway platform

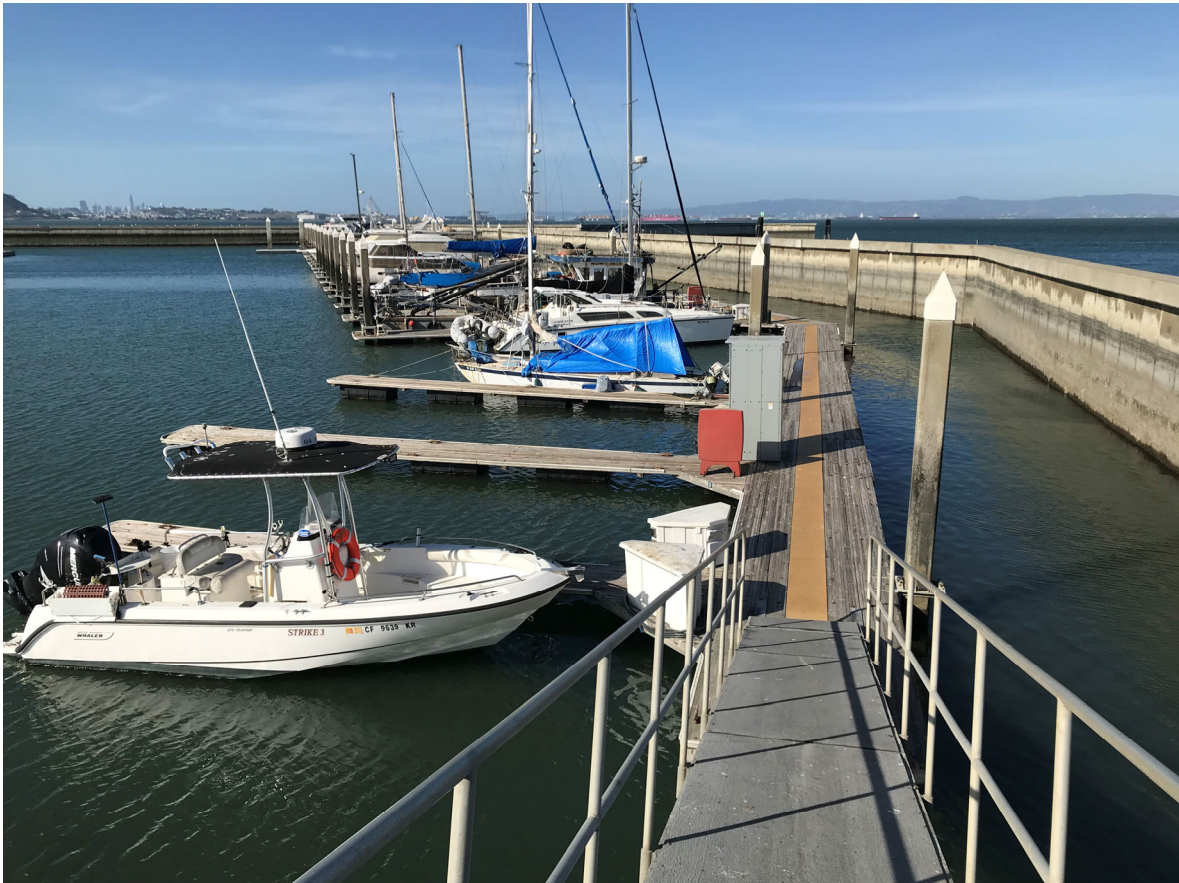
43 – View of East Basin Dock 14

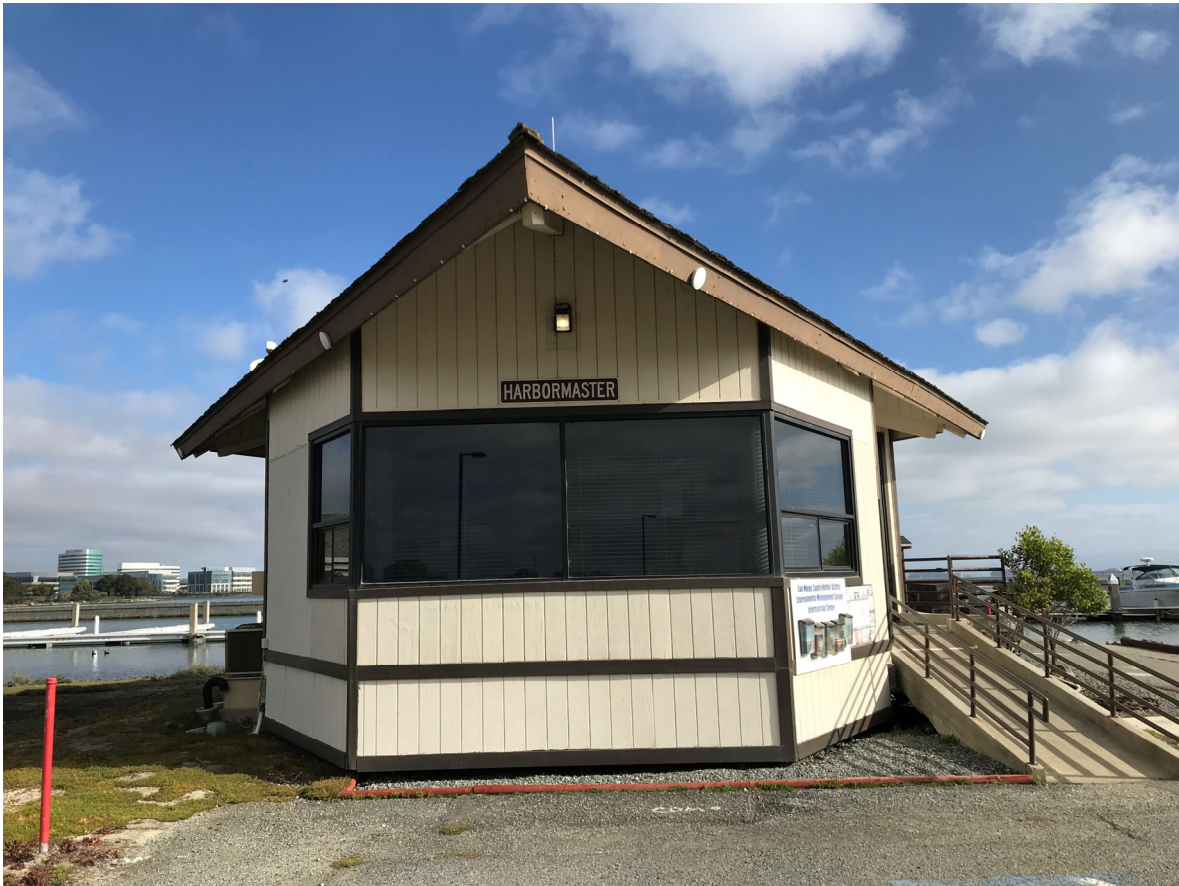
48 – View of Harbormaster's Office Building

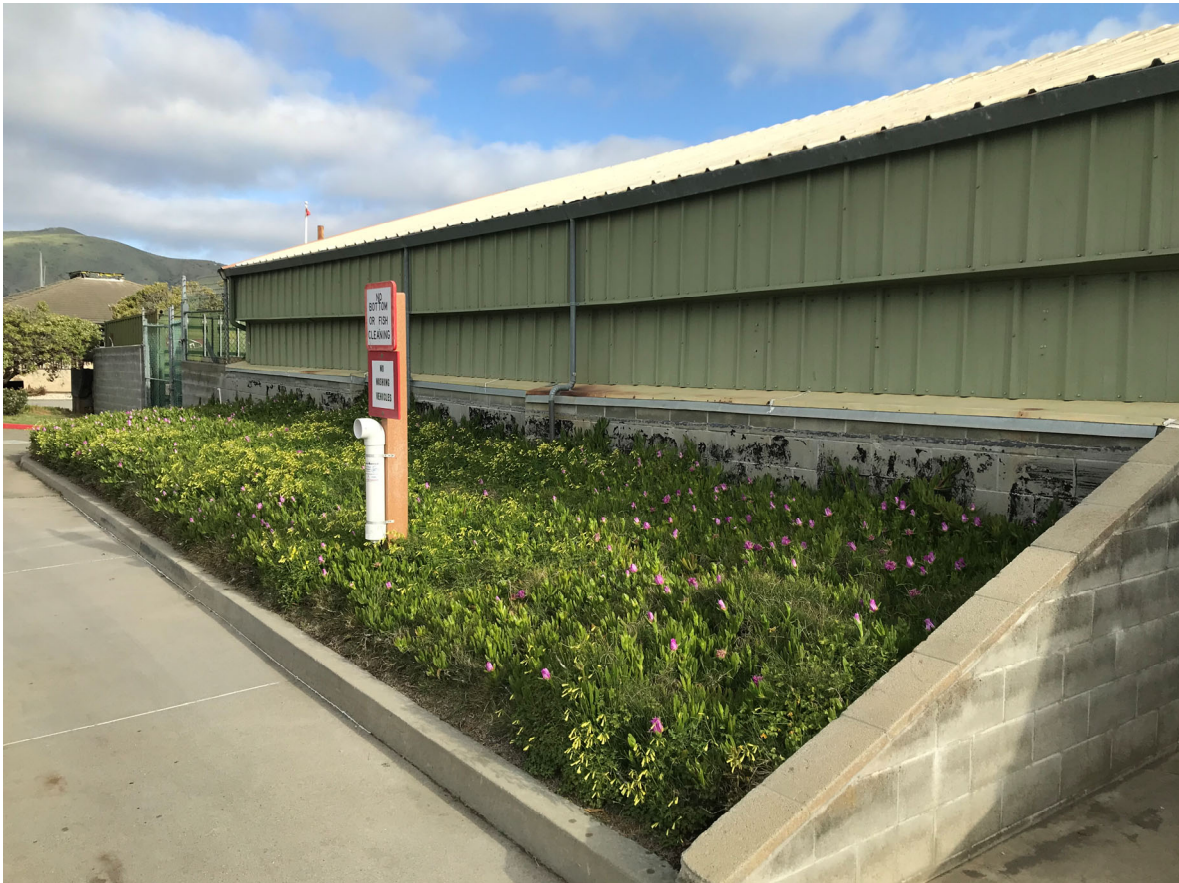
51 – View of south face of Maintenance Building

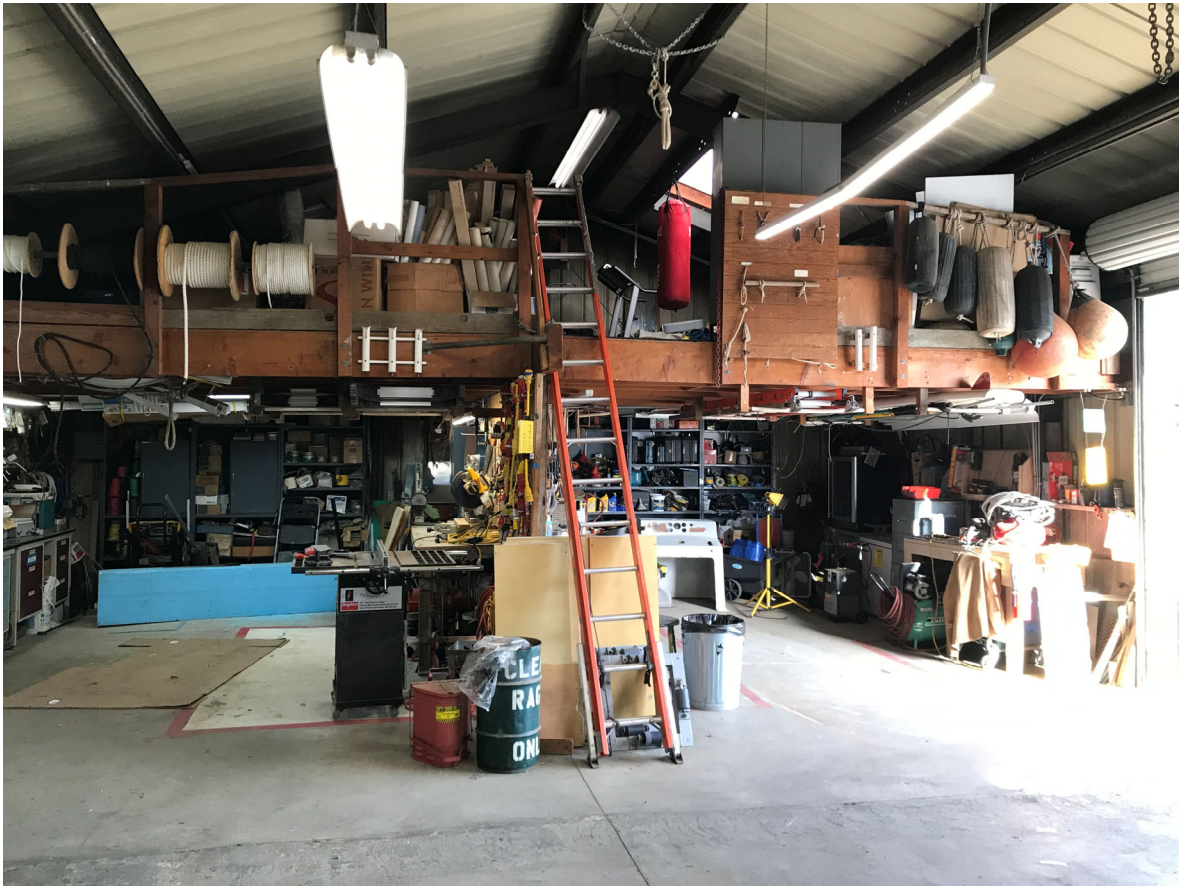
52 – View of interior of Maintenance Building

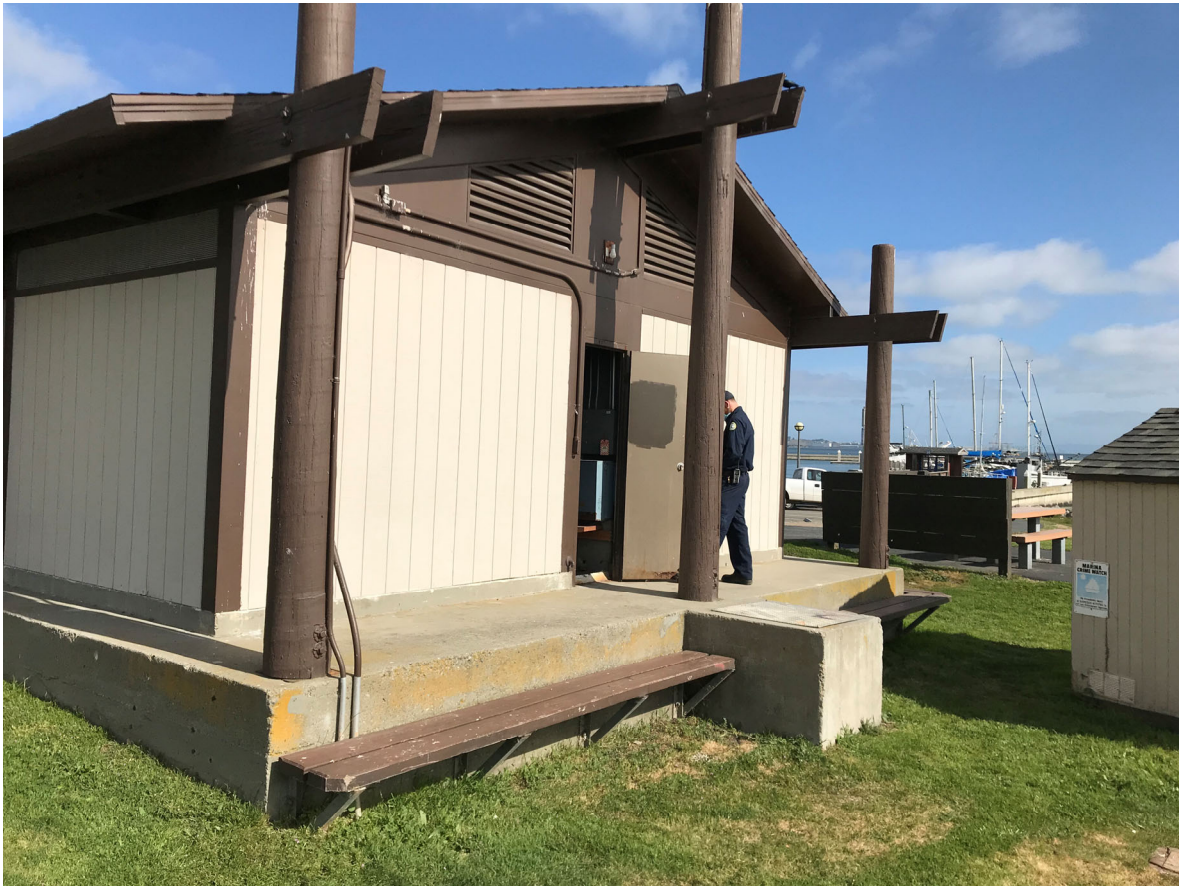
54 – View of Restroom Building 1 adjacent to Public Fishing Pier

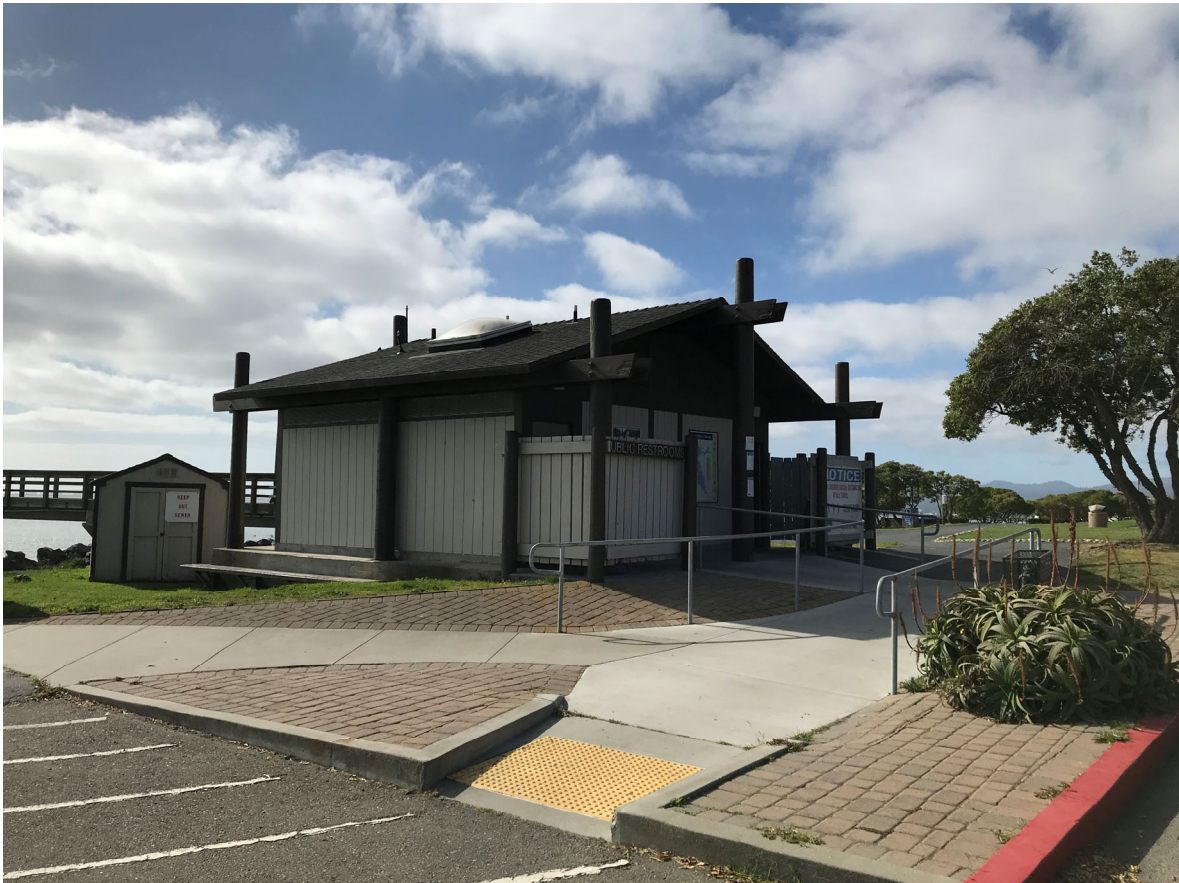
55 – View of Restroom Building 1 adjacent to Public Fishing Pier

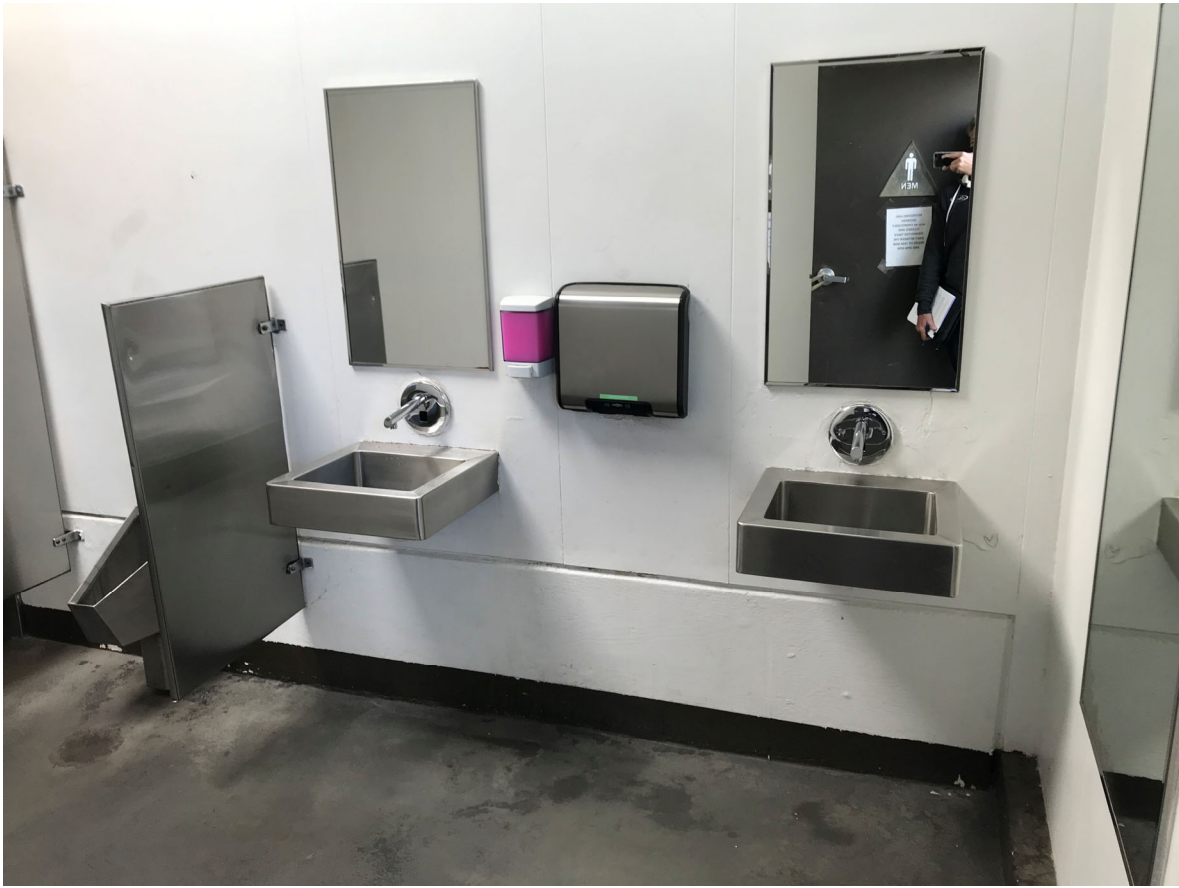
56 – View of Restroom Building 1 interior

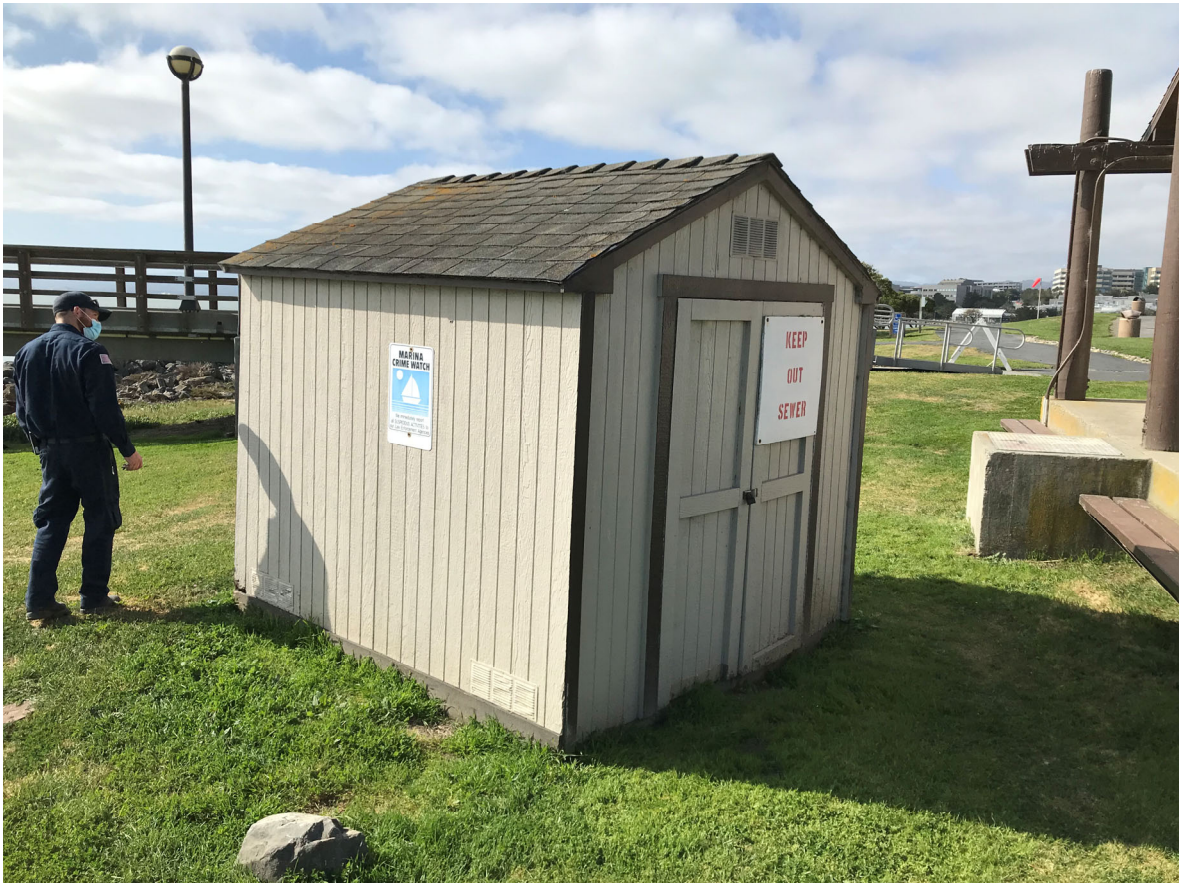
57 – View of small sewer system housing next to Restroom Building 1

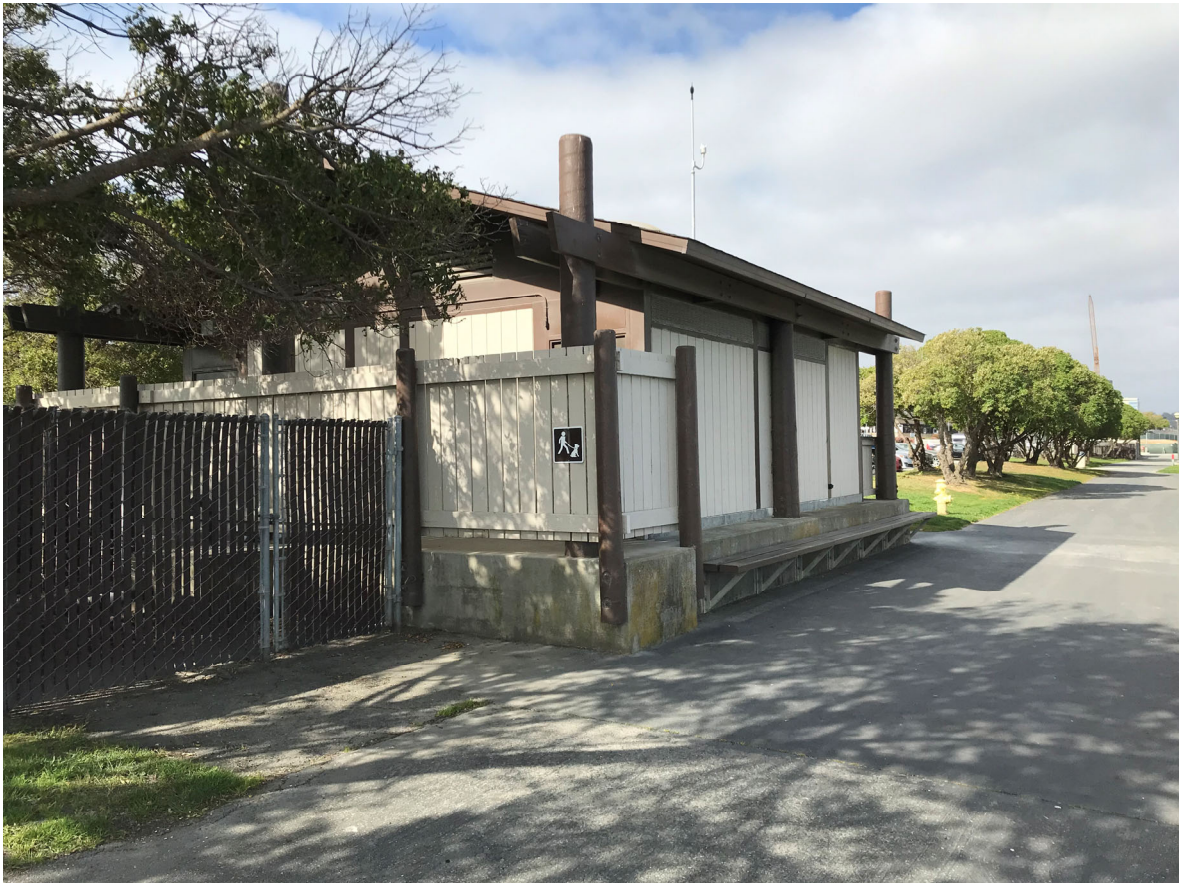
59 – View of East Basin Restroom 2 near Docks 12 and 13

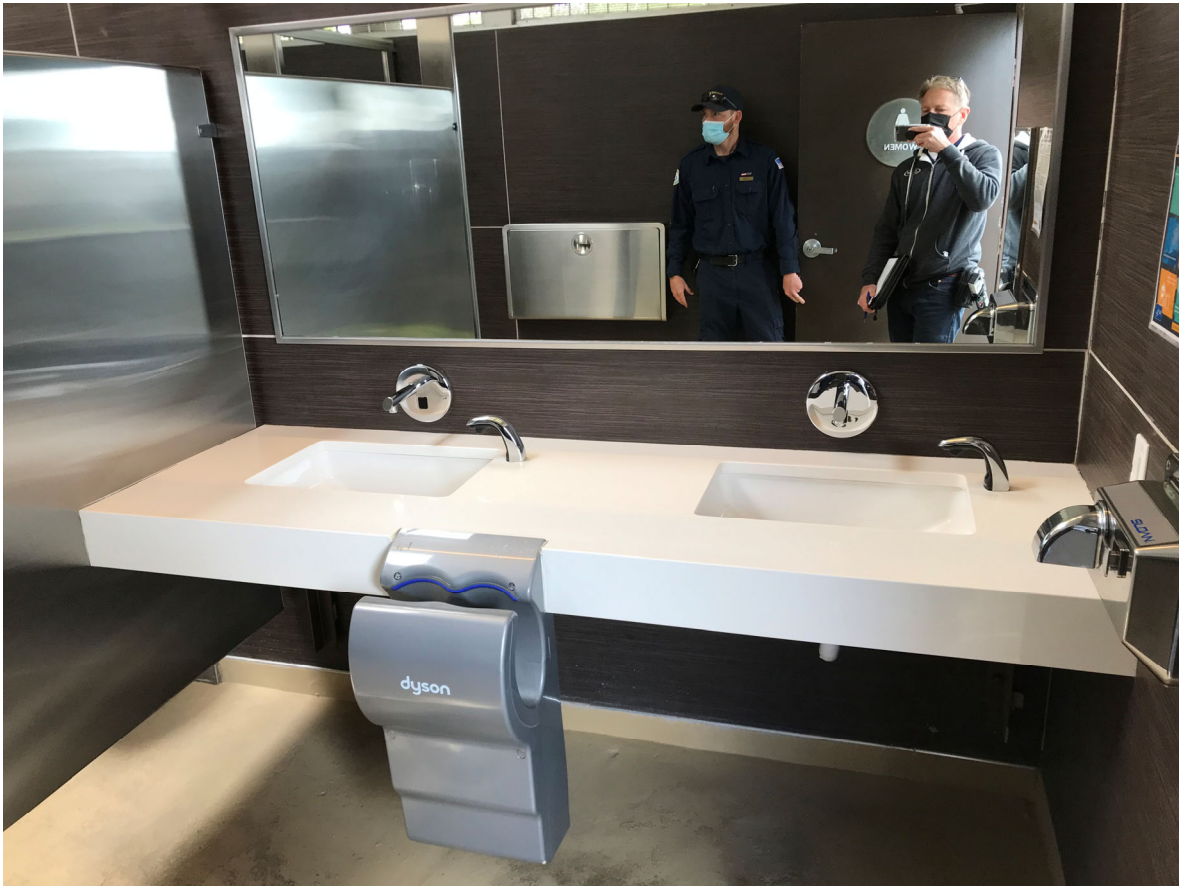
60 – View of Restroom 2 interior

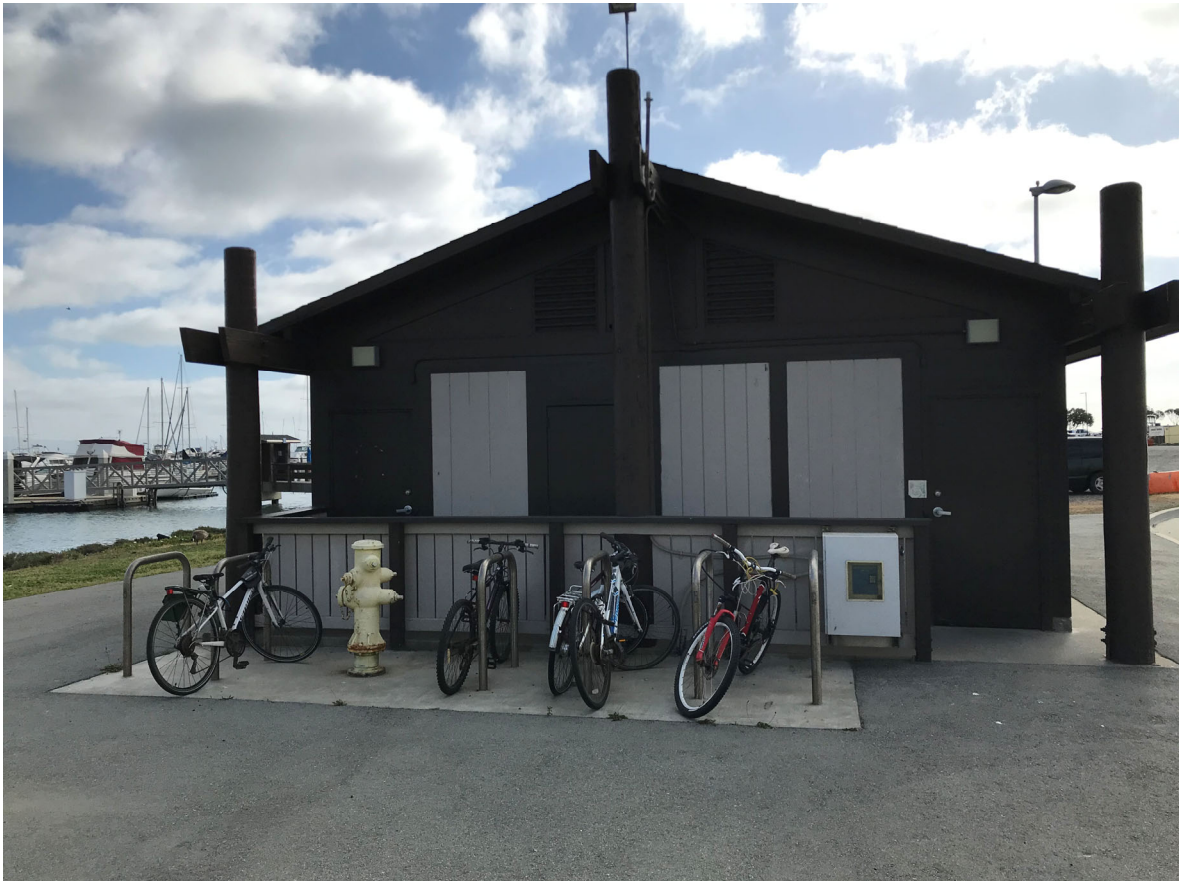
61 – View of East Basin Restroom 3

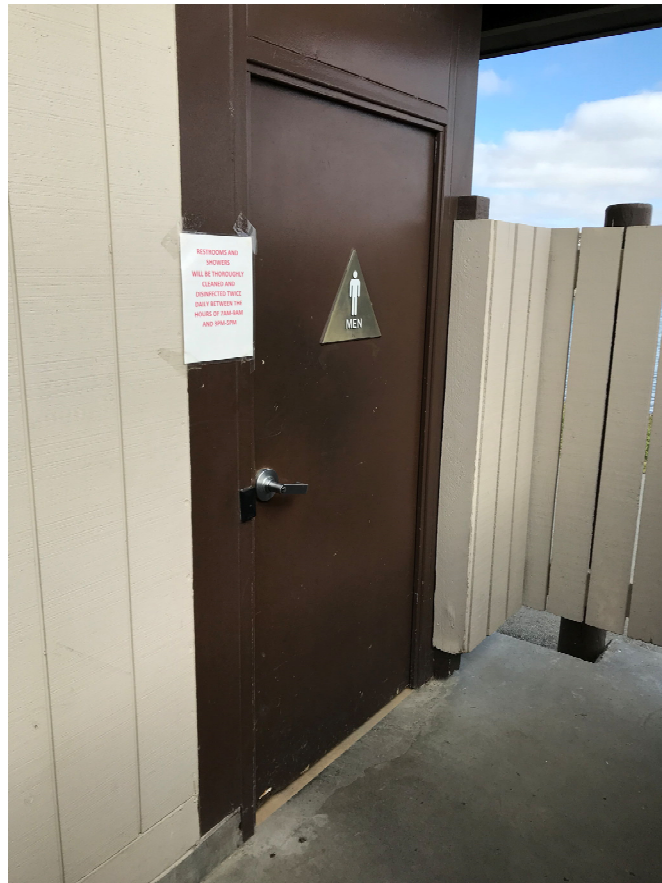
63 – View of East Basin Restroom 3 exterior door and paint

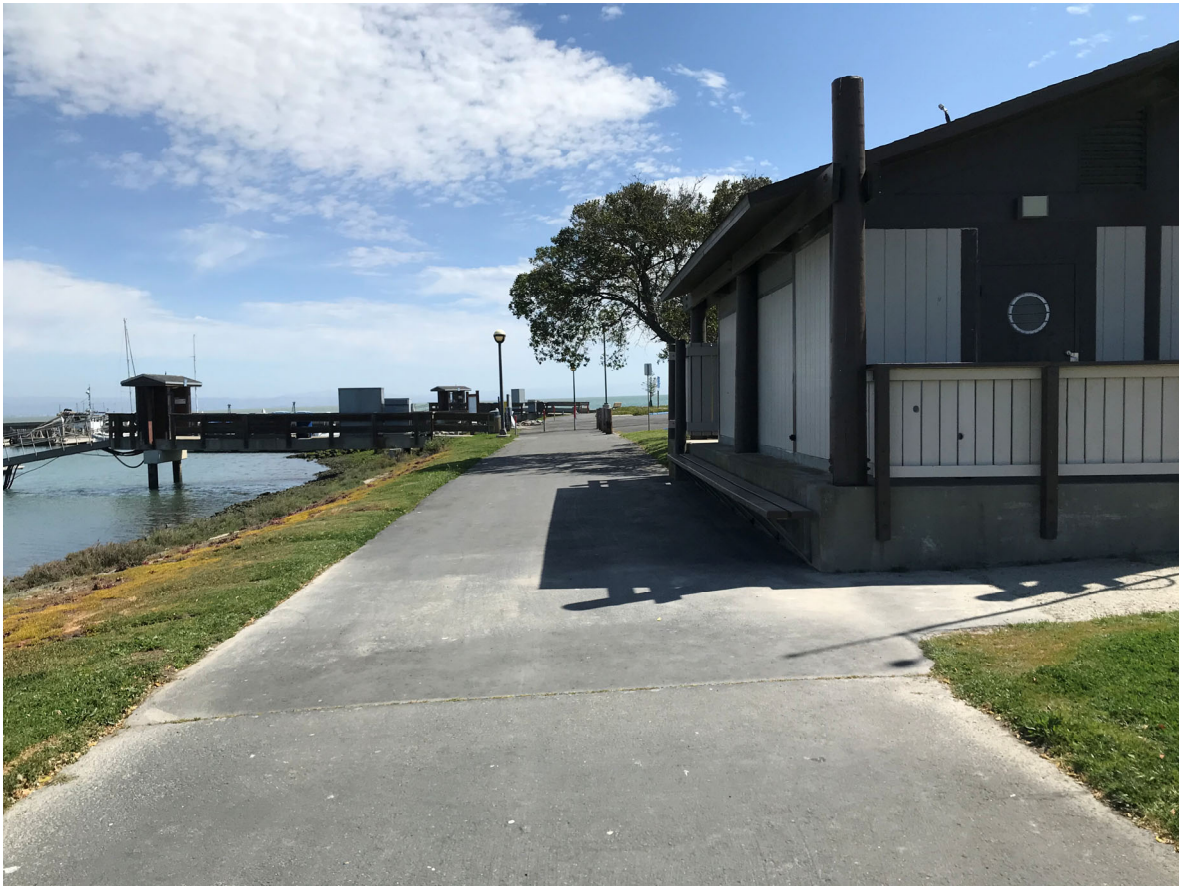
68 – View of San Francisco Bay Trail adjacent to Dock 12

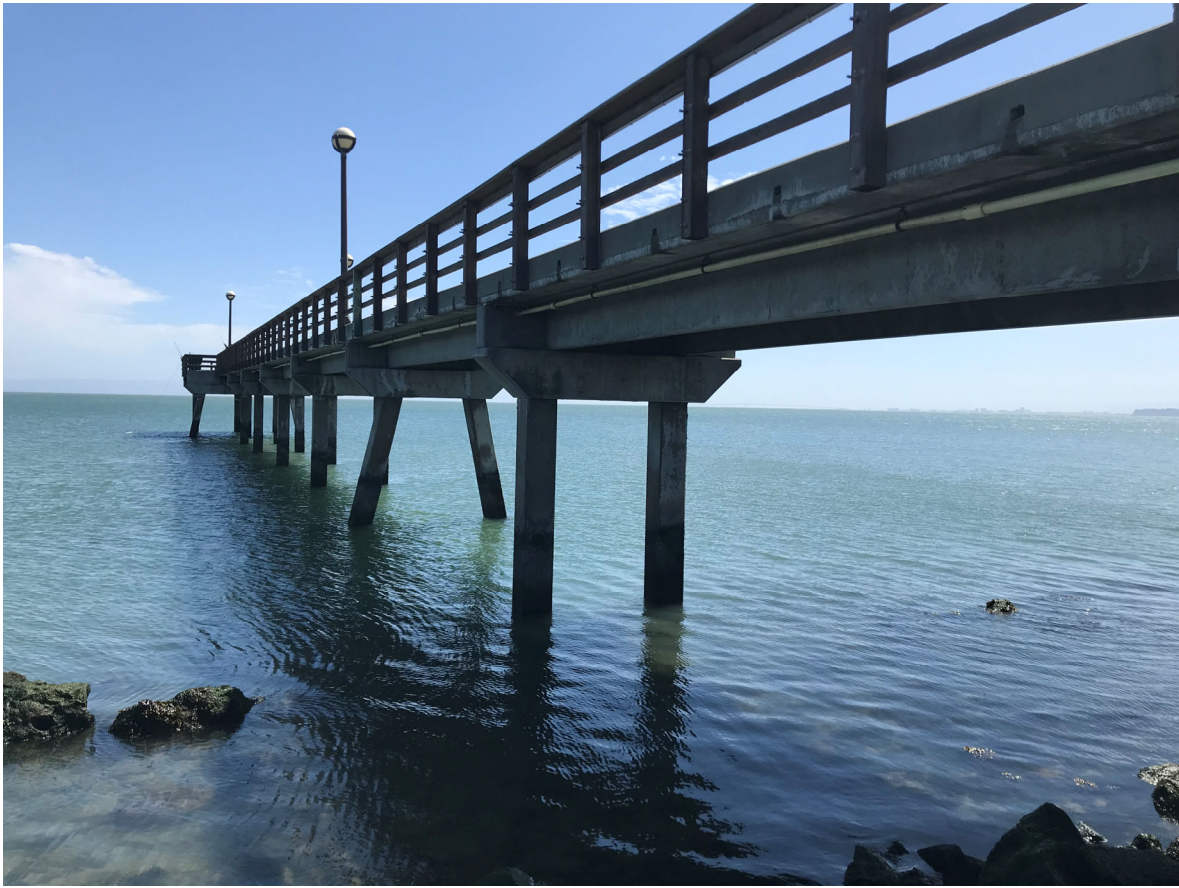
80 – View of Public Fishing Pier

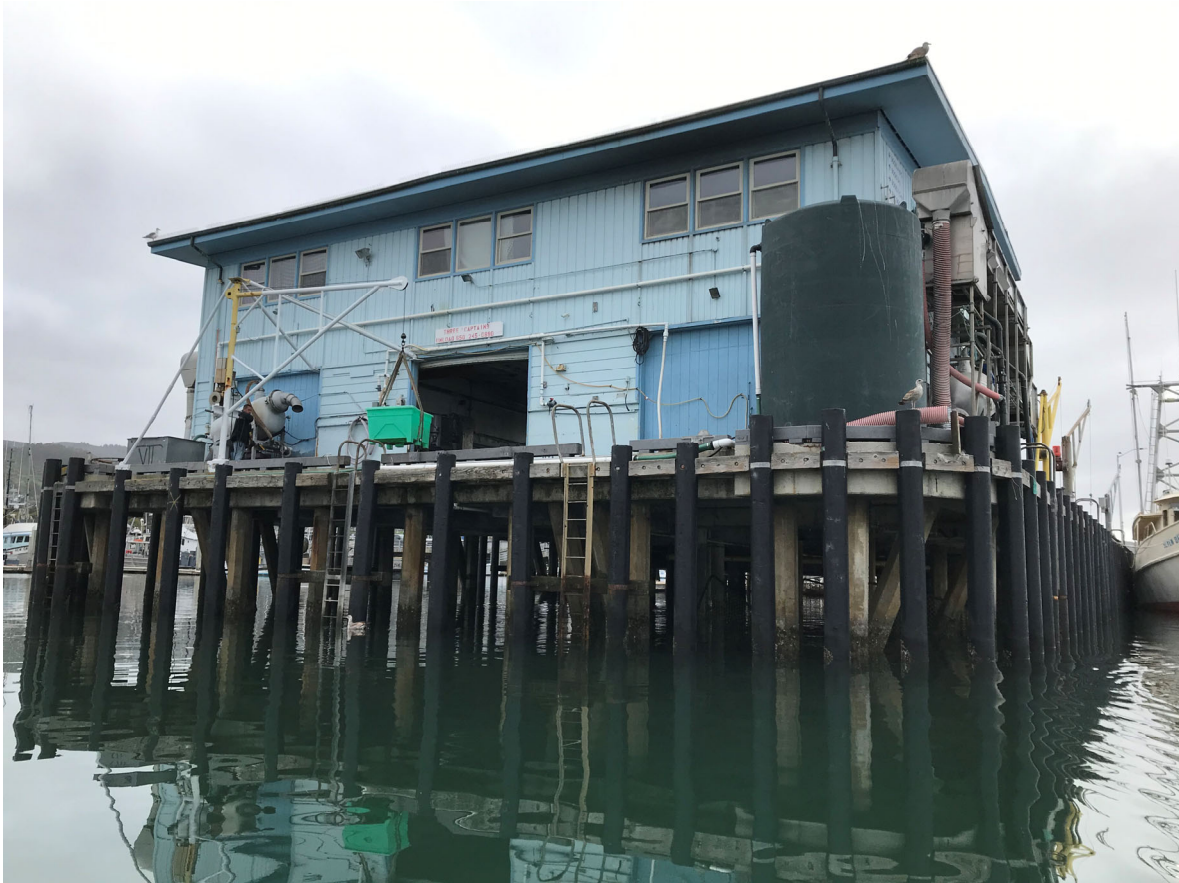
11 – View of Fish Buyer Building at end of pier

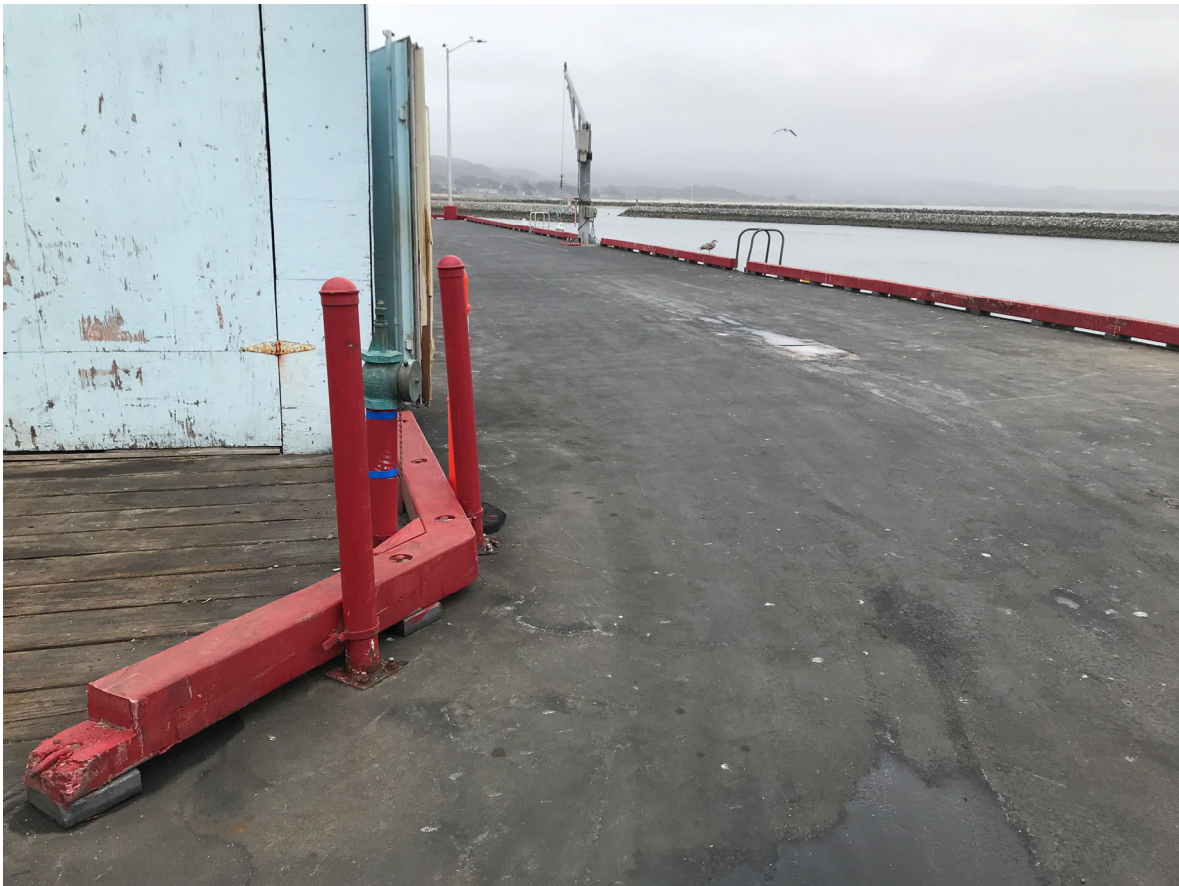
13 – View of high traffic area of pier deck next to Fish Buyer Building

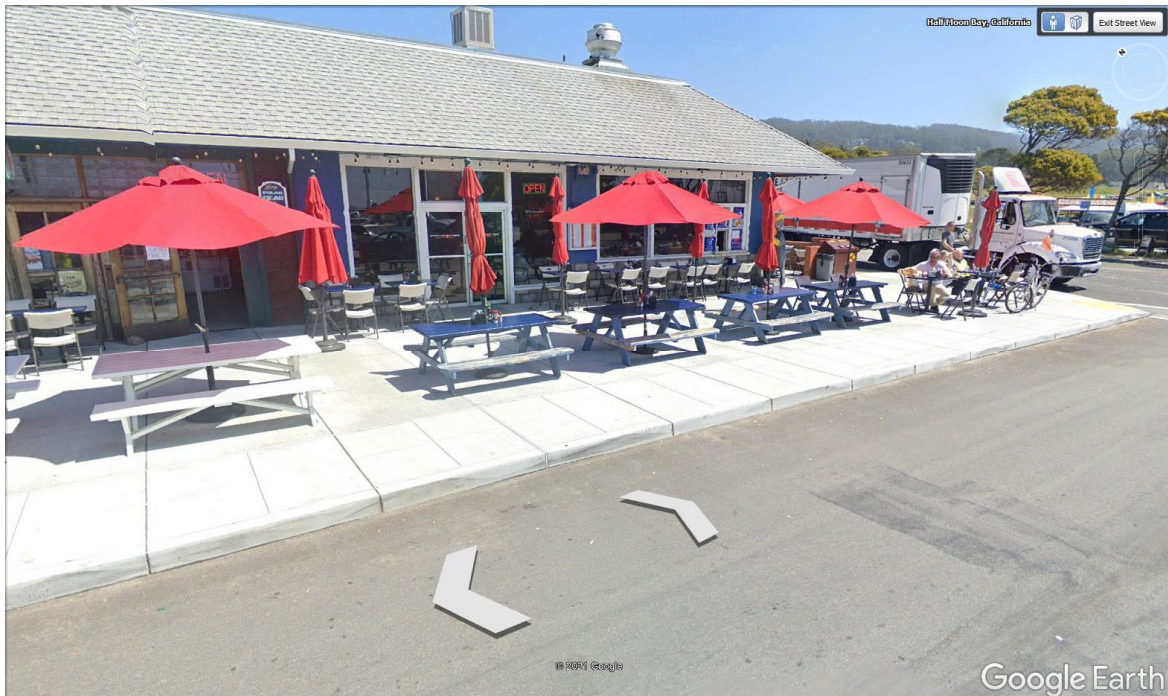
34 – View of Tenant Row Building extended patio seating (Google Earth Pro)
