Oyster Point Marina

Updated Marina Facility Condition Survey Report

Prepared for:
San Mateo County
Harbor District

May 2021

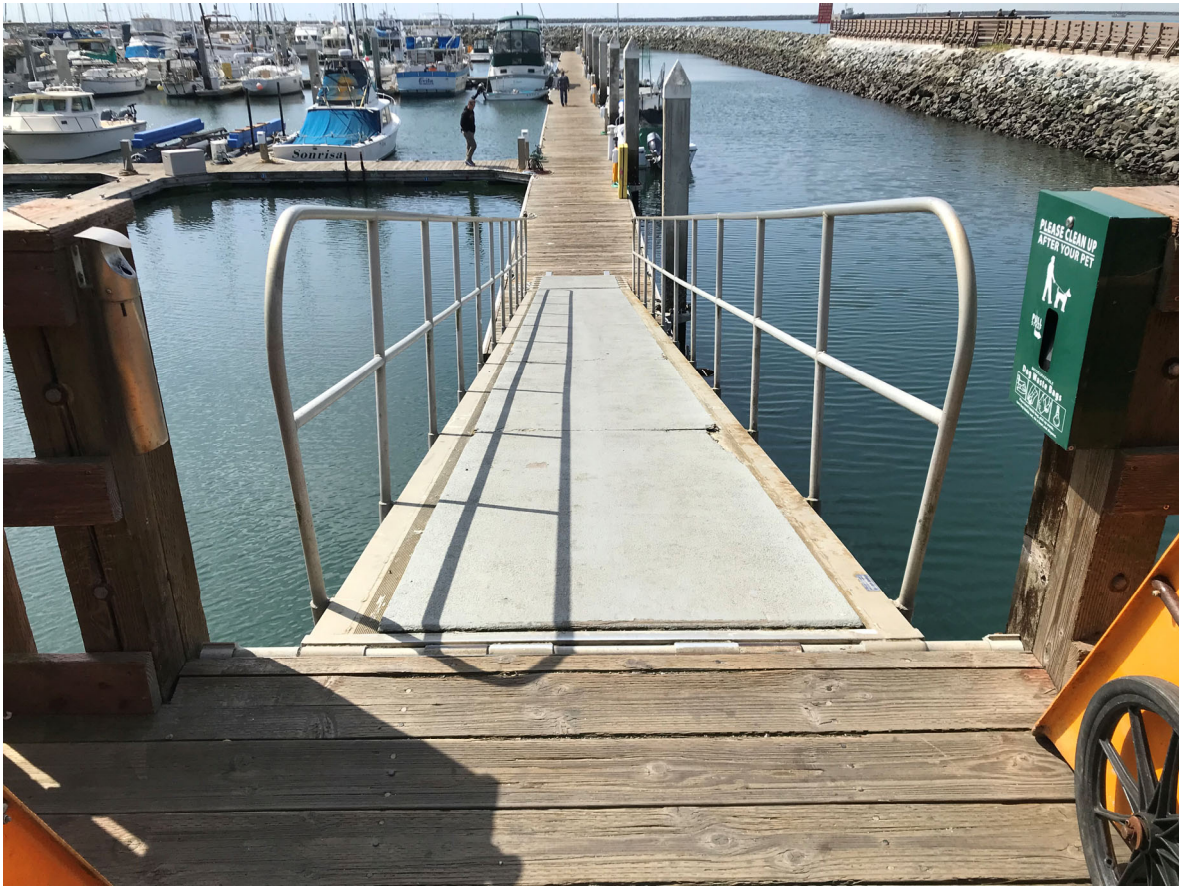
50 – View of Dock A-C gangway and main walkway

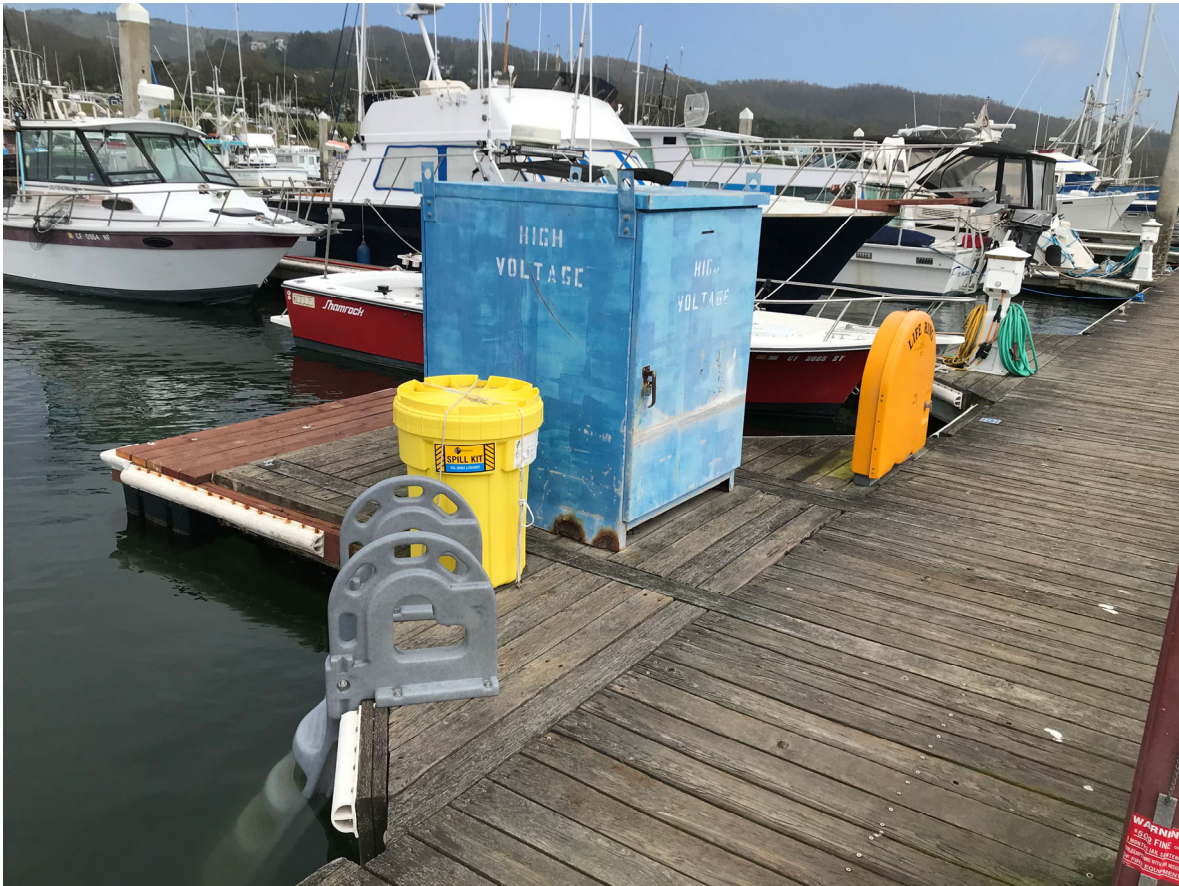
68 – View of Dock H electrical transformer

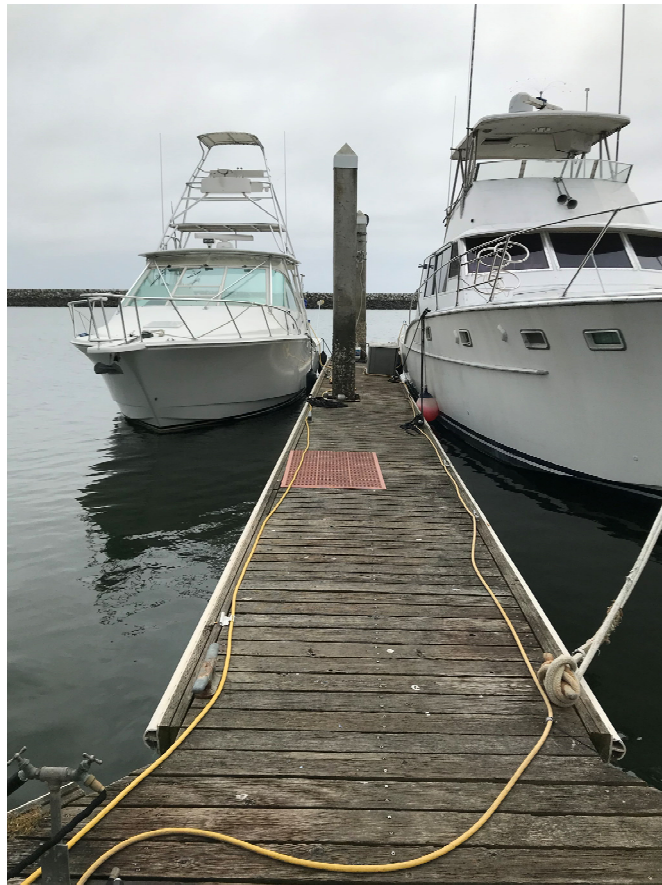
69 – View of typical Dock H finger
