Appendix A
Site Photos

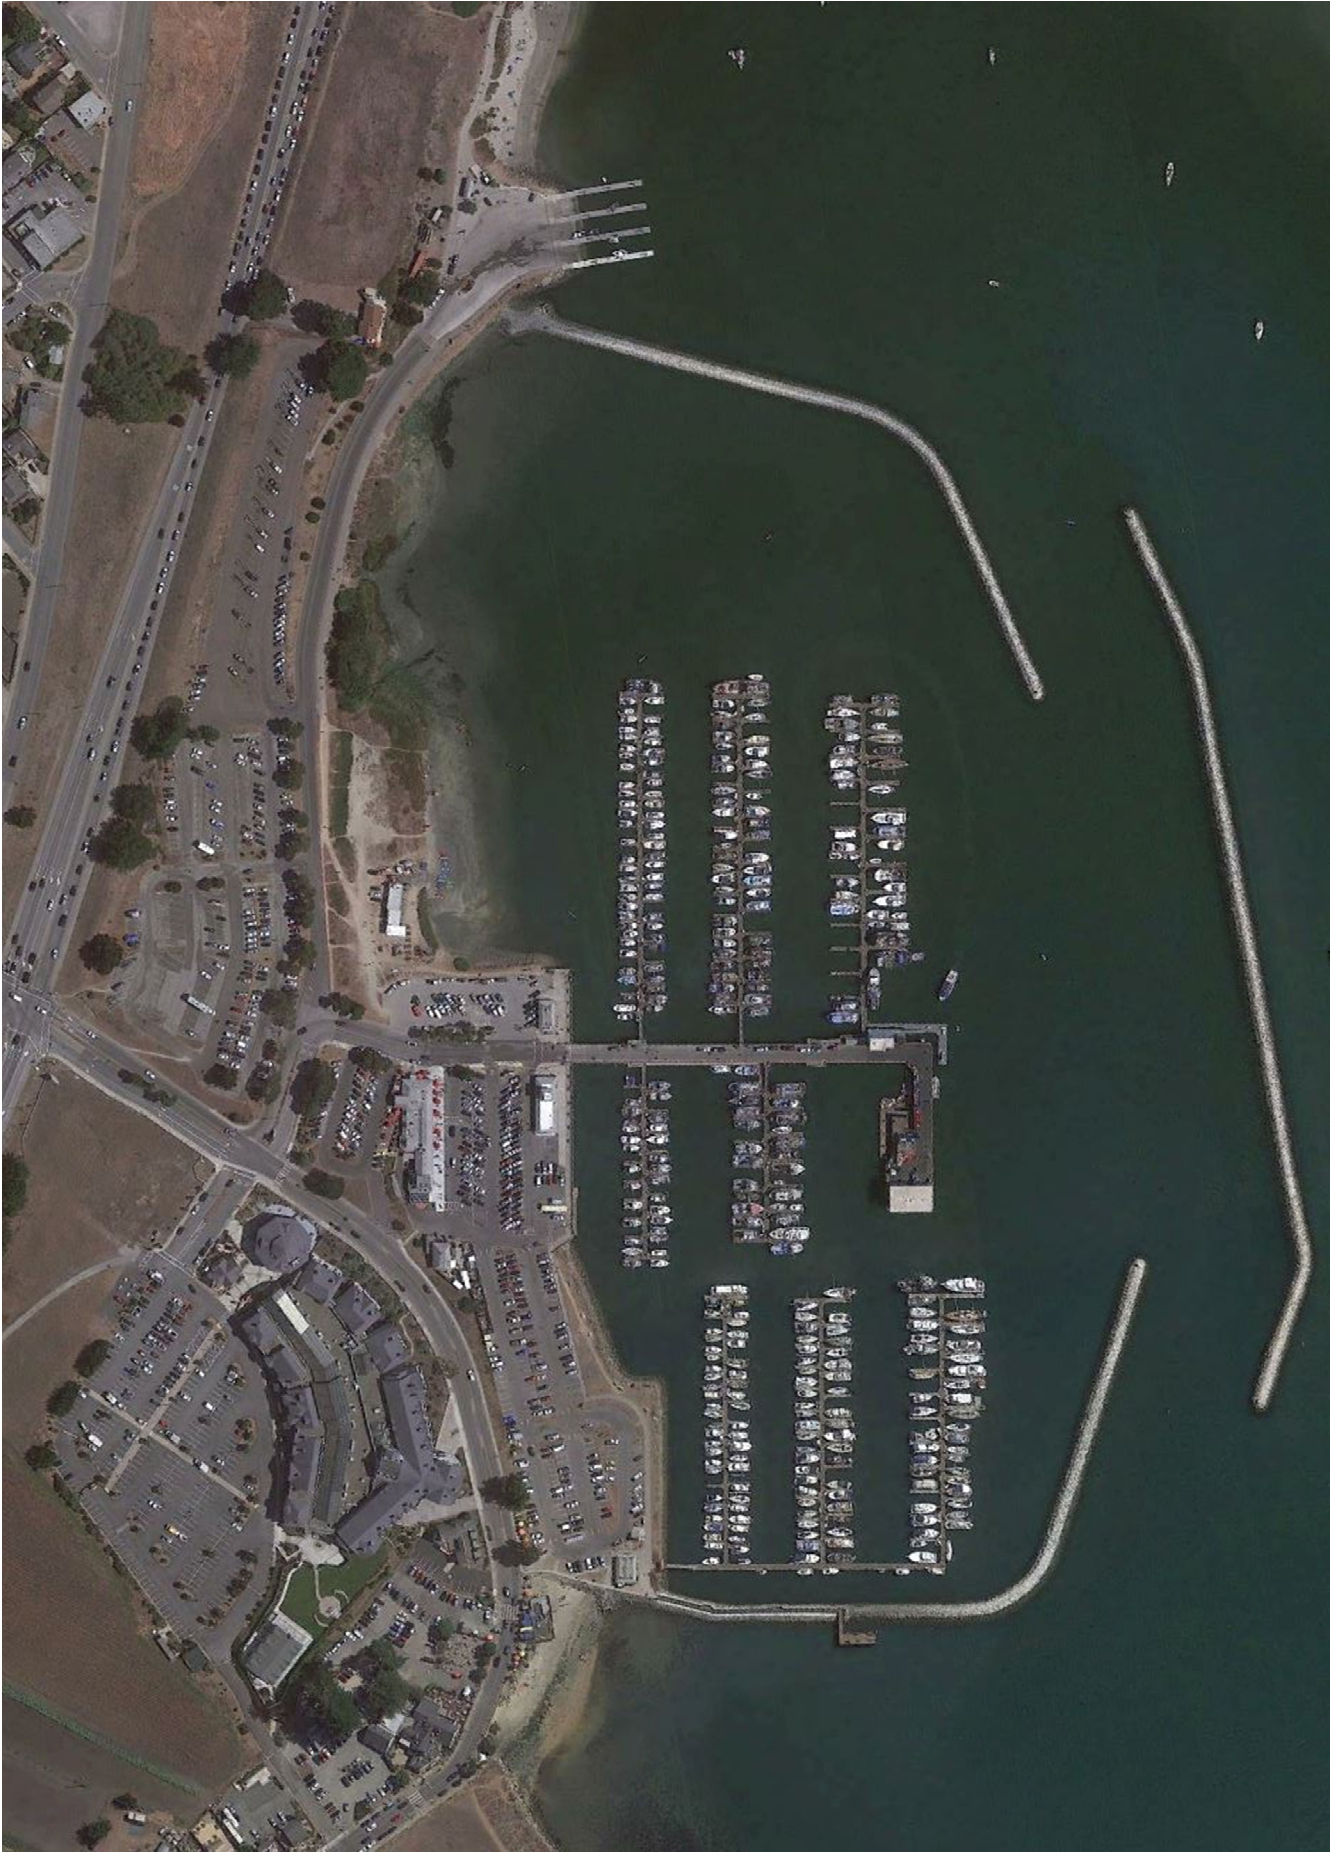
1 – Aerial view of harbor (source: Google Earth Pro)
